Stucco Report

Jack & Jill Home Buyers

Property Address:
11420 Bunny Rabbit Street
Leawood KS 66221

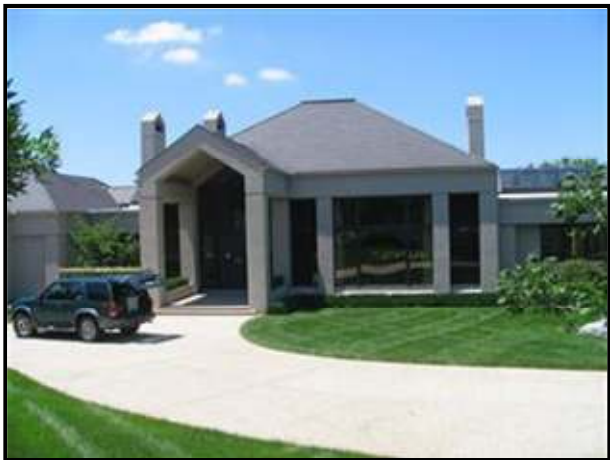
11.0.A Picture 1

1.- Front Elevation

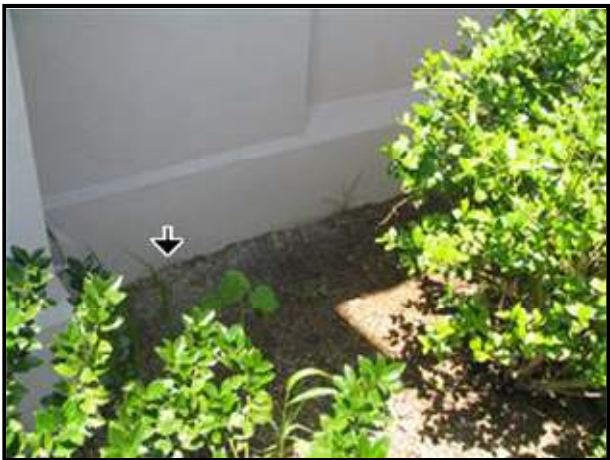
11.0.A Picture 2

- 2.- The stucco is too close to the soil. Right side of front door.
- 3.- The kickout flashing is improperly installed.
- 4.- General area of photo # 3
- 5.- Gaps in gable flashing (seal this)

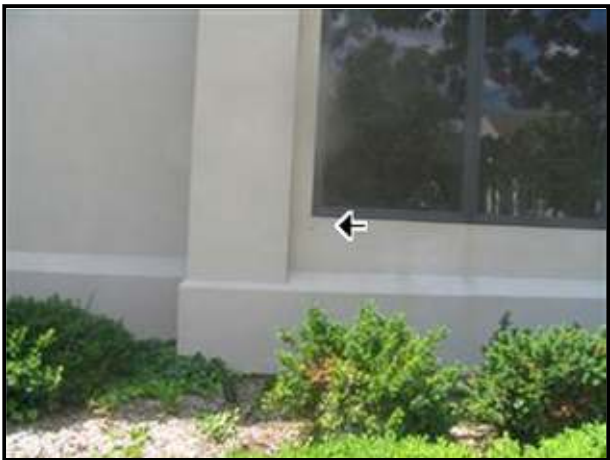
11.0.A Picture 6

6.- The moisture content when probed was: **8.7%**

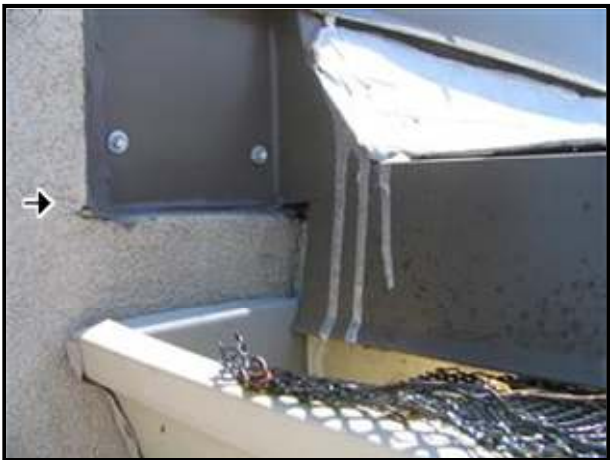
11.0.B Picture 2

2.- The kickout flashing is improperly installed.

Some kickout flashings appear to be installed improperly and/or improperly sized and need to be re-installed (they are failing). Kickout flashing should always penetrate the stucco cladding to function properly.

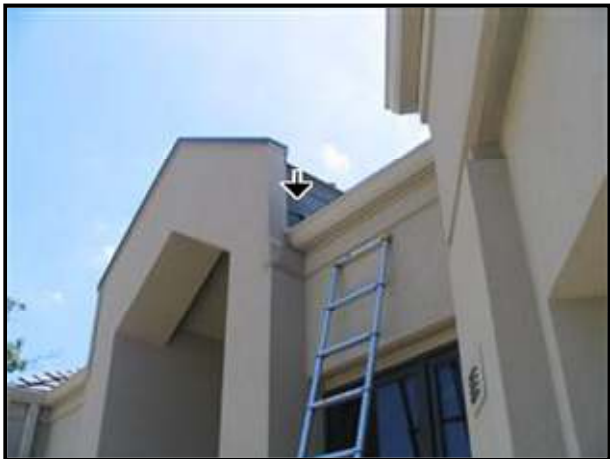
11.0.B Picture 3

3.- General area of photo # 3 The moisture content when probed was: 39.3% and substrate was soft

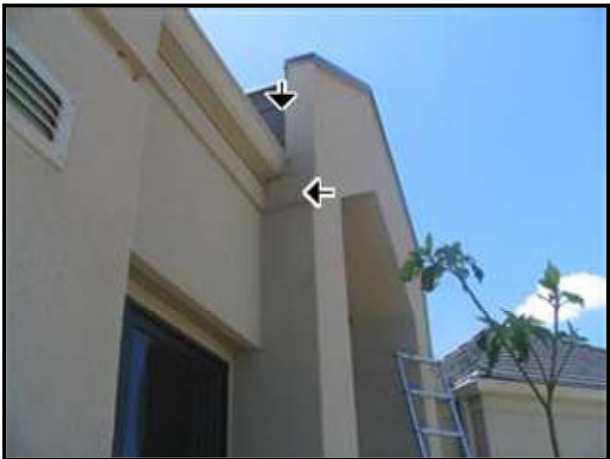
11.0.B Picture 4

4.- The kickout flashing is improperly installed. The moisture content when probed was: 32.2% and substrate was soft

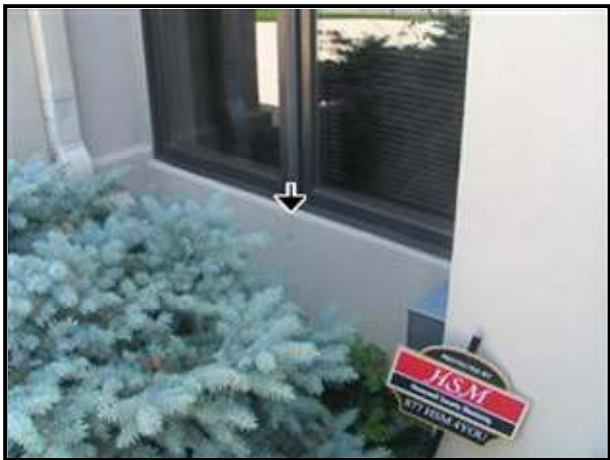
11.0.B Picture 5

5.- The moisture content when probed was: **20.3% Below the window, and substrate was soft.**

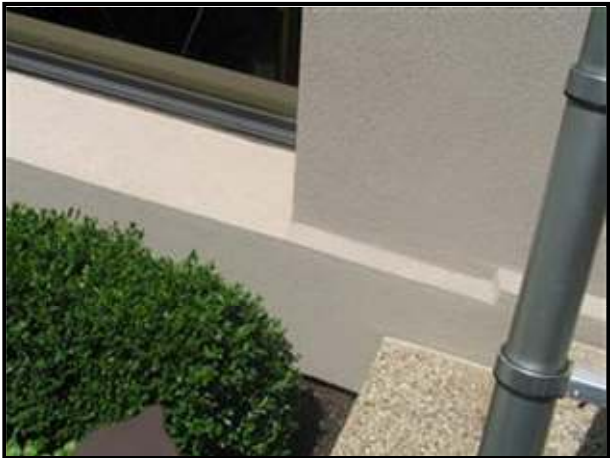
11.0.C Picture 2

2.- Cracks at stucco. Near back door (typical detail). The moisture content when probed was: **24.6% and substrate was firm**

There were areas where impact damage, cracks and/or holes were noted (see photos). These may allow moisture intrusion and should be repaired.

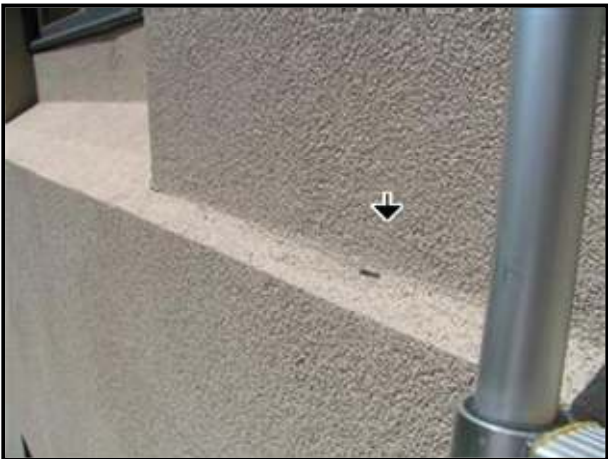
11.0.C Picture 3

3. - Separation @ flat area. Above photo # 2.

Not all of the flat accents and/or quoins were sealed, or sloped correctly. This can allow moisture to enter behind the stucco and cause moisture damage to the stucco and structure. Caulk, seal or slope all flat accents and/or quoins. Re-attach any loose accents or quoins.

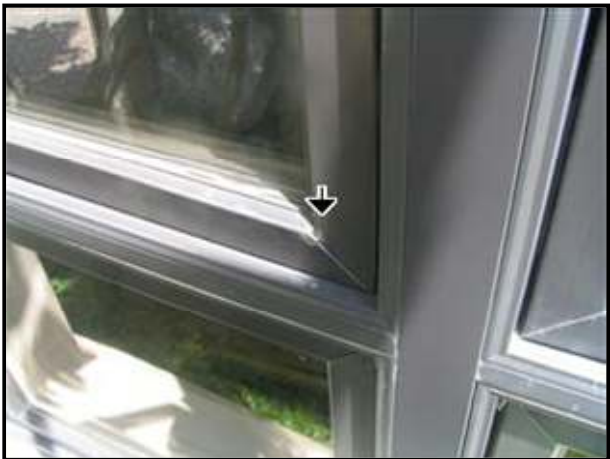
11.0.C Picture 4

4.- The windows(s) have separations at the sash cladding (most)

- The sashes of some windows do not fit squarely in the window frame. This causes the weather stripping to fit loosely and may allow water to penetrate the window assembly.
- Gaps in the window weather stripping can allow moisture into the window assembly. Repair and/ or install weather stripping or caulk as needed to keep out the moisture.
- The sash cladding is pulling loose, this can allow moisture in to the window assembly and then into the wall.

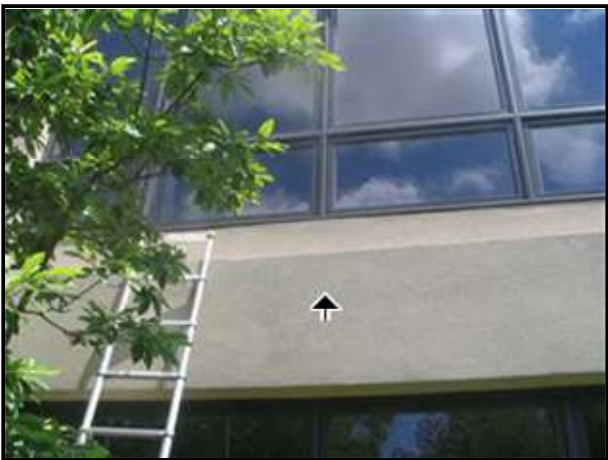
11.0.C Picture 5

5.- The moisture content when probed was: **34.9% and substrate was soft**

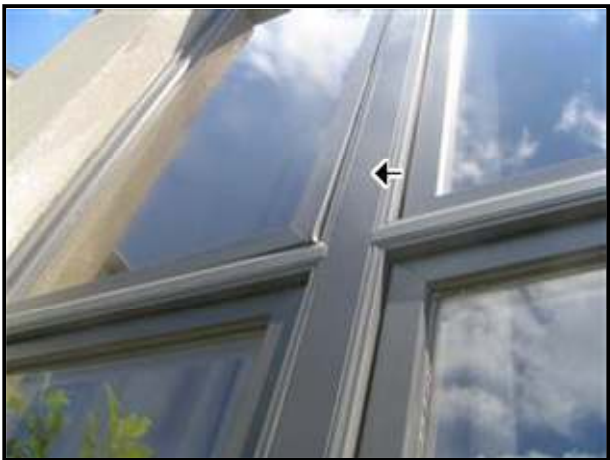
11.0.C Picture 6

6.- The window is damaged. Repair needed.

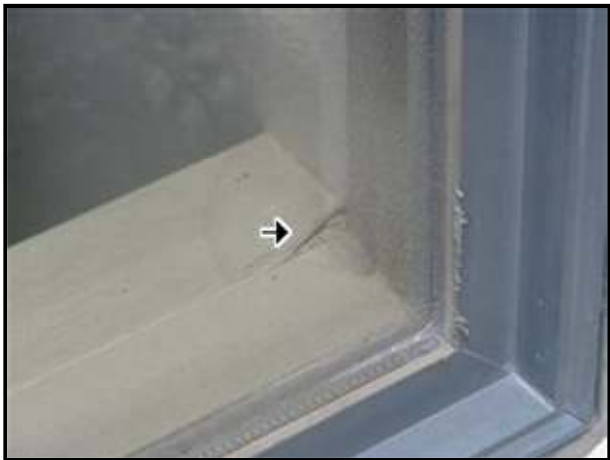
11.0.C Picture 7

7.- Interior water damage. Service and repair.

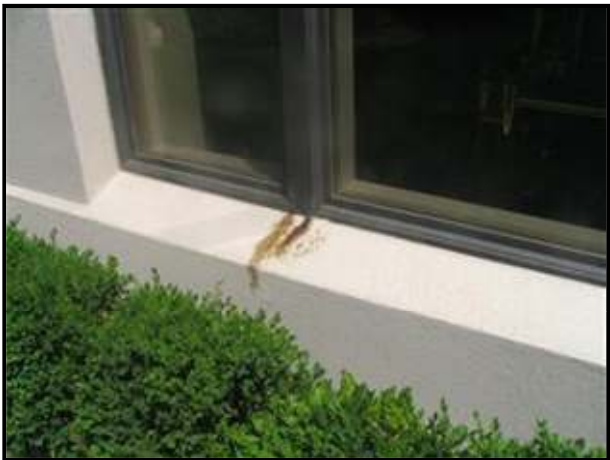
11.0.C Picture 8

8.- The stucco is stained.

There are areas where mold and/or mildew are present on the Stucco walls (see photos). These areas should be tested by an environmental specialist trained in detecting hazardous mold conditions. If the mold and/or mildew is non-toxic, it should be cleaned with a mild soap or cleaner recommended by the stucco manufacturer. Careful or no use of a high-pressure sprayer is advised Apply the cleaner using a sponge or brush.

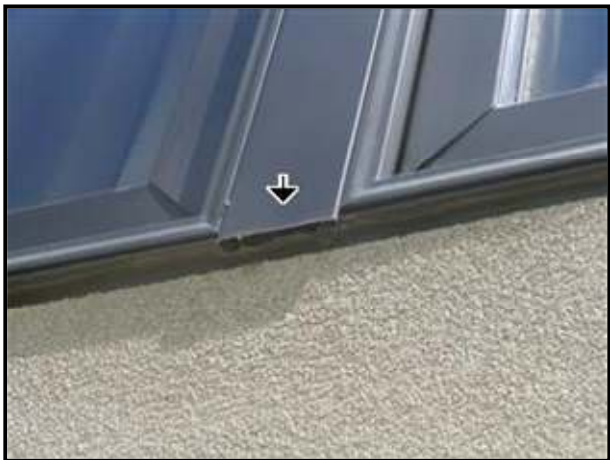
11.0.C Picture 9

9.- The caulking is improperly installed.

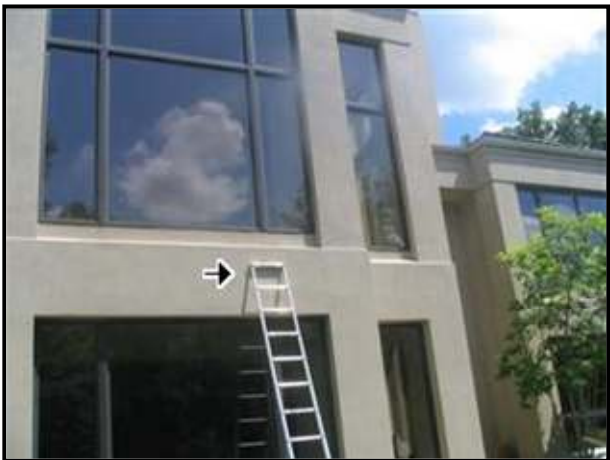
11.0.C Picture 10

10.- The moisture content when probed was: **40.0 % and substrate was medium soft**

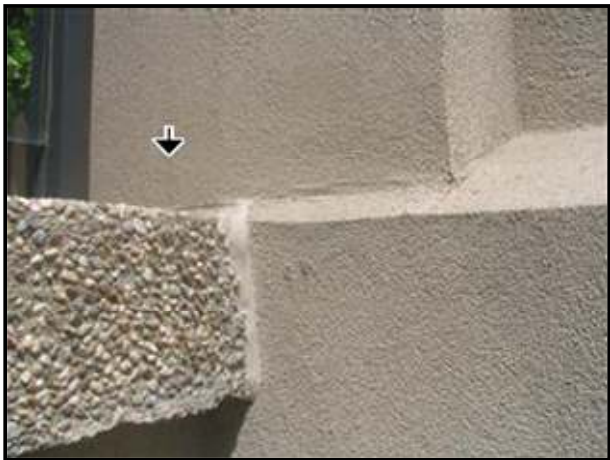
11.0.C Picture 11

11.- No visible flashings at the deck.

No visible deck flashing was noted. Install, repair or verify the existence of, an effective deck flashing.

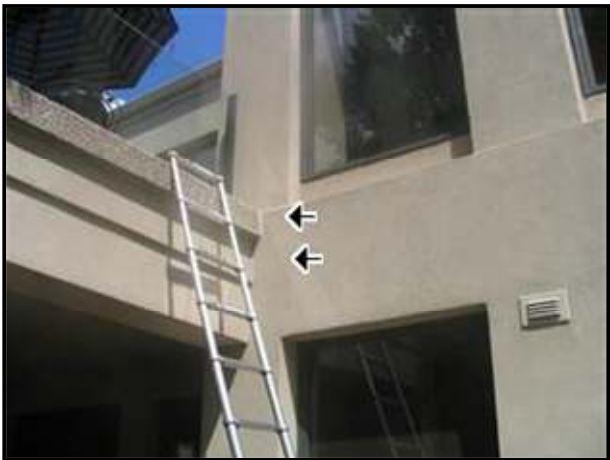
11.0.C Picture 12

12. - General area of photo #: 11 The moisture content when probed was: **19.0 % upper**, 11.0% lower

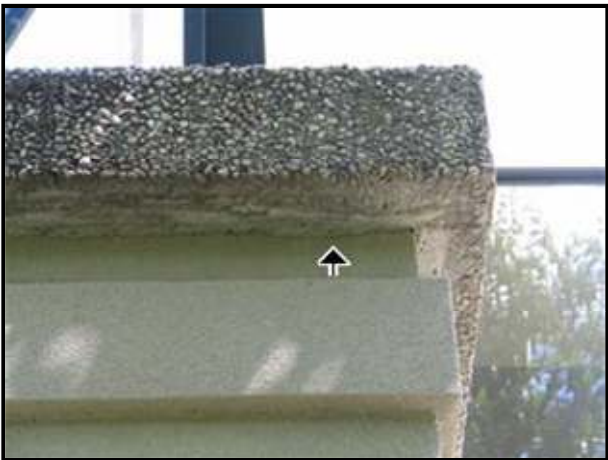
11.0.C Picture 13

13. - Caulking joint is missing.

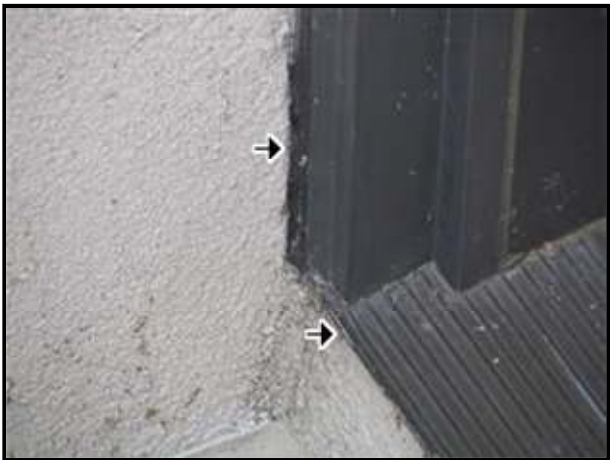
11.0.C Picture 14

14. - Caulking joint is missing. At deck door.

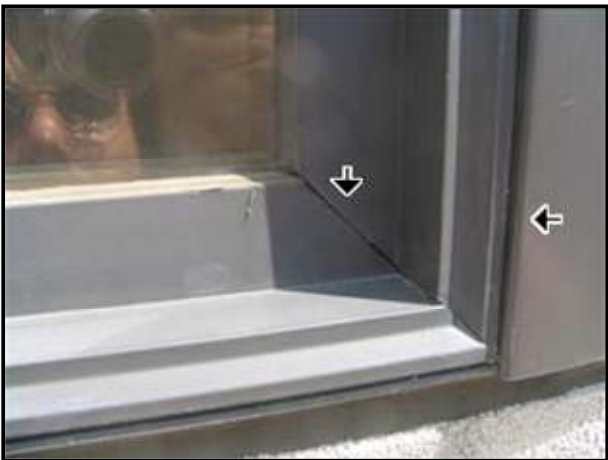
11.0.C Picture 15

15. - Caulking is missing.

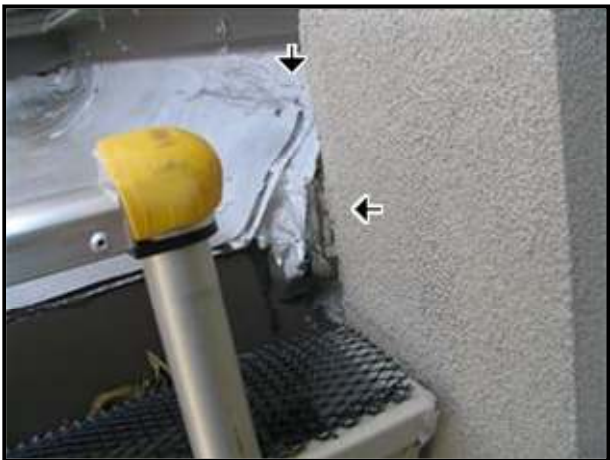
11.0.C Picture 16

16.- The kickout flashing is improperly installed. Above deck door.

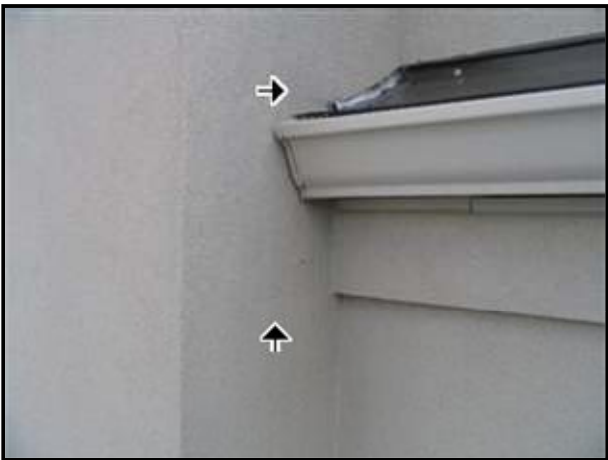
11.0.C Picture 17

17.- The kickout flashing is improperly installed. The moisture content when probed was: **19.0%**

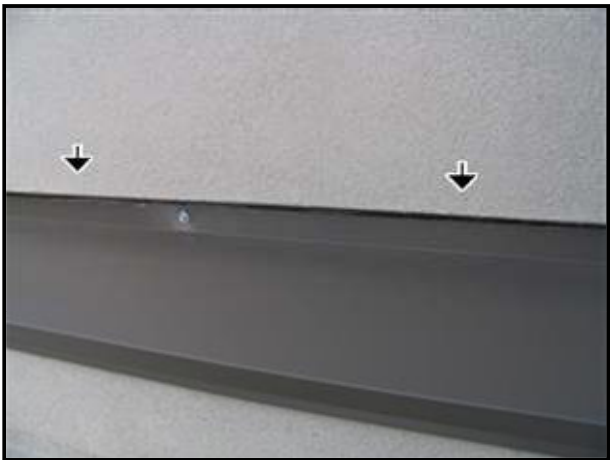
11.0.C Picture 18

18.- Gaps in roof flashing. At upper roof.

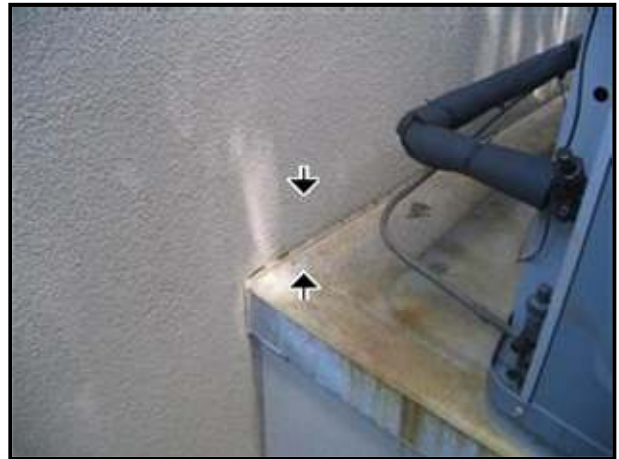
11.0.D Picture 2

2.- The stucco is too close to the slab. The caulking is failing / re-caulk.

Damage to the stucco can occur if is is too close to a concrete slab. Seal slab/wall joint and seal stucco at least 6" up the wall at front stoop area.

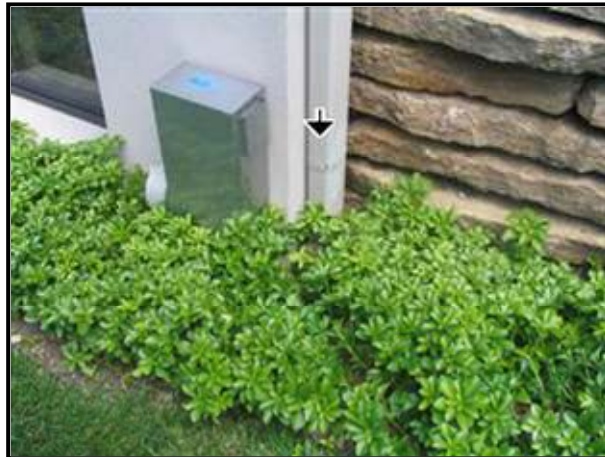
11.0.D Picture 3

3.- The stucco is too close to the soil. Service and correct.

Your stucco is in direct contact with the ground at several areas (see photos). These areas should be re-graded to prevent insect infestations and the possibility of moisture intrusion.
