Stucco Report

Property Address:
14367 Anyplace Street
Overland Park KS 66209

Holmes Inspection Company

Date: 7/13/2012	Time: 09:30:00 AM	Report ID: 876532
Property: 14367 Anyplace Street Overland Park KS 66209	Customer: Stucco Home Buyer	Real Estate Professional:

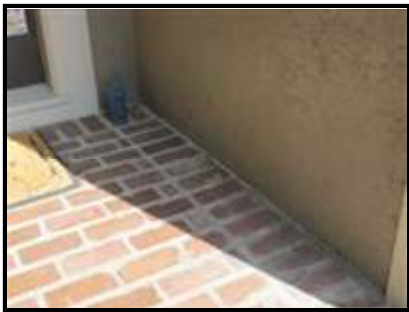
2.3 Picture 1

2.3 There were one or more locations where concrete slabs were too close and/or touching the stucco wall (front stoop and drive). This is a common but improper building practice. There should have been a space where they meet to allow any future movement of the slabs from causing cracks or moisture damage to the stucco walls. On drainage systems this allows water to escape from behind the stucco.

The slab/wall joint is caulked and we saw no damage at this time.

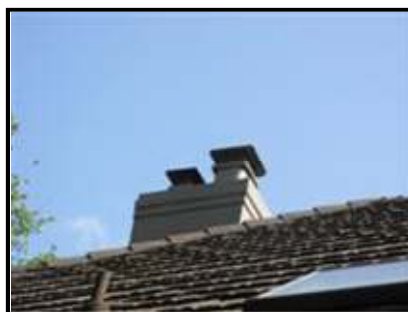
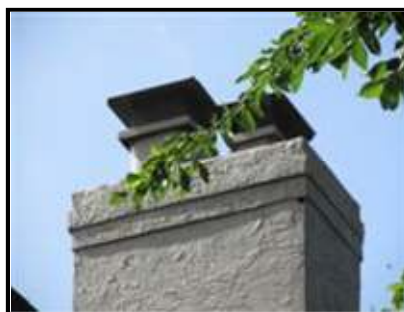
4.0 Too tall to fully see. Unknown

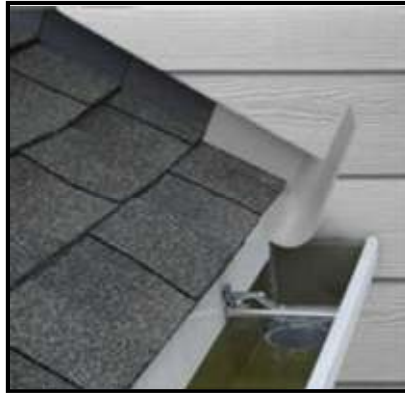
4.6 In a house clad with EIFS or stucco, there should be a **"kickout flashing"** installed at any area where a gutter meets a wall or at certain roof to wall junctions. At this home "kickout flashings" were either: not present at all recommended locations; not visible; or not properly installed OR sized according to industry design criteria at some areas. A contractor can install proper "kickout flashings" for about \$250-\$350 each. Missing or improperly installed "kickout flashings" have been a common moisture entry point on stucco homes.

4.6 Picture 1 Example - Good Kickout Flashing

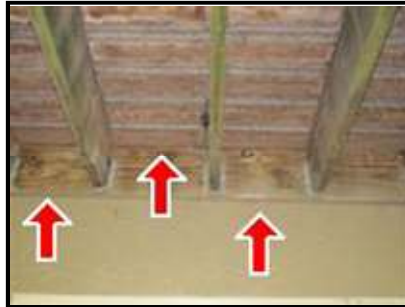
4.7 Picture 1

4.7 No visible deck flashing was noted. Install an effective deck flashing or verify an effective deck flashing as needed.

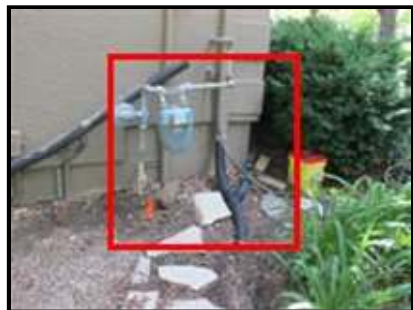
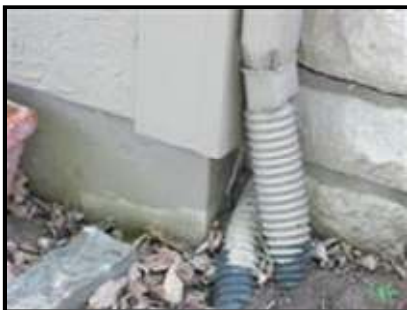
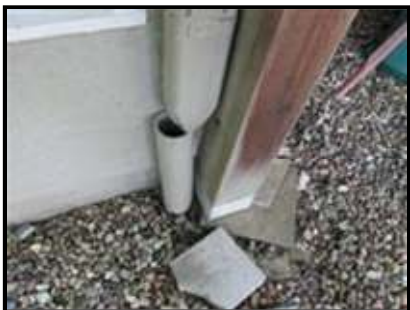
6.0 Gutter downspouts are small and crimped and can hold or slow down the flow of water off the roof areas and away from the stucco walls. Downspouts drain too close to the house at spots and can lead to leakage thru stucco like at SW corner / left side of building. Service and correction recommended (possibly oversized ones).

Downspouts needs to be adjusted to redirect water drainage away from the house.

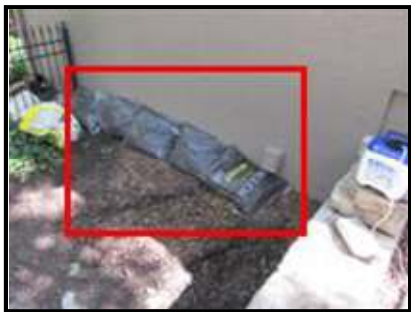
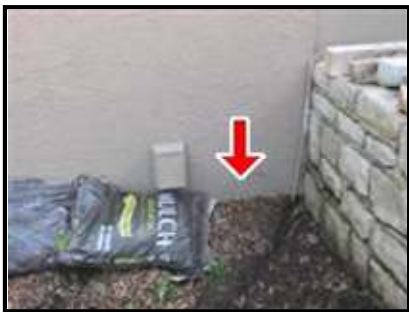
8.0 Your stucco is in direct contact with the ground at the left side (SW corner). This area should be re-graded to prevent insect infestations and the possibility of moisture intrusion.

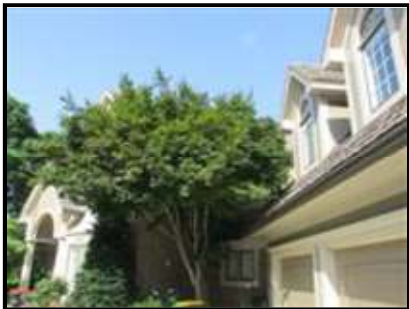
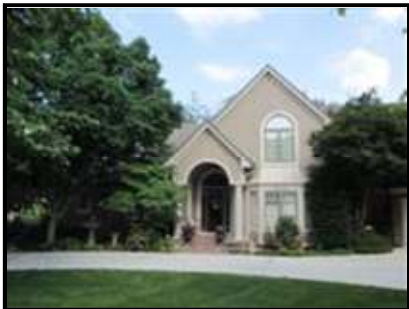
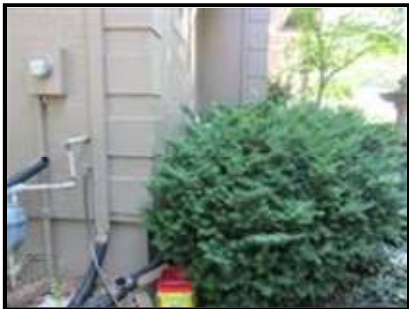
8.1 Bushes or other foliage are very close or rub the stucco walls at varied locations around the homes exterior. This can give pests an easy bridge into the home and can also allow for moisture damage. Always keep these bushes or other foliage trimmed well back from the walls or roofing. See Examples

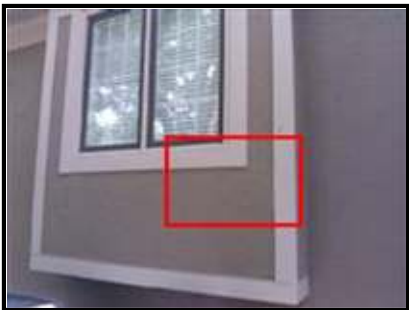
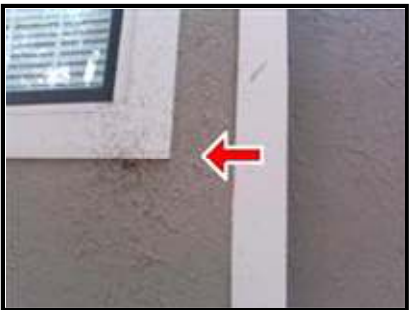
Ants of some type were noted coming out of house wall when probed. Left Side of house.

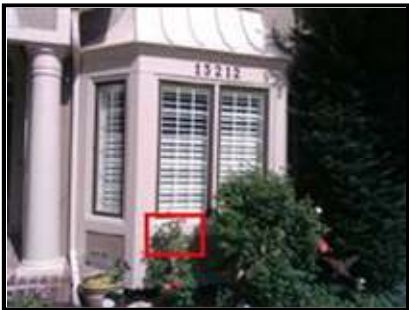
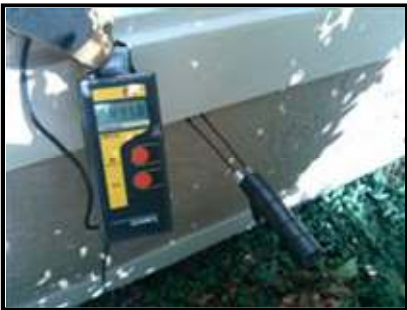
(2) The moisture content when probed was:45.8%

The substrate was MISSING when probed.

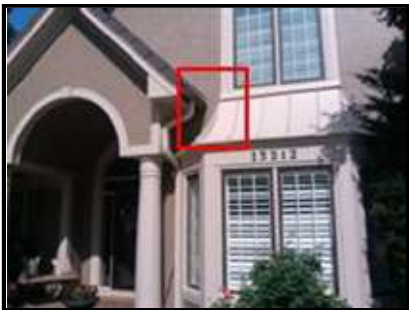
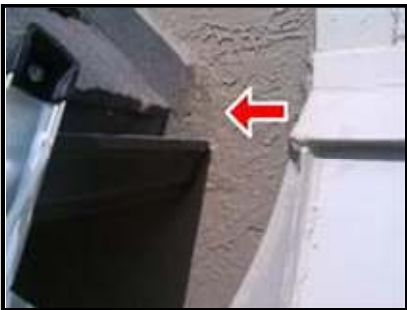
(3) The moisture content when probed was: 10.2%

The substrate was SOFT when probed.

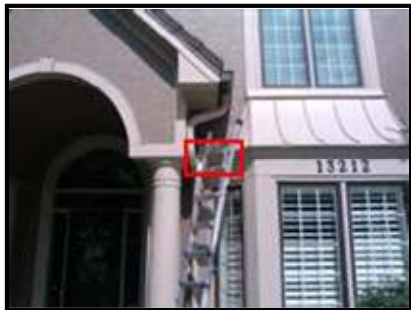
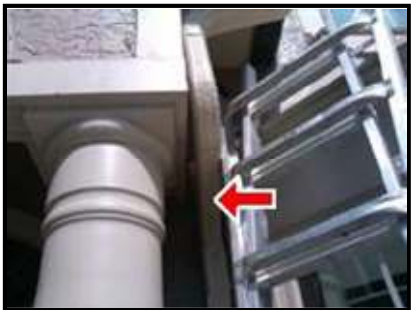
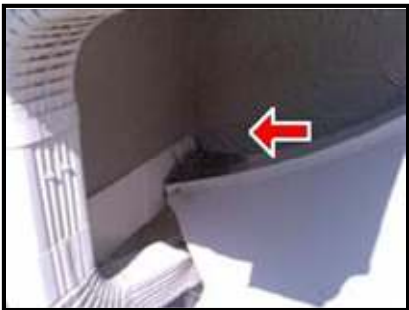
(4) The moisture content when probed was:18.9%

The substrate was MISSING when probed.

The kickout flashing is missing.

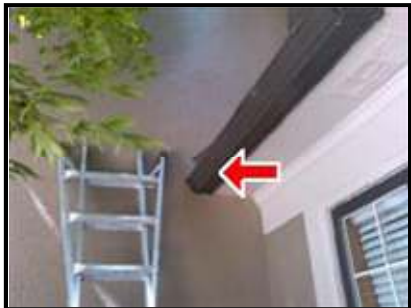
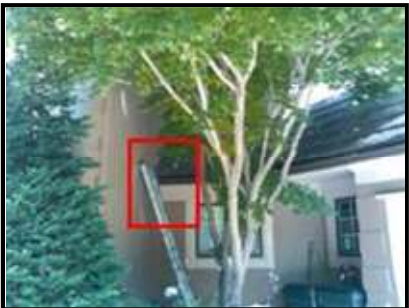
(5) The kickout flashing is missing.

The moisture content when probed was:14.2%

The substrate was SOFT when probed.

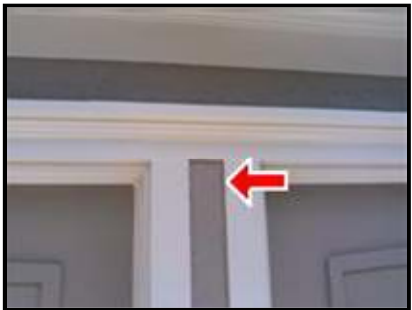
11.0 Picture 11

(6) The moisture content when probed was:9.7%

The Substrate appears SOLID where probed.

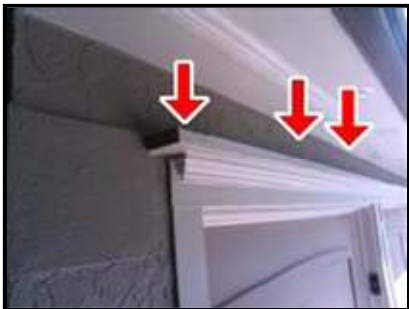
11.0 Picture 12

(7) Proper flashing is needed.

Caulking needed.

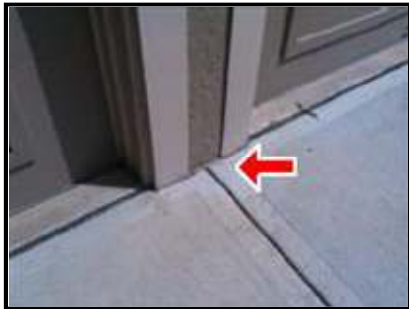
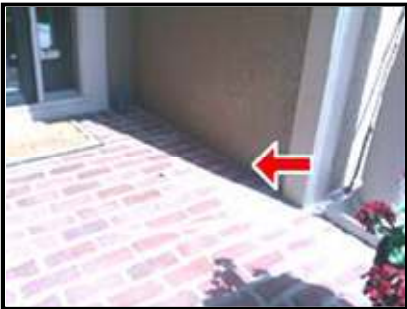
(8) The stucco is too close to the stoop and drive.

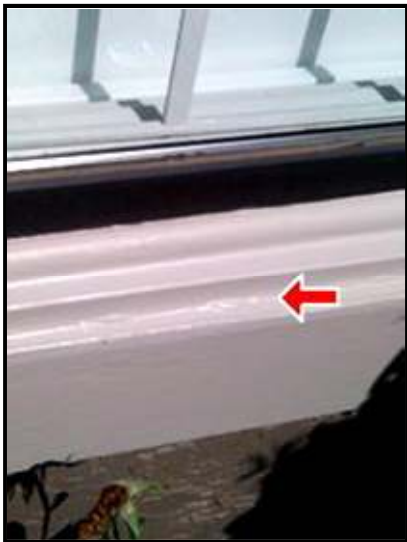
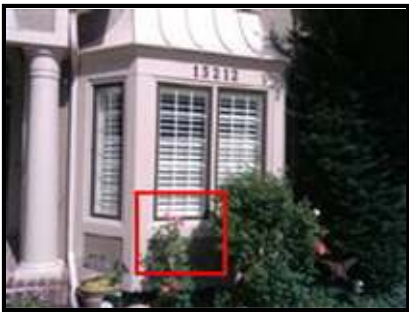
(9) The paint has adhesive failure. This usually is caused by moisture trying to escape.

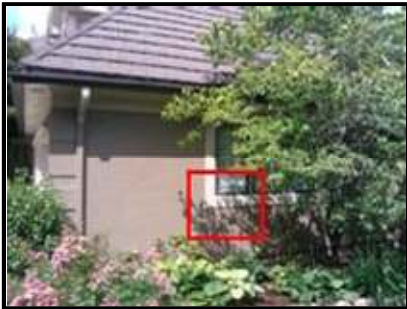
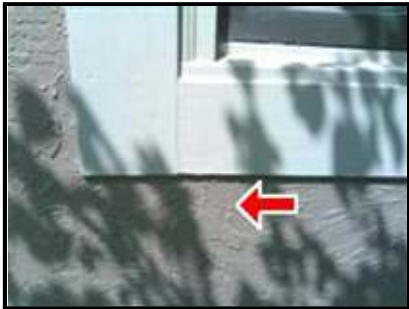
(11) The moisture content when probed was:34.2%

The substrate was MISSING when probed.

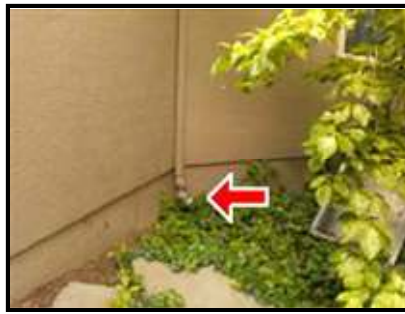
11.0 Picture 20

(12) Loose Downspout

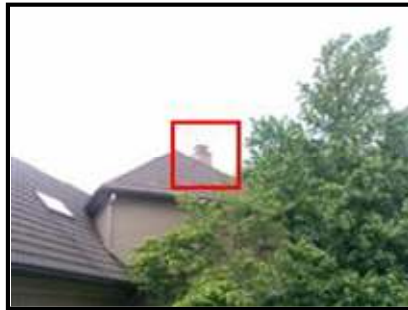
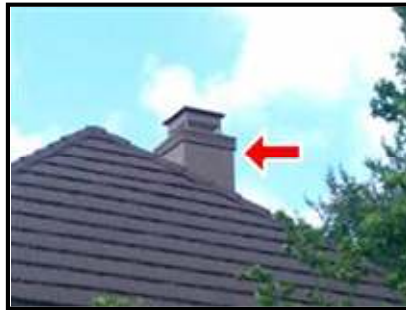
(13) Caulking needed.

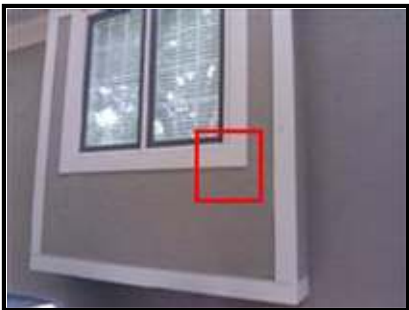
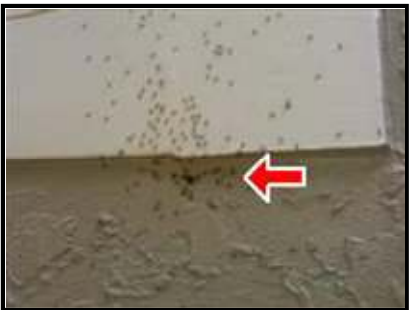
(15) The moisture content when probed was:18.2%

The substrate was MISSING when probed.

Ants noted

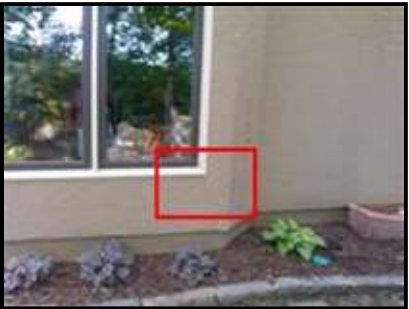
11.0 Picture 27

(17) The moisture content when probed was: 21.0%

The substrate was MISSING when probed.

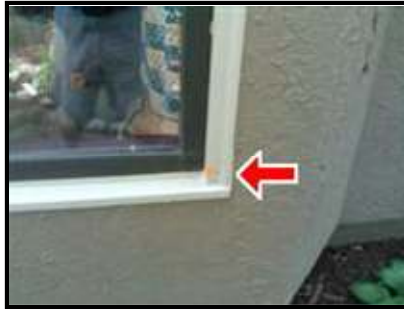
11.0 Picture 28

Wood rot.

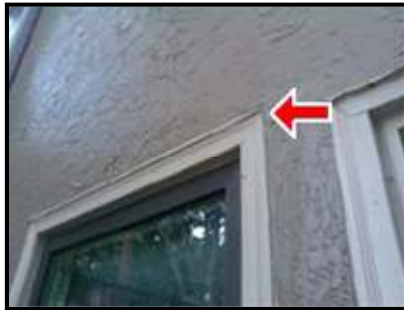
11.0 Picture 29

(19) Caulking needed.

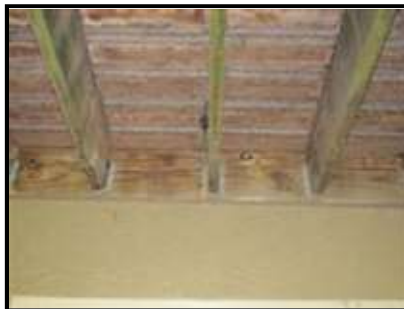
11.0 Picture 30

(20) The Deck flashing is missing.

The moisture content when probed was:29.0%

The substrate was MISSING when probed.

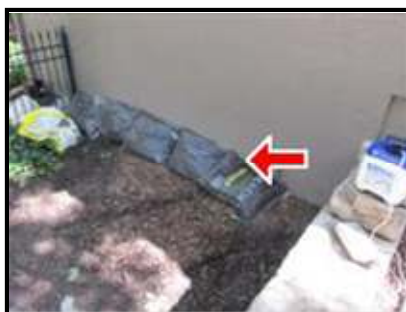
11.0 Picture 31

(21) The stucco touching the soil.
