# Stucco Report

**Property Address:**  
44556 Jones St  
Leawood KS 66211

**Holmes Inspection Company**

<b>Date:</b> 12/24/2014	<b>Time:</b> 11:35 AM	<b>Report ID:</b> JoCo8888888
<b>Property:</b> 44556 Jones St Leawood KS 66211	<b>Customer:</b> Olivia Stucco Buyer	<b>Real Estate Professional:</b> NONE

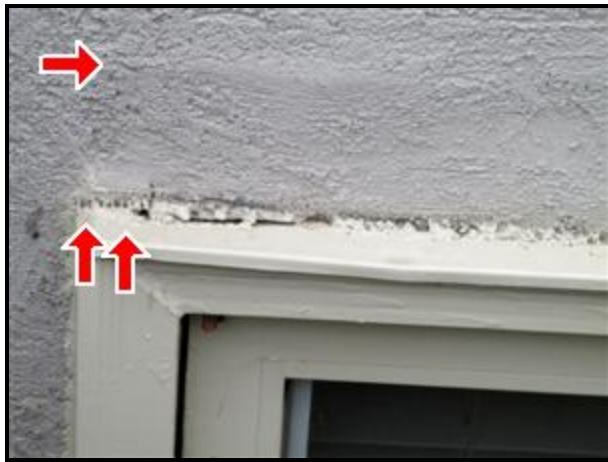
**2.2** The typical architectural details for a EIFS Stucco, such as on this building, is the presence of "Horizontal Control Joints" at floor lines on the exterior of the building. These joints help control cracking of the stucco by anticipating certain types of movement of the structure and the shrinkage/compression of the wood framing members. **This detail was not applicable to this building except possibly at a very small section over the daylight window at the right rear side of the building.** That area had bulging or compression movement to the stucco as well as mesh showing through at two areas. We recommend having a competent stucco contractor repair or modify this detail as needed.

2.2 Picture 1 Exposed Mesh & Bulge

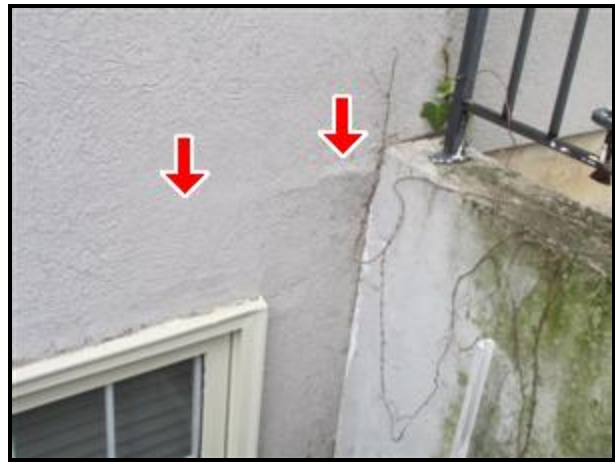
2.2 Picture 2 Bulge or Compression

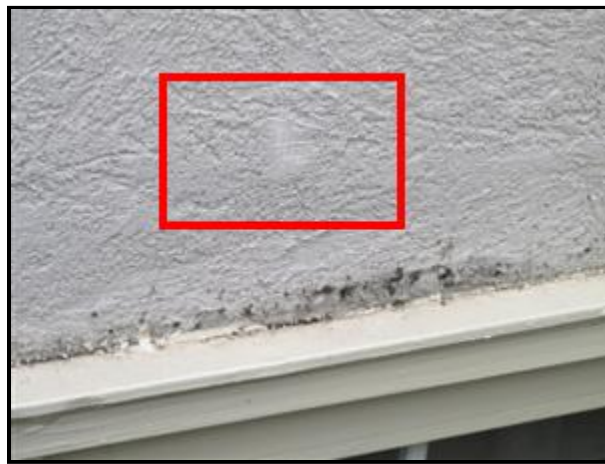
2.2 Picture 3 Mesh Showing Through

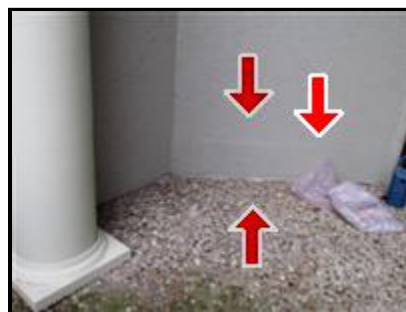
2.3 Picture 1

**2.3** There was one location where concrete slab were touching the EIFS / stucco wall. This is a common but improper building practice. There should have been a space where they meet (with a metal flashing at the junction) to allow any future movement of the slabs from causing cracks or moisture damage to the stucco walls. On drainage systems this allows water to escape from behind the stucco.

The EIFS wall had bulging or compression at this area. Seal slab/wall joint and seal stucco about 6" up the wall.

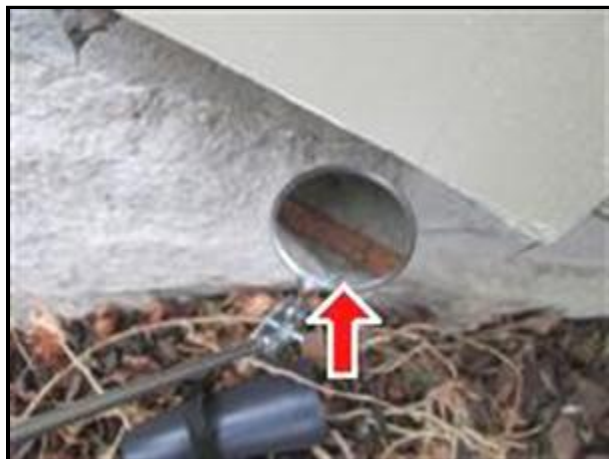
2.4 Looking under the walls AND inside the open holes in the stucco at several locations shows poly-iso foam and plastic mesh (EIFS).

2.4 Picture 1 Foam Under Wall

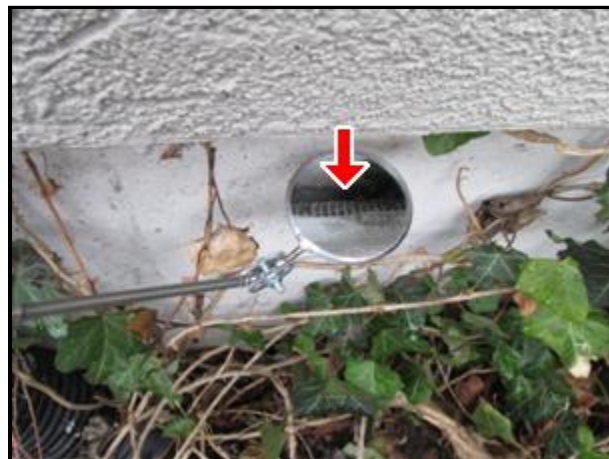
2.4 Picture 2 Plastic Mesh Under Wall

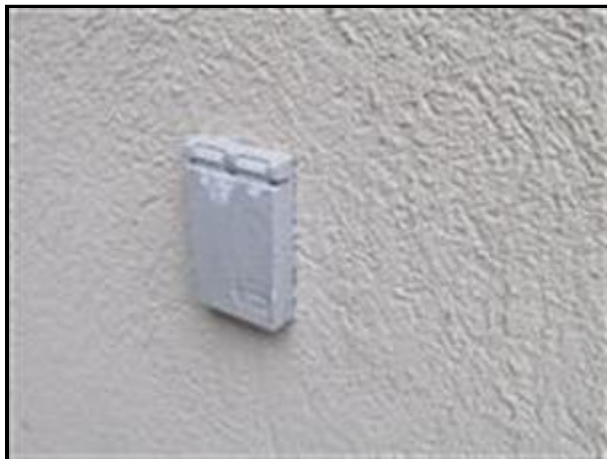
**3.2** Anywhere an electrical line, gas line, light fixture, plumbing hose bibb, etc. penetrate the exterior walls they are commonly called a "breach location" in the stucco world. Although some breach locations were properly sealed, others were not (see example in pictures). Caulk or re-seal any place below the soffit line where stucco meets another material such as around dryer vents, hose bibbs, electrical outlets or light fixtures, cable TV openings, freon lines, and other penetrations of the wall cladding materials.

3.2 Picture 1 Example of Breach

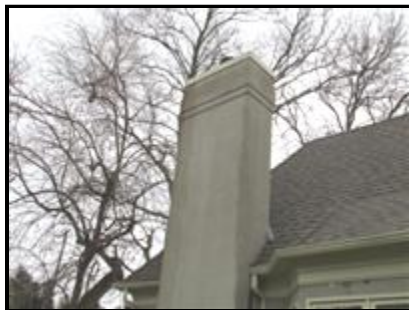
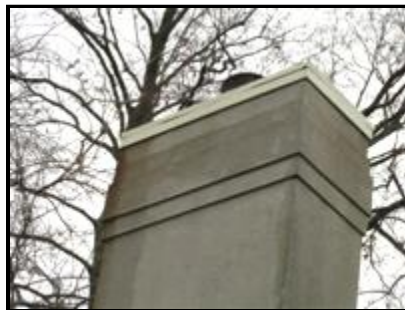
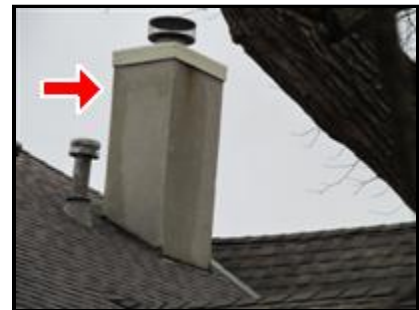
**4.0** Both the chimneys had metal caps to help prevent moisture intrusion BUT both had heavy staining on them NOT only at the metal chimney cap level running down the sides but at the missing kickout flashing areas. We recommend having a chimney sweep OR roofer check them and if needed install or repair any defects at the caps, trim, etc to prevent moisture intrusions. All gaps should be sealed.

4.0 Picture 1 Left Chimney

4.0 Picture 2 Left Chimney

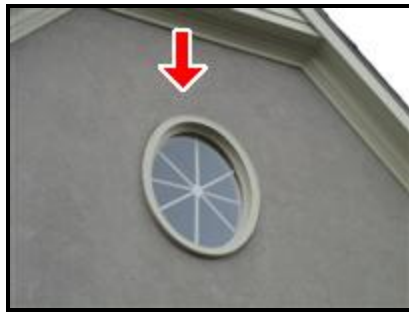
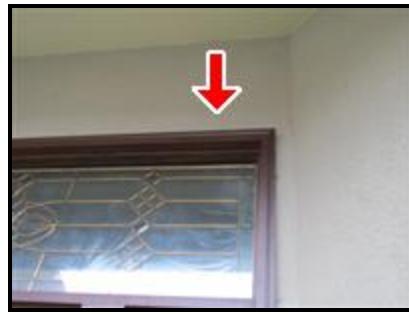
**4.2** There were some windows and trim around windows and doors (octagon window in garage gable and front door, etc) with no visible flashings. Some windows or doors may have a integral flashing fin built into the window. Verify with the builder or building designer as to how this detail was handled.

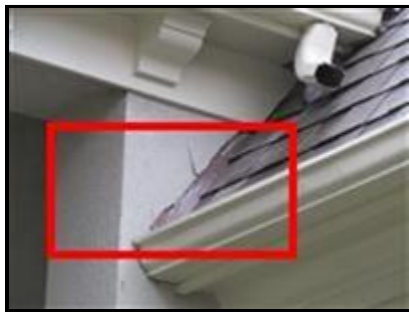
**4.5** (1) In a house clad with stucco, there should be a "kickout flashing" installed at any area where a gutter meets a wall or at certain roof/wall junctions like around the chimney, etc. At this home "kickout flashings" were not present at recommended locations (either side of front entry, on either side of the Left chimney, and at the rear of the home left of deck). All of these areas had varying degrees of staining to stucco surface. Missing or improperly installed "kickout flashings" have been a common moisture entry point in stucco homes.

4.5 Picture 1 Front Entry

A properly sized, designed and sealed "Kick-out Flashing" should be installed at any roof-to-wall intersection to help divert water away from the structure (this can help prevent moisture damage to the building and staining to walls). We recommend service and correction by a qualified and licensed roofing contractor.

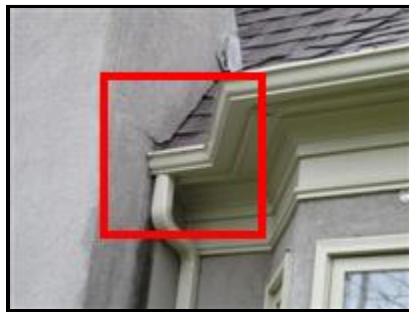
4.5 Picture 2 Left Chimney

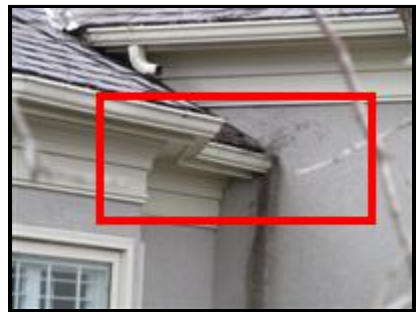
4.5 Picture 3 Rear of Home

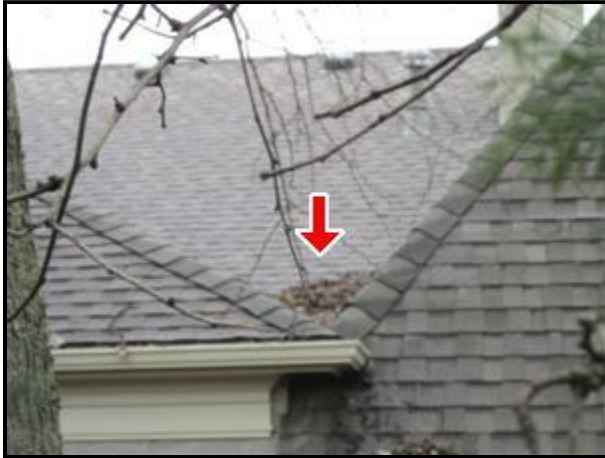
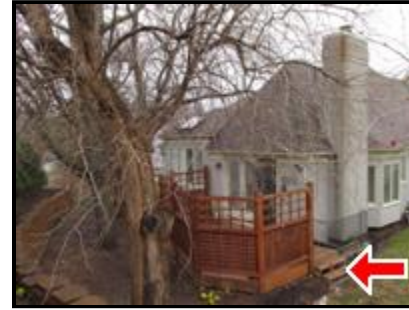
**4.6** This area is at the rear of the home. The roof area was clogged with leaves and we did not see how they would be easily washed off by rain water. Have stucco or roof contractor verify this (service or modify if needed).

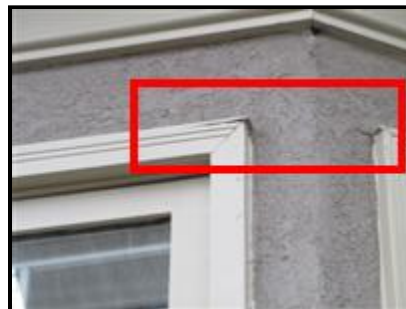
**4.8** (1) There were some trim pieces with improper flashings (raised, short, etc) OR missing (octagon window & front door). Installation and/or service of these is suggested. Repairs may include; end dams created, sealing overlaps, caulking the bottoms, bent flashing straightened, installing if missing, etc.

4.8 Picture 1 Rear

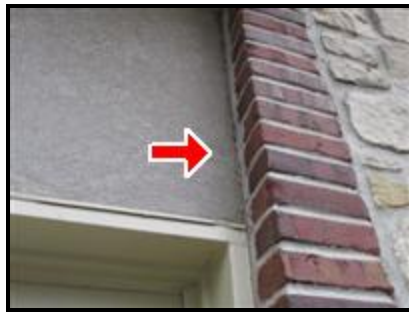
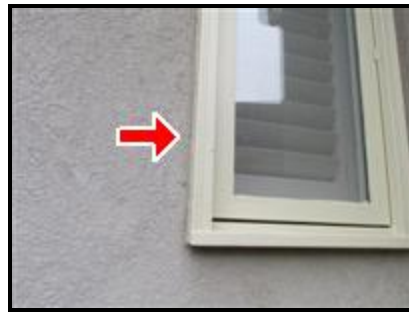
(2) There was no visible caulk joint at areas like windows, doors, where stucco meets another building material like brick, stone or wood, etc. Typically on a house clad with stucco or EIFS we should see a 3/8" gap around areas like the windows, doors, other materials, etc - a "backer rod" is then placed in the gap and this area is properly sealed - this detail did not appear to be visible on this home. We would suggest contacting the builder and/or reviewing the original engineering details and blueprints to validate the absence or presence of this detail and to find out how this detail was handled. Repair or modifications may be needed. See Examples in Pics.

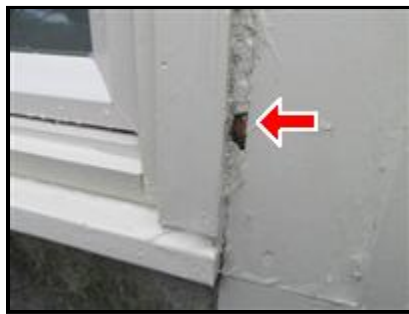
**5.0** Rot, previous repair, peeling paint, questionable caulking or moisture deterioration was noted at various windows and the deck doors. When windows or doors have wood rot this can allow water to penetrate the assembly and enter behind the stucco system. Service, Repair or Correction Recommended.

5.0 Picture 1 Front Bow

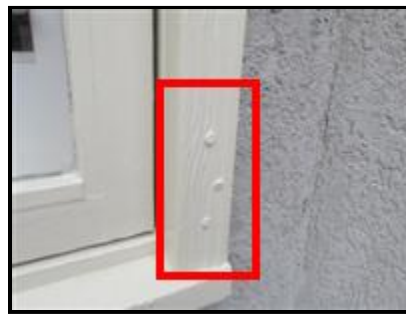
5.0 Picture 2 Previous Repair - Left Side

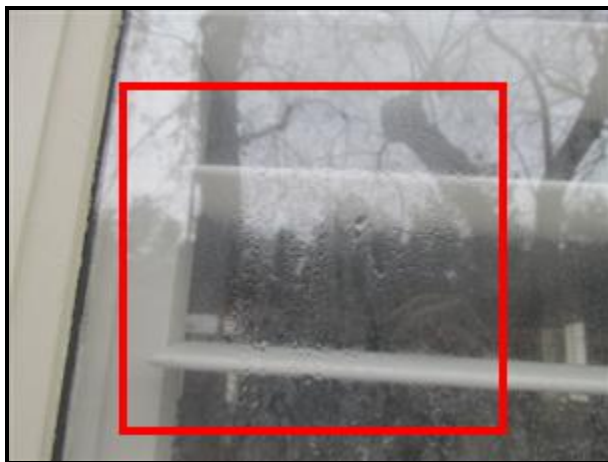
**5.1** We noted what looks like thermal seal failures at 1 or more glass panes such as, the window left side of home, the deck sliding door(s) and windows left of deck. Service / repair.

5.1 Picture 1 Deck Door

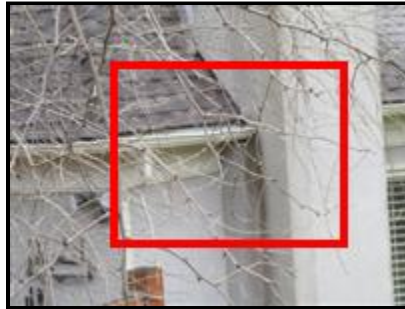
6.0 Picture 1

**6.0** Gutters were clogged at multiple locations (large trees close by) and should be cleared of all debris. The gutters at the rear / side (such as by chimney) are bowed and/or sloped wrong to drain properly ..... Have contractor align and reslope all gutters as needed to drain to downspouts properly.

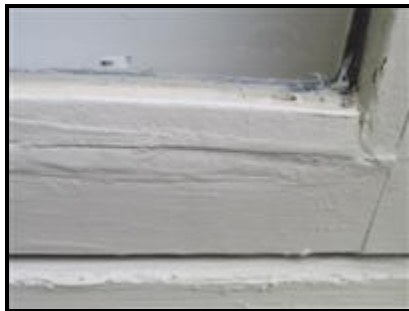
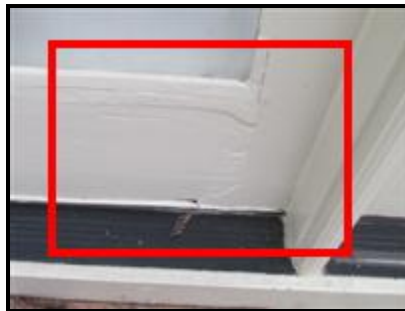
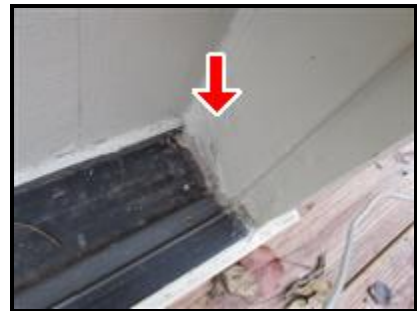
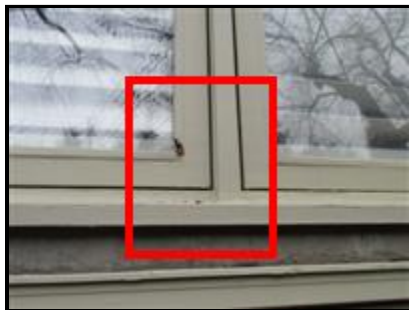
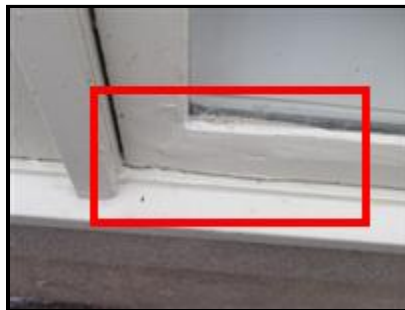
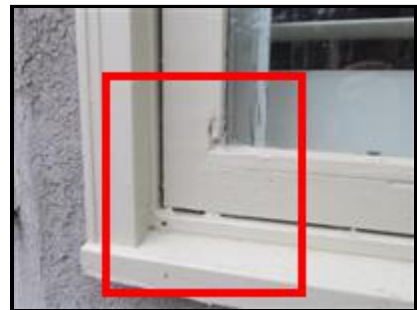
**7.0** On the surface what looks like minor wood rot and/or moisture damage was present at multiple wood window, door or trim surface locations. We **DID NOT** do moisture testing or probing into the wall system, windows, doors, trim, etc. Service and Repair as needed. See Examples

More rot could be revealed at other areas with extensive probing. Have a contractor probe and repair these areas as needed.

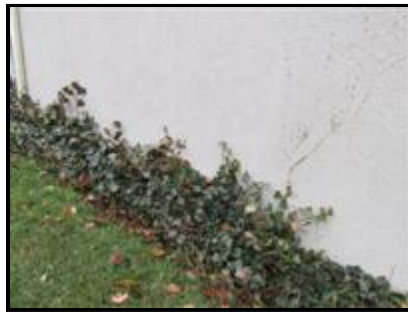
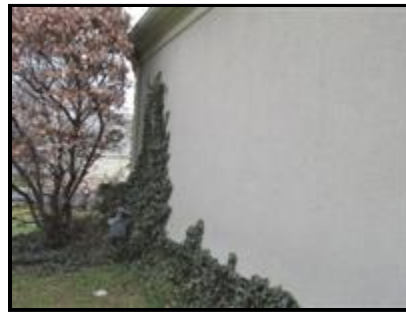
**8.1** Bushes or other foliage rub the stucco walls at various locations around the homes exterior. This can give pests an easy bridge into the home and can also allow for moisture damage. Common homeowner maintenance will include keeping the bushes or other foliage trimmed back from the walls.

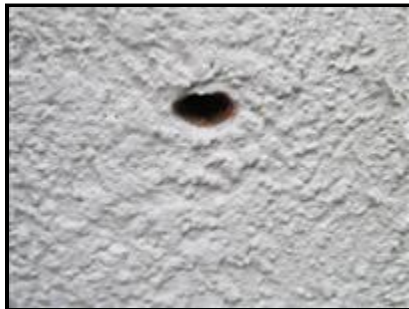
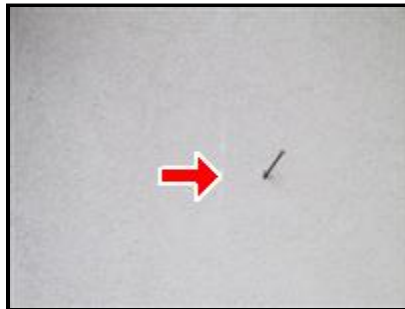
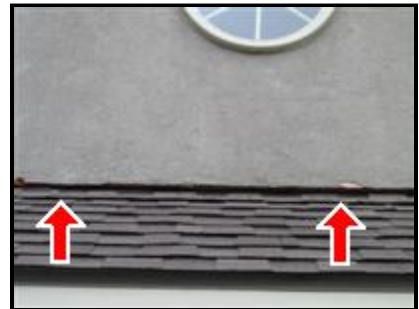
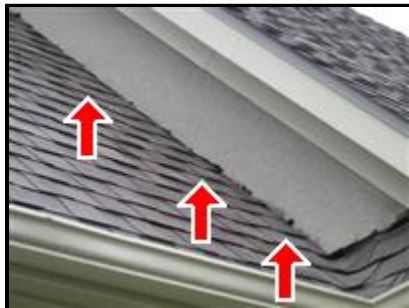
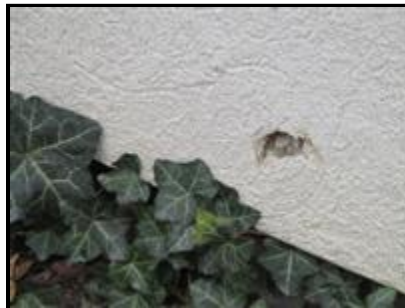
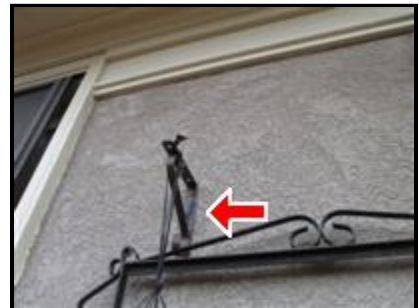
**9.0** There were multiple areas around the home where minor impact damage, previous repairs, nails or screws thru the stucco, chipped stucco with exposed mesh or foam. and cracks and/or holes were noted. These could allow moisture intrusion. Service and repair needed.

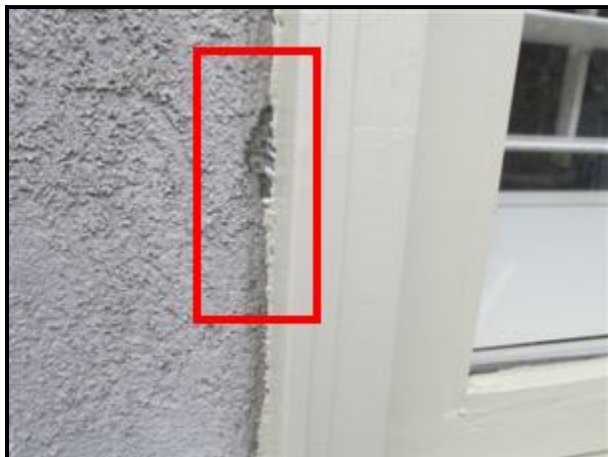
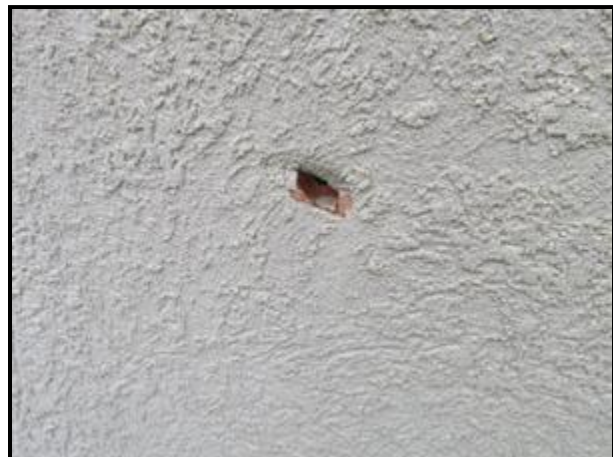
9.0 Picture 7 Left Side / Mesh Visible

9.0 Picture 8 Right Side

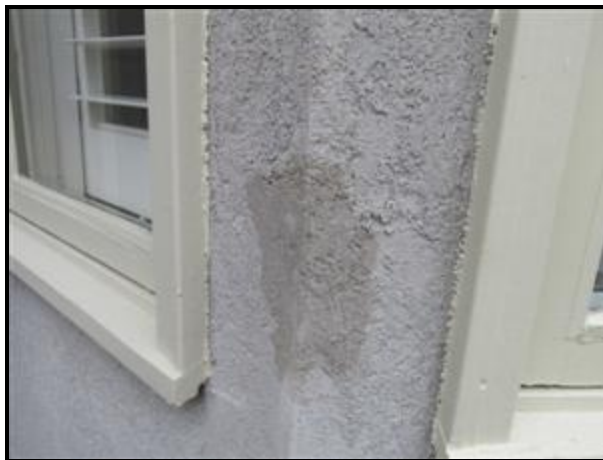
9.0 Picture 9 Left Side Home

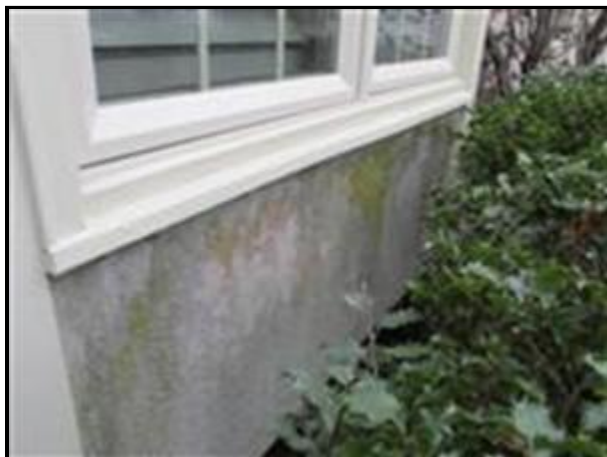
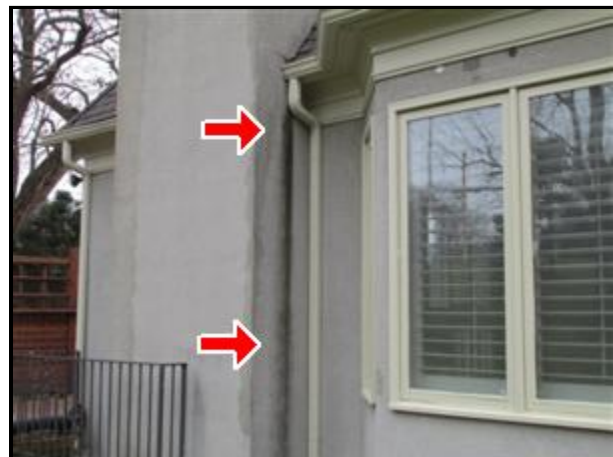
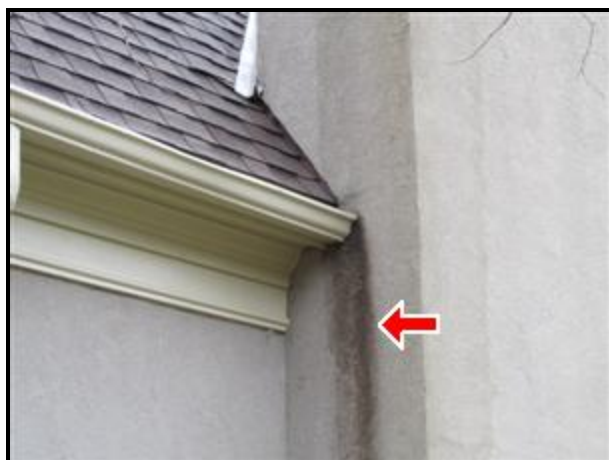
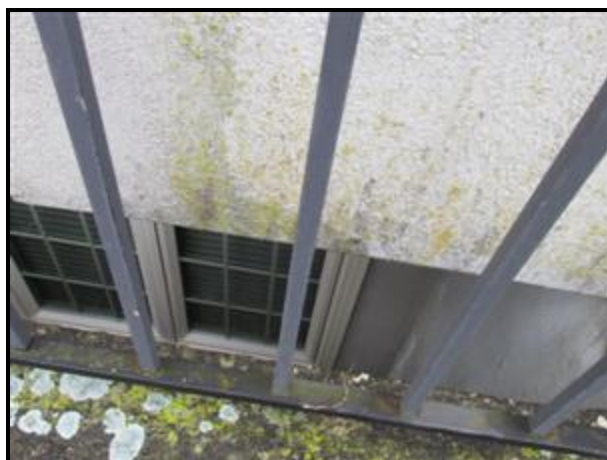
**9.1** (1) There are areas on all sides of the home where heavy stains and/or a mold like substance are present on the stucco walls and/or trim (like by chimneys, under missing kickout areas, by rear deck and under front bow window, etc). These areas should be cleaned with a mild soap or cleaner recommended by the stucco manufacturer. Careful or no use of a high-pressure sprayer is advised. Apply the cleaner using a sponge or brush.
