Inspection Report

Property Address:
4478 SW Sample Dr
Columbia MO 65203

Dan Bowers Company

Date: 1/11/2022	Time: 10:00 AM	Report ID: Sample EIFS
Property: 4478 SW Sample Dr Columbia MO 65203	Customer: John Doe	Real Estate Professional: NONE

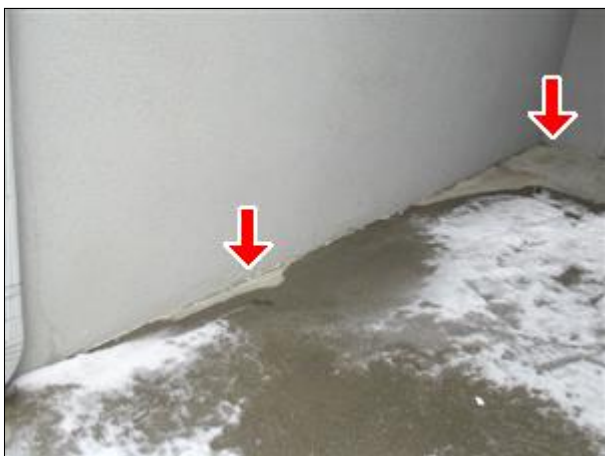
2.3 Picture 1

(1) There were multiple locations where concrete slabs or other flatwork were too close and/or touching the stucco wall(s). This is a common but improper building practice. There should have been about a 2' space or gap where they meet to allow any future movement (like soil heaving) of the flatwork from causing cracks or moisture damage to the stucco walls. It can also help prevent moisture "wicking" up into the wall cavities. Some stucco is porous and this can help allow moisture to escape from behind the stucco rather than accumulating in the wall cavity.

The slab/walls show damage at some areas. Repairs or modifications are needed.

Solution: Stucco industry details have flashing at the base of the wall, **OR** alternatively, a 2" clearance above the hard surface or an integrated weep screed. Install proper flashing and/or weep screed per stucco manufacturer's recommended repair details and specifications.

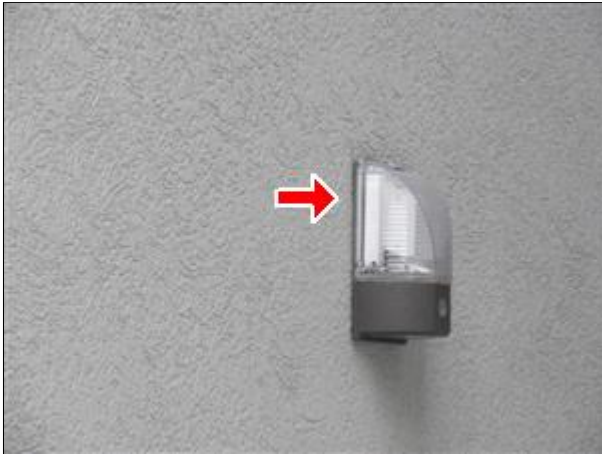
3.1 Picture 1

Anywhere an electrical line, gas line, light fixture, plumbing hose bibb, etc. penetrate the exterior walls they are commonly called a **"breach location"** in the stucco world. Most breach locations were improperly sealed OR not sealed. Have a competent stucco contractor caulk or re-seal any place below the soffit line where stucco meets another material such as around light fixtures, electrical outlets, hose bibbs, gas lines, freon lines, dryer vents, cable TV openings, and other penetrations of the wall cladding materials.

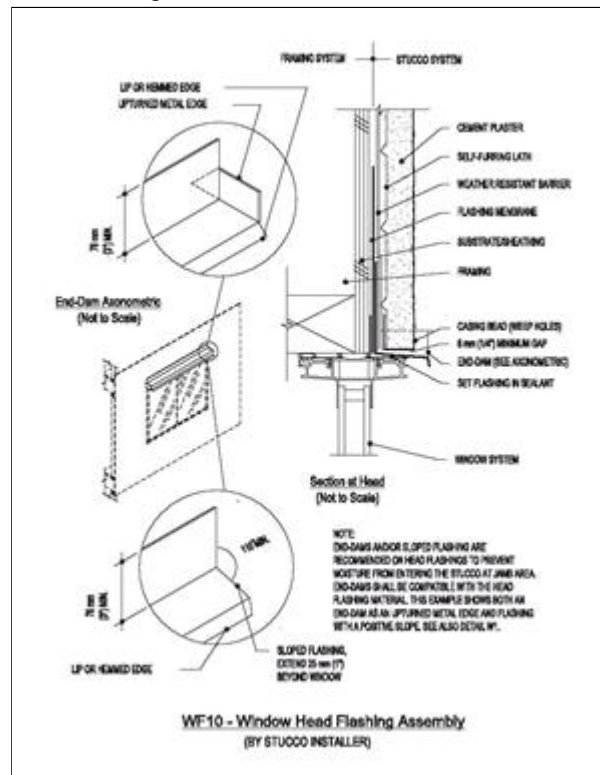
4.0 Picture 1

(1) Most areas we observed had no visible head flashing (like windows, doors or trim). Installation and/or repair of these is recommended. Installation, modification and/or repairs could include; installing flashing, creating end dams, caulking the bottoms, or other service, etc.

(2) See the Example of a proper Head Flashing with an "End Dam"

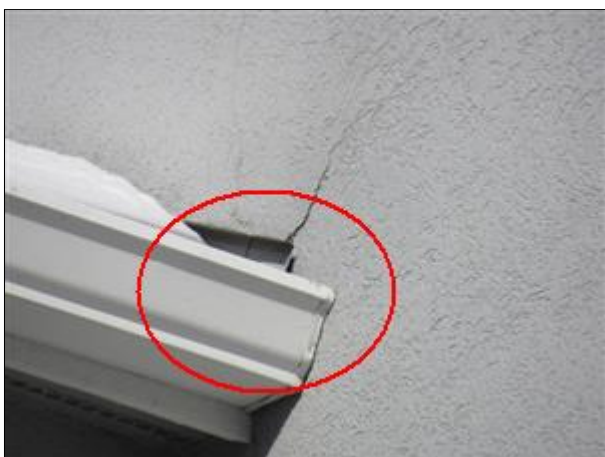
4.3 Picture 1

Missing or improperly installed "kickout flashings" have been a very common moisture entry point on stucco buildings. We recommend installing proper kickout flashings where applicable.

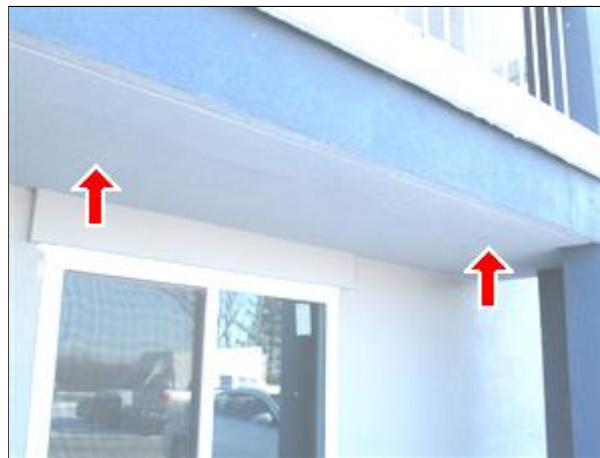
4.4 Picture 1

The underside of decks or balconies was finished out and the presence or absence of a deck flashing **OR** connections was not visible or determined. We recommend stucco repair contractor validate the presence or absence of this detail and determine if repair or modification is needed.

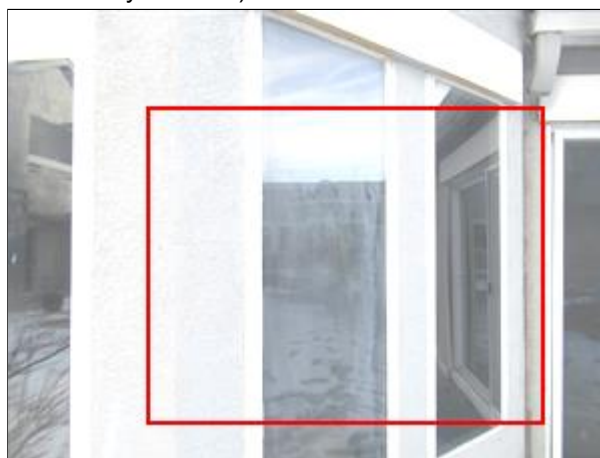
5.0 Picture 1

(1) Gaps, improper caulking, missing flashings, flat surfaces, inadequate prior repairs noted, can allow moisture into the window assembly. Repair and/ or Modify window assembly's as needed to keep out the moisture.

(2) Although not part of the stucco inspection, we noted you have one or more windows with a possible glazing / failed thermal seal problem (See Example in Courtyard area).

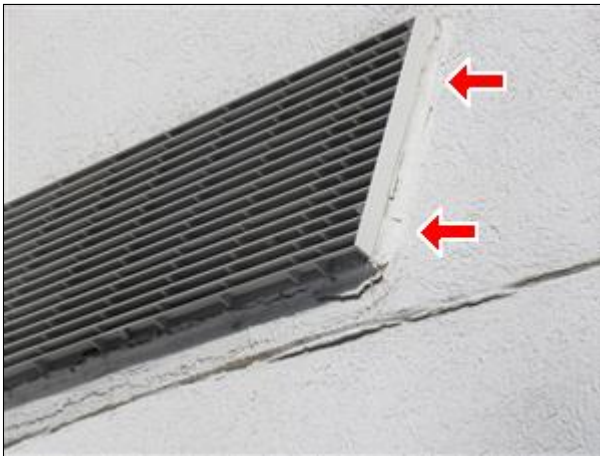
5.2 Picture 1

Typically on a building clad with stucco we should see a minimum 3/8"-7/16" gap around areas like the windows, doors and the junctions of different building materials - a "backer rod" is then placed in the gap and this area is properly sealed - this detail did not appear to be present on this building. We recommend having your stucco contractor Install and Modify the applicable areas

Solution: When there is no sealant at trim intersections with windows, doors, etc and no sealant, backer rod, or bond breaker noted at stucco intersection with windows, doors, trim, etc Stucco industry details require a minimum 3/8" caulk joint with a closed-cell backer rod and sealant at all stucco intersections with dissimilar materials. Install this.

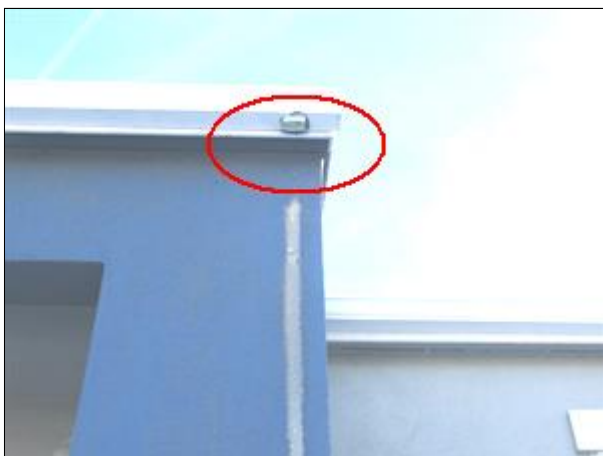
6.0 Picture 1

The gutters leak at some areas and there are holes near them. This can allow moisture to get into the stucco clad wall cavities or the fascia board below them. Service and Repair as Needed.

Your downspouts are attached or screwed to the walls in a manner that can allow moisture penetration. Downspout installation can be modified to provide better protection from possible moisture intrusion. The use of clip-on brackets provide a better protection from moisture. The brackets are attached to the stucco cladding - sealed - and then the downspout can be attached to this.

We noted some gutters or downspouts improperly depositing the roof run-off water next to the foundation. This can lead to leaks or foundation movement. We recommend extending them further away from the building (6' or more).

Loose or missing downspouts and elbows were noted at various locations on the building. Service and Correct.

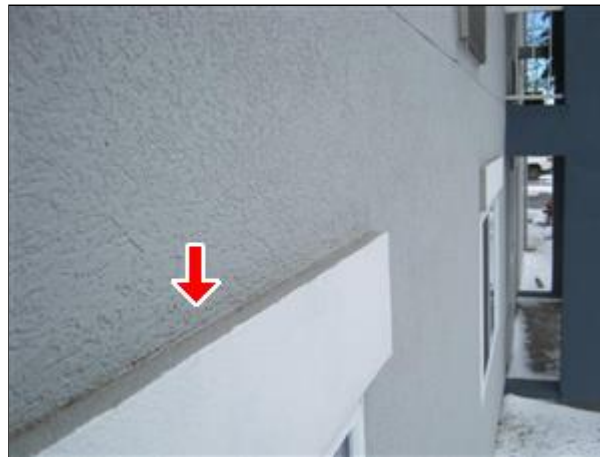
9.0 Picture 1

Although some accents or trim was sloped, there were flat accents present at most places on the building (the EIFS or trim, etc). All flat accents need to be kept sealed and well caulked. Ideally EIFS would not have flat accents, but should have been adequately sloped to allow moisture to run-off and prevent it from ponding on the accent.

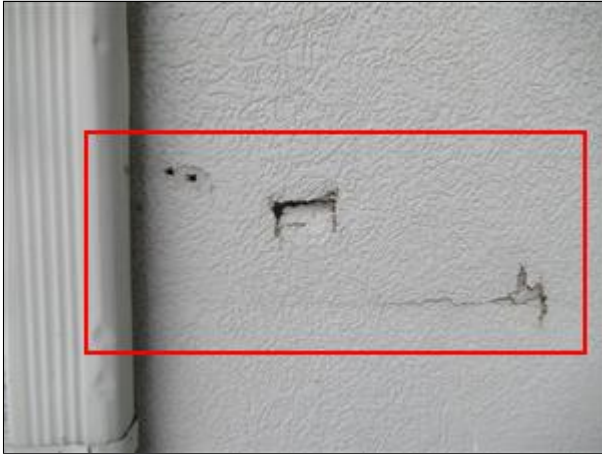
9.2 Picture 1

There were many areas at most all sides of the building where impact damage, cracks and/or holes were noted. These may allow moisture intrusion and should be repaired.

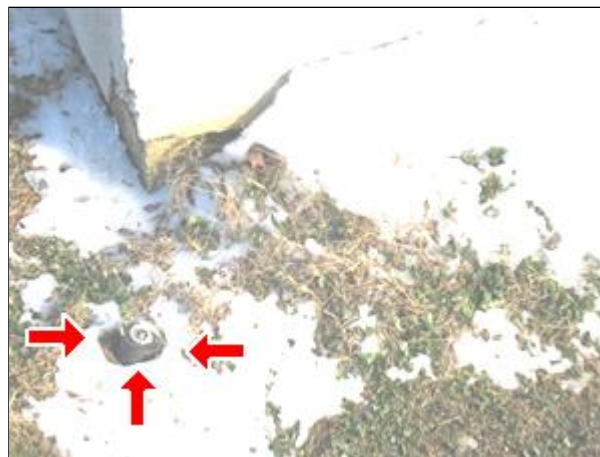
9.4 Picture 1

All sprinkler heads should be directed away from the stucco and windows to prevent moisture intrusion and damage to the Stucco System.

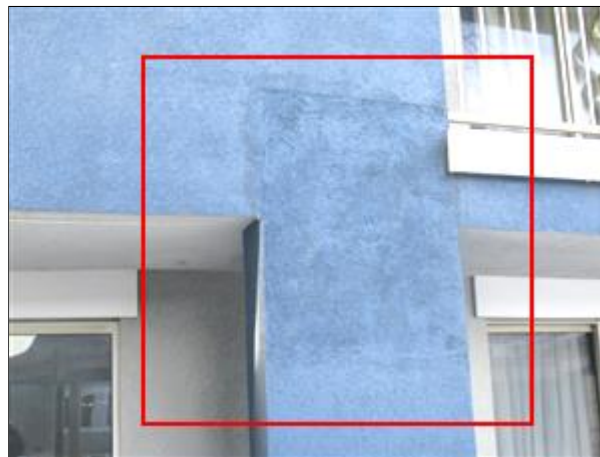
9.6 Picture 3

(3) Several areas in the Courtyard area have bulging and/or separated stucco. **It looks like Drywall was used at some areas for a substrate instead of wood.** Have your stucco contractor evaluate then provide a proper Repair as Needed.

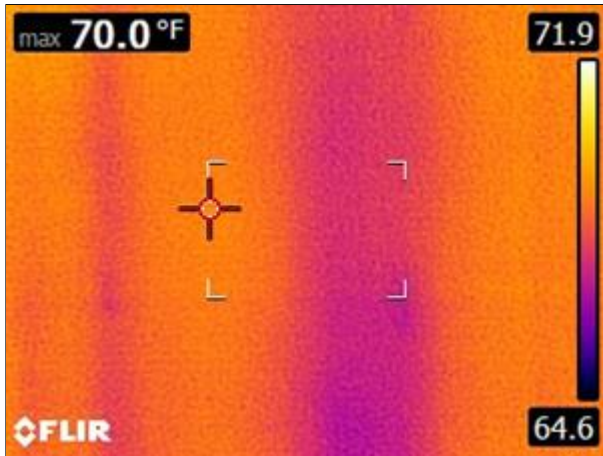
10.5 Picture 1

There were visible signs of moisture leakage, deterioration and anomalies however we did not observe signs of active leakage at this time. Our recommendation is to address the exterior problems first and see if that stops leakage. If it does not then further evaluation or repairs would be needed.

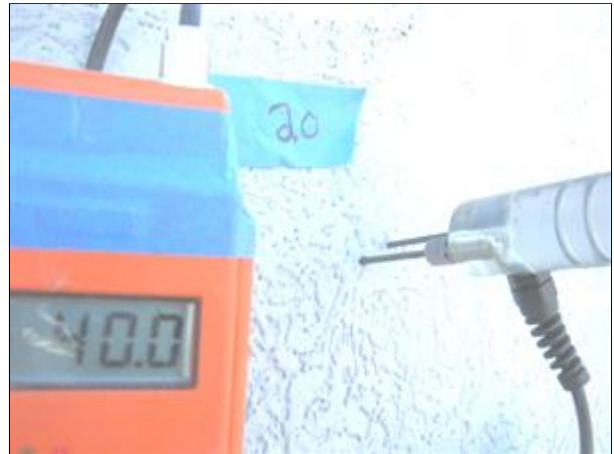
11.4 Picture 4

(3) The moisture content when probed was: **40% (High)**

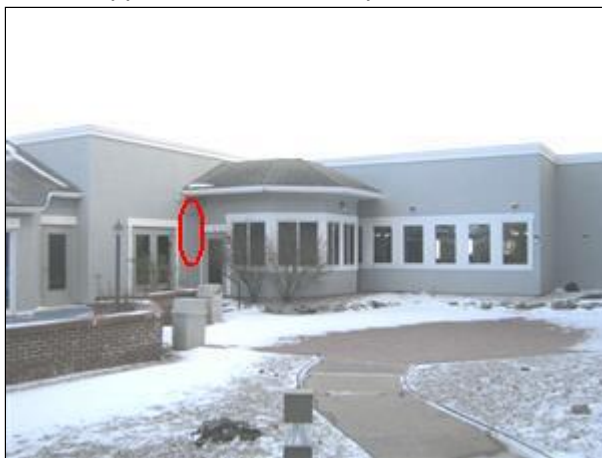
11.10 Picture 2

(2) The moisture content when probed was: 11.2%

The Substrate appears **SOFT** where probed.
