# Inspection Report

**Property Address:**  
4154 Anywhere Street  
Overland Park KS 66208

<b>Date:</b> 5/31/2020	<b>Time:</b> 01:00 PM	<b>Report ID:</b> 4207 - EIFS
<b>Property:</b> 4154 Anywhere Street Overland Park KS 66208	<b>Customer:</b> Tom Thumb	<b>Real Estate Professional:</b> RALTER

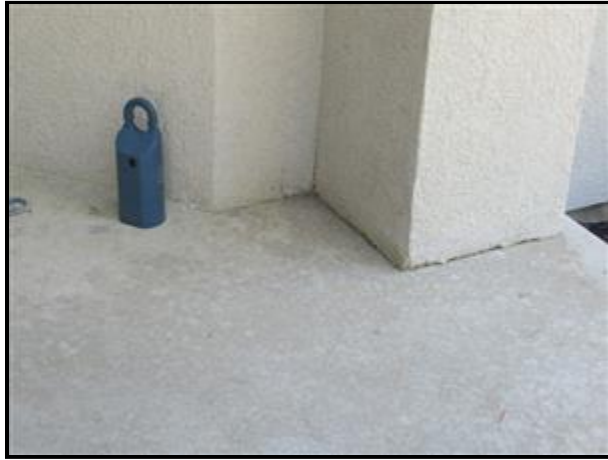
2.3 Picture 1

**2.3** There was at least one or more locations where concrete slabs were too close and/or touching the stucco wall as shown in the attached photos (stoop and patio). This is a common but improper building practice. There should have been a 2' space where they meet to allow any future movement of the slabs from causing cracks or moisture damage to the stucco walls. Stucco is porous and on drainage systems this can allow moisture to escape from behind the stucco.

Damage to the stucco has occurred at one or more places (stoop and patio) / Stucco Contractor to Repair.

**Solution:** Stucco industry details require flashing at the base of the wall or, alternatively, a 2" clearance above the hard surface with an integrated weep screed. Install proper flashing and/or weep screed per stucco manufacturer's recommended repair details and specifications.

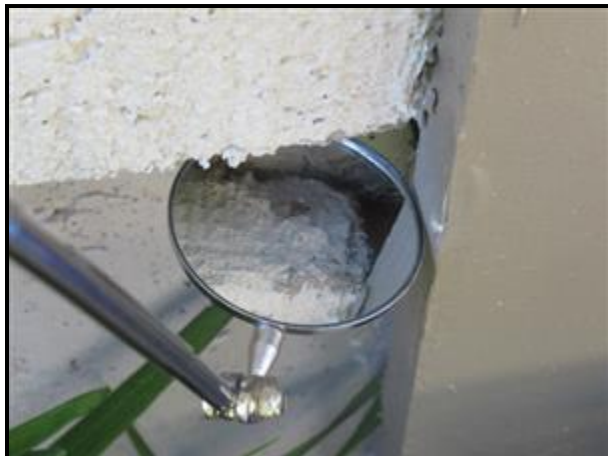
2.4 Picture 1

**2.4** EIFS with Ploy-Iso foam underneath. Bottoms of walls are backwrapped with small bits of foam and plastic mesh visible.

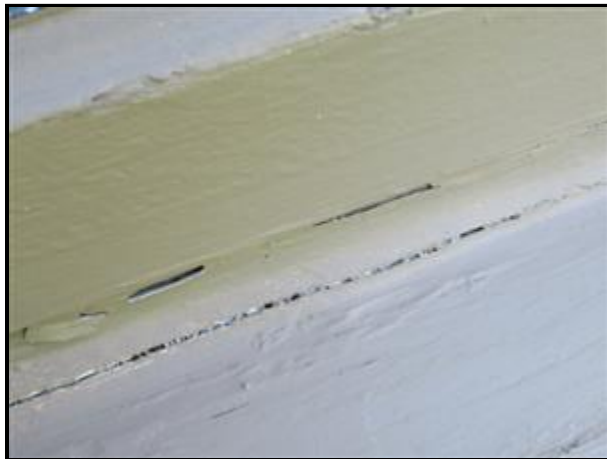
3.0 Picture 1

**3.0** Most caulking looks like it was good to start, but now has various places where it is worn, separating, the wrong type, split, etc (which can allow moisture intrusions). Have a competent stucco contractor caulk AND re-caulk any place below the soffit line where the stucco meets another material, such as windows, doors, trim, siding, wood, flashing, etc.

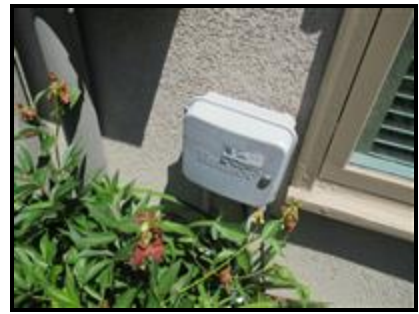
3.1 Picture 3

**3.1** Anywhere an electrical line, gas line, light fixture, plumbing hose bibb, etc. penetrate the exterior walls they are commonly called a "breach location" in the stucco world. Although some breach locations were properly sealed, others were not. Caulk or re-seal any place below the soffit line where stucco meets another material such as around dryer vents, hose bibbs, electrical outlets or light fixtures, cable TV openings, freon lines, and other penetrations of the wall cladding materials.

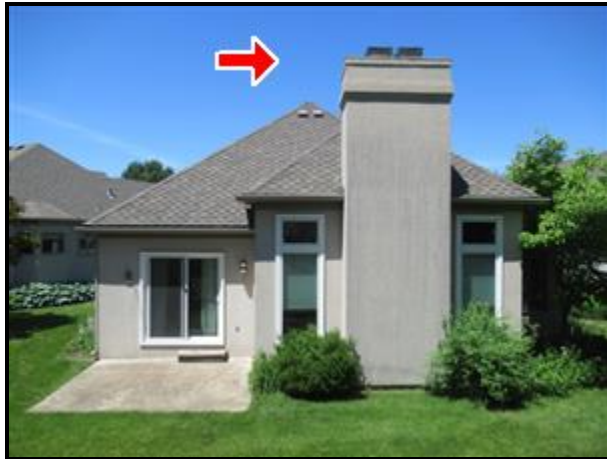
4.0 Picture 1

**4.0** A chimney cap is present, but due to the height, the top of the chimney and/or components were not fully visible from the ground. You would need your home inspector, a roofer or chimney contractor to verify the condition of this.

There are unsealed gaps at the flashing overhangs. Stains are present below the cap. Service, check flashing and sealing recommended at chimney cap, cricket, saddle, etc.

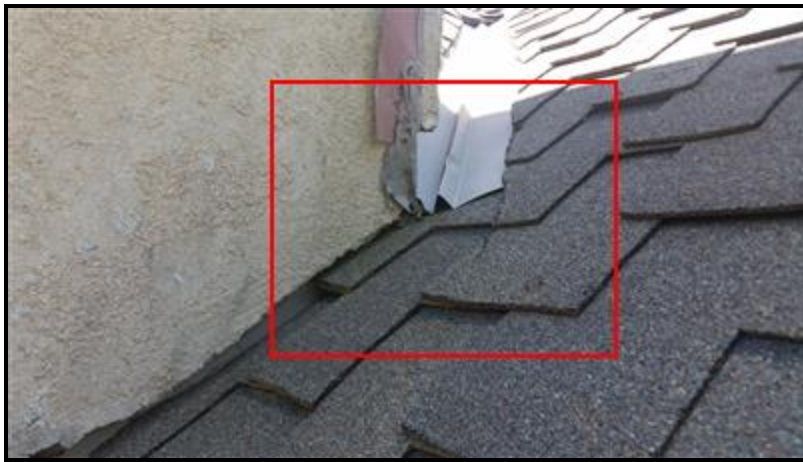
4.1 Picture 1

**4.1** A cricket was present, but due to the height we could not verify the condition of the cricket or diverter behind the chimney. You would need your home inspector, a roofer or chimney contractor to verify the condition of this.

There are unsealed gaps at the chimney cricket, saddle, etc. Service and Correct.

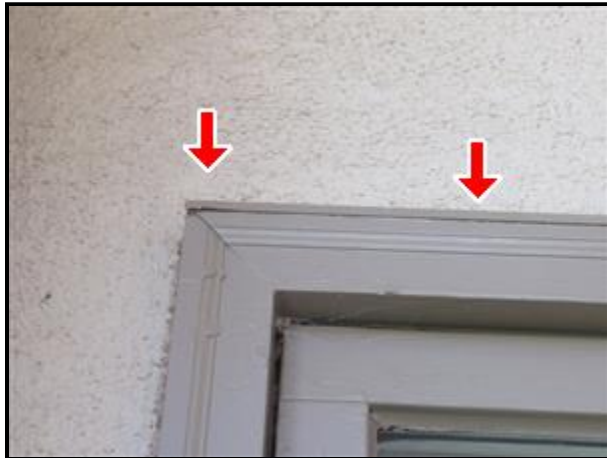
4.2 Picture 1

4.2 Older wood windows yes ..... Newer windows are wrapped with metal or vinyl looking trim and head flashings were not visible.

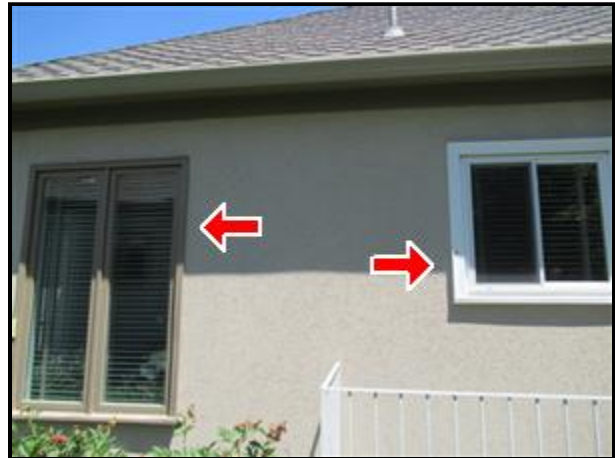
4.2 Picture 2 Old / New Windows

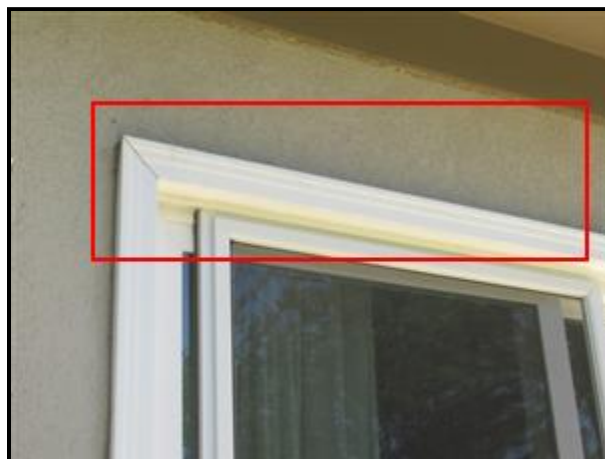
4.2 Picture 3 New Unit

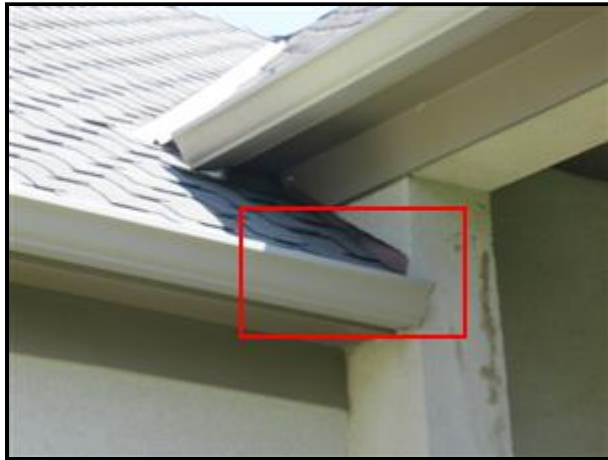
4.5 (1) In a house clad with EIFS, there should be a "kickout flashing" installed at any area where a gutter meets a wall or at certain roof/wall junctions. At this home "kickout flashings" were not present at all recommended locations, BUT newer looking add-on ones were present at other areas that are not proper and have leaked (see Pic 9).

4.5 Picture 1 Kickout Not Visible

A competent stucco contractor can install proper "kickout flashings" for about \$395-\$475 each. Missing or improperly installed "kickout flashings" have been a common moisture entry point on stucco homes. We recommend installing proper kickout flashings where applicable.

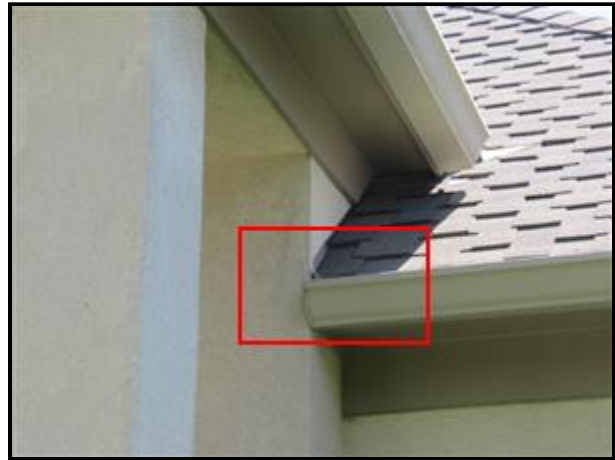
4.5 Picture 2 Kickout Not Visible

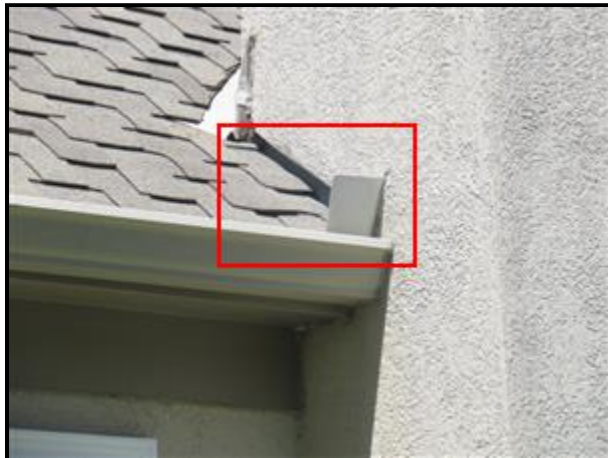
4.5 Picture 3 New Add-On Kickout

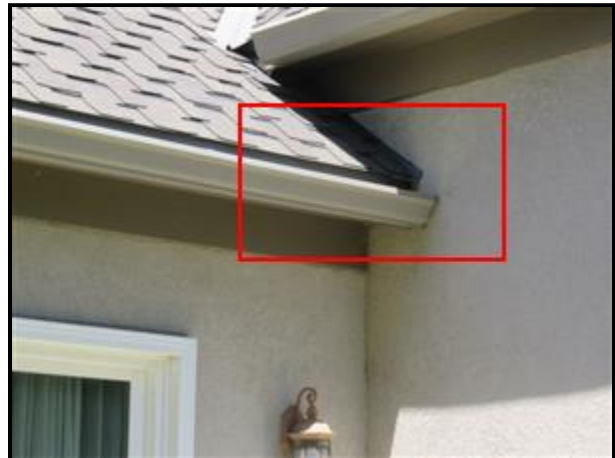
4.5 Picture 4 Kickout Not Visible

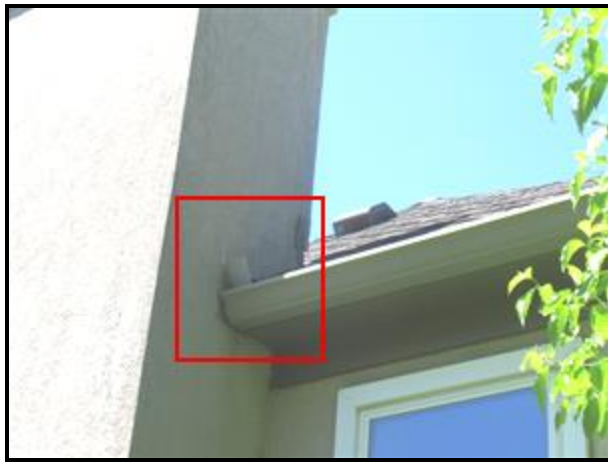
4.5 Picture 5 New Add-On

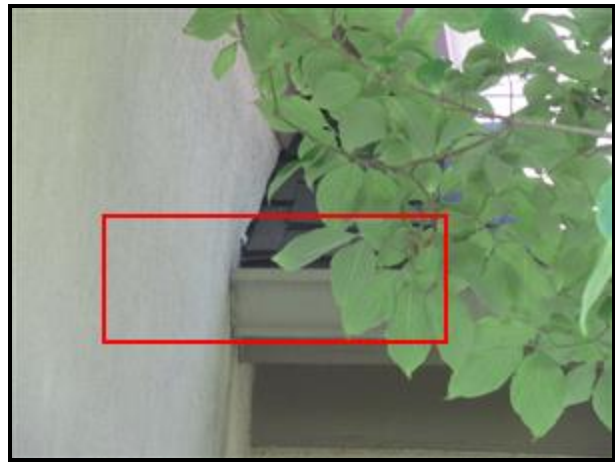
4.5 Picture 6 Kickout Not Visible

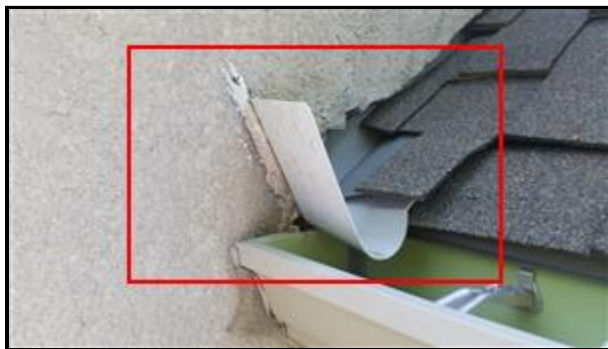
4.5 Picture 7 New Poor Kickout

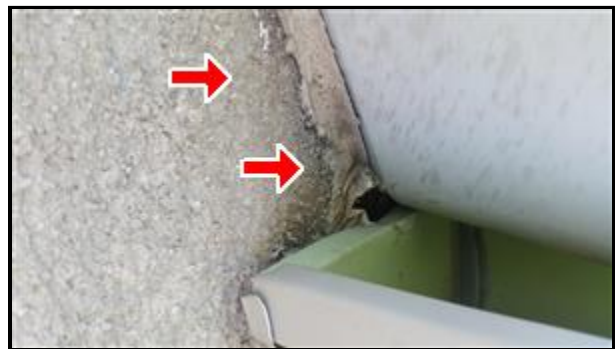
4.5 Picture 8 New Poor Kickout

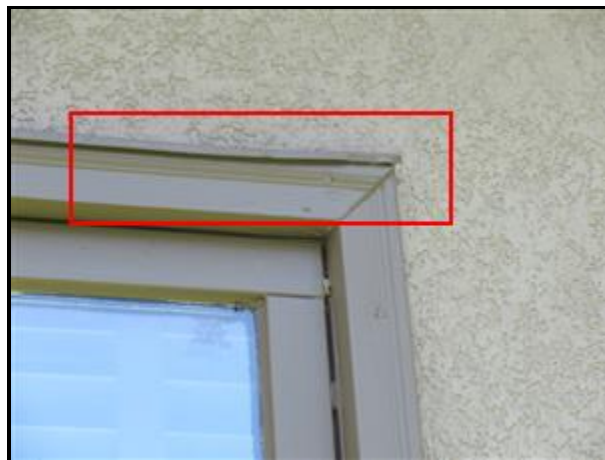
4.8 Picture 1

4.8 There were some trim pieces with raised flashing, unsealed flashing, gaps, no end dams. Service and Repair of these is suggested. Repairs may include; end dams created, sealing overlaps, caulking the bottoms, bent or raised flashing corrected, etc.

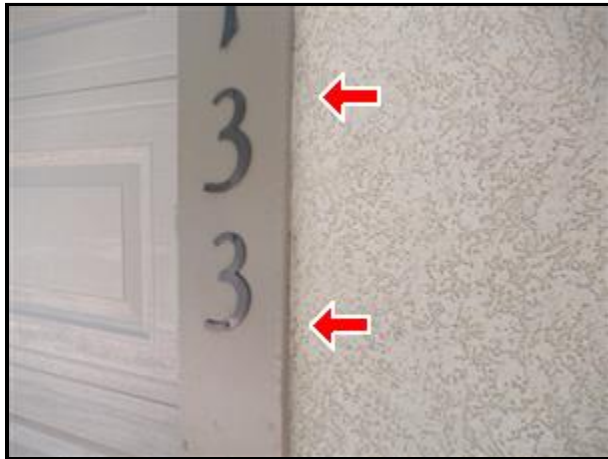
5.0 Picture 1

**5.0** (1) Caulk Joints were not visible at areas like windows, doors, the junction of 2 different building materials, etc.

Typically on a house clad with EIFS we should see a minimum 3/8" gap around areas like the windows, doors and the junctions of different building materials - a "backer rod" is then placed in the gap and this area is properly sealed - this detail did not appear to be visible on this home. We recommend contacting the builder and/or reviewing the original engineering details and blueprints to validate the absence or presence of this detail and to find out how this detail was handled.

Repair or modifications recommended.

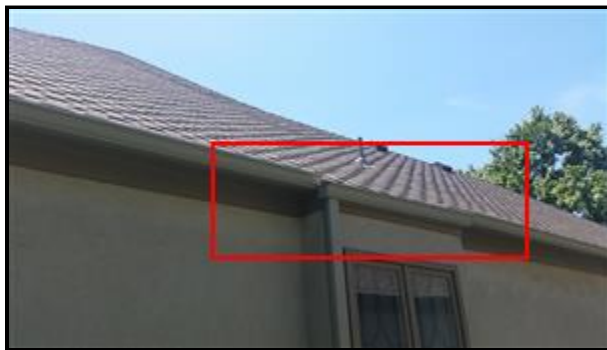
6.1 Picture 1

**6.1** (1) Short Gutter Overlap ..... Re-flash the drip edge above left side bay window to divert water into lower gutter better (short gutter overlap looks like it has leaked before onto wood window / wall, etc).

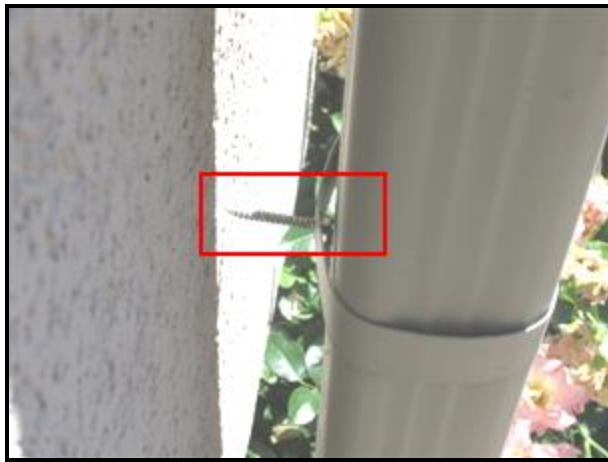
6.1 Picture 4

(2) Gutter downspouts were SCREWED into the EIFS. The preferred way that provides better protection from possible moisture intrusion, is the use of a clip-on bracket. The brackets are attached to the stucco cladding - sealed - and then screws are run into them.

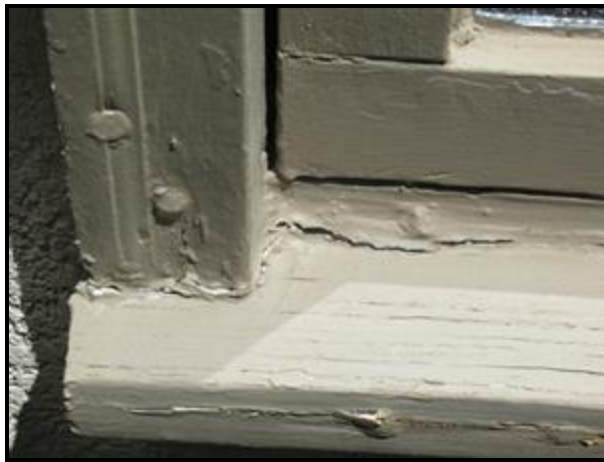
7.1 Picture 1

**7.1** See Example ..... There have been areas that have been repaired, and there are areas where the wood needs sealed to protect from deterioration.

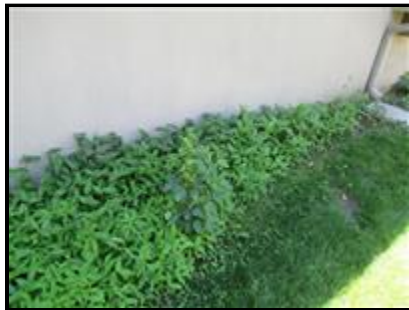
8.1 Picture 1

**8.1** Bushes or other foliage rub the stucco walls at various locations around the homes exterior. This can give pests an easy bridge into the home and can also allow for moisture damage. Trim the bushes or other foliage back from the walls at least 18"to 24" to help prevent this.

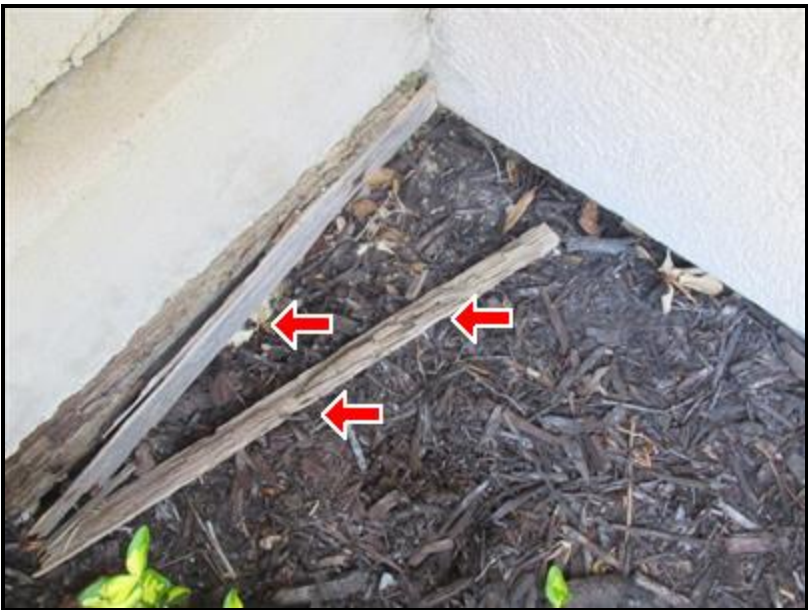
8.2 Picture 1

There was a piece of damaged form lumber or wood on the right side of the front stoop. It is unknown to us if it moisture damage, wood rot or termite damage. A state licensed WDI specialist can provide testing for you.

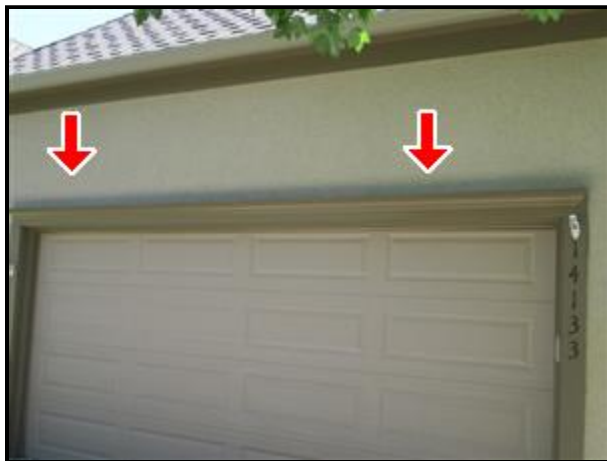
9.0 Picture 1

**9.0** Stucco manufacturers recommend sloped accent pieces or trim to prevent water or snow pooling there and ever becoming leaks. The accent piece on top of the garage doors are flat. Keep these areas well sealed at all times or modify these areas.

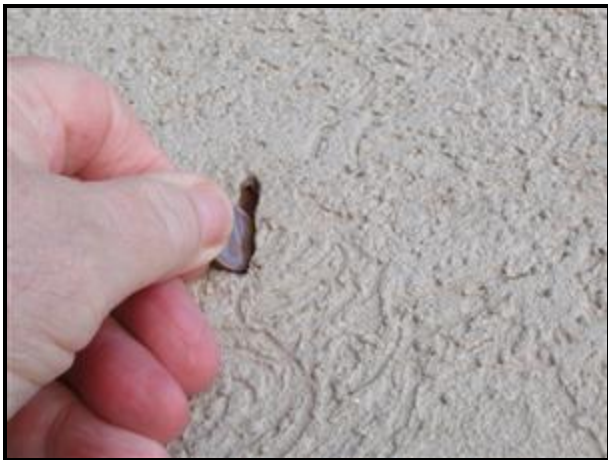
9.1 Picture 1

**9.1** There were areas where minor impact damage, cracks and/or holes were noted. These may allow moisture intrusion and should be repaired.

A suggested repair in the future that should be budgeted for is the complete coating of the stucco with a elastomeric paint.

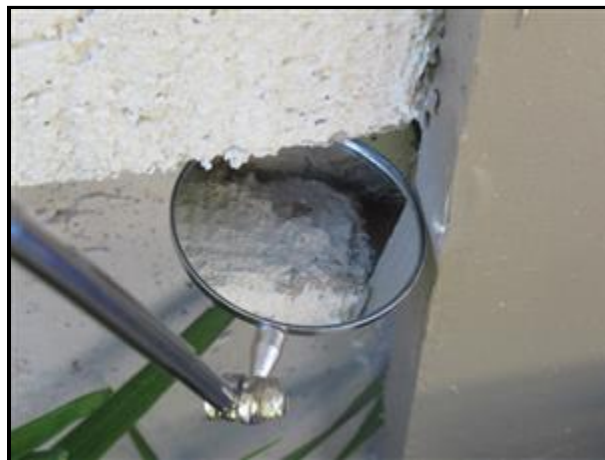
9.2 Picture 2

9.2 A few small pieces at corners, but most is backwrapped

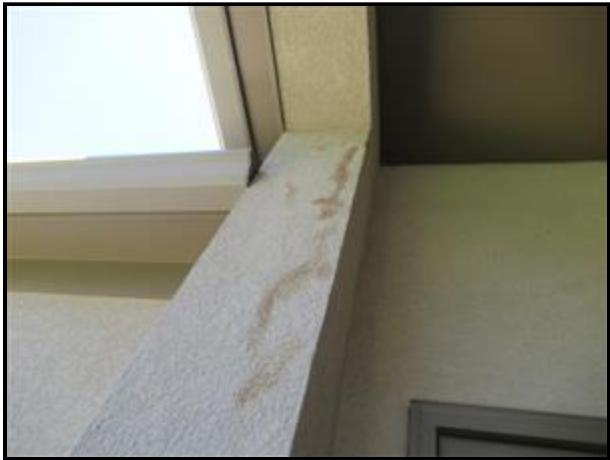
**9.4** There are areas where stains or rust spots are present on the EIFS walls and/or trim. These areas should be cleaned with a mild soap or cleaner recommended by the stucco manufacturer. Careful or no use of a high-pressure sprayer is advised. Apply the cleaner using a sponge or brush.

9.4 Picture 1 Front

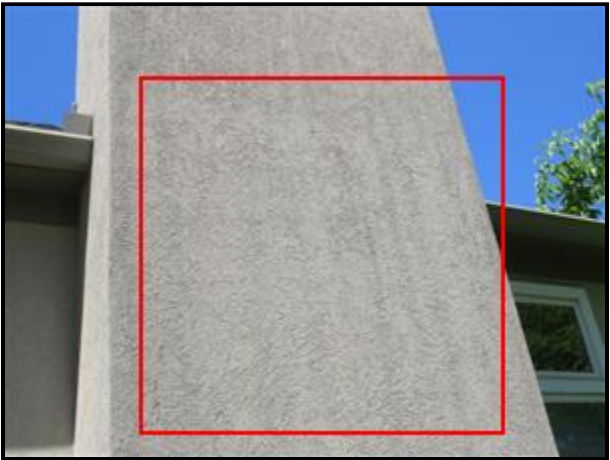
9.4 Picture 2 Chimney

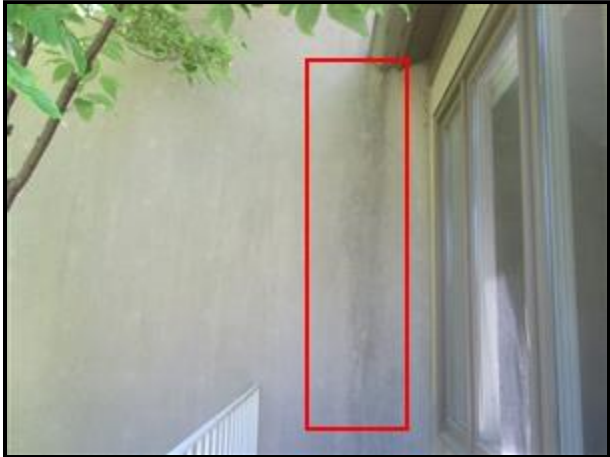
9.4 Picture 3 Under Missing Rear Kickout

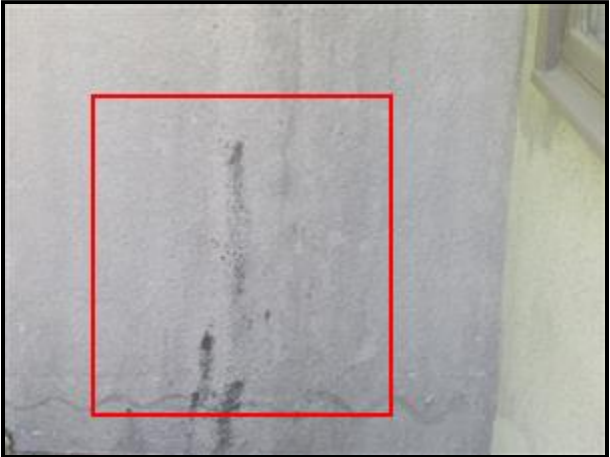
9.4 Picture 4 Rear

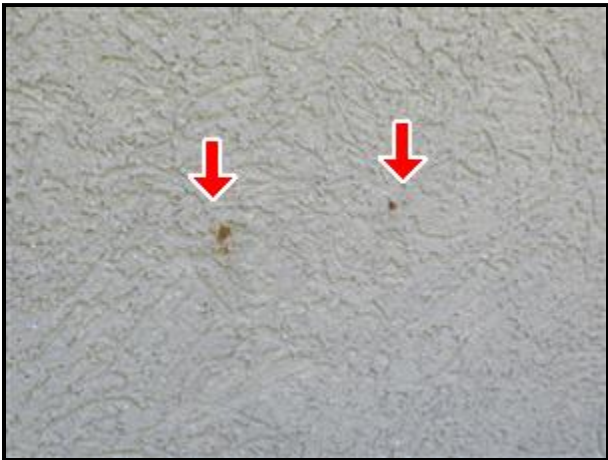
9.4 Picture 5 Rust Spots

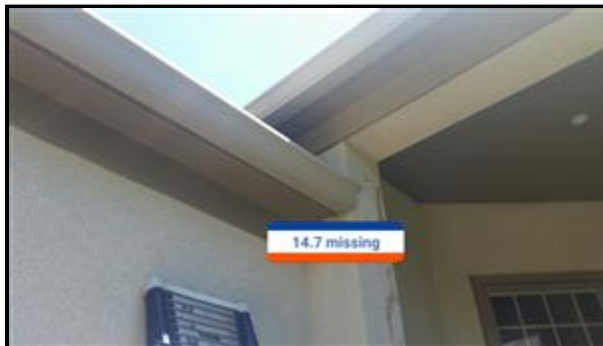
11.0 Picture 2

(2) The moisture content when probed was: 14.7%

The substrate was **MISSING** when probed.

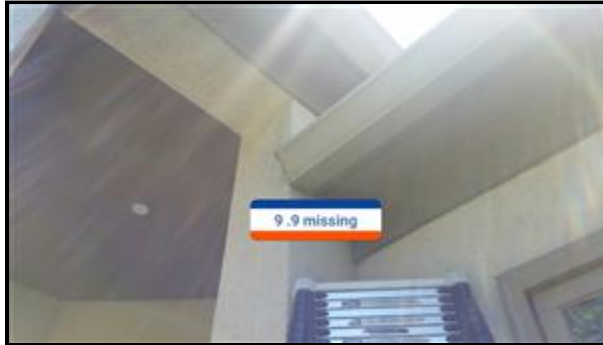
11.0 Picture 3

(3) The moisture content when probed was: 9.9%

The substrate was **MISSING** when probed.

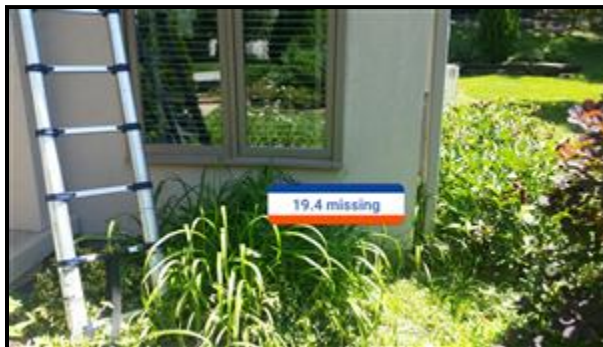
11.0 Picture 4

(4) The moisture content when probed was: **19.4%**

The substrate was **MISSING** when probed.

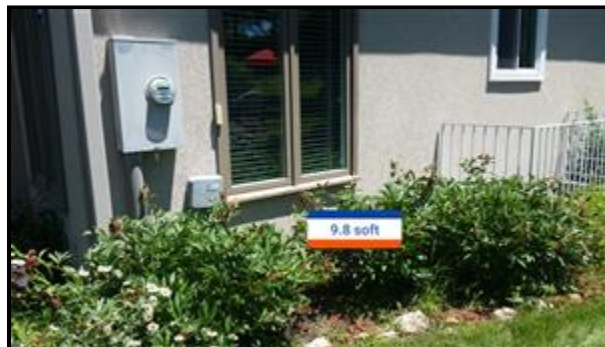
11.1 Picture 2

(2) The moisture content when probed was: 9.8%

The Substrate appears **SOFT** where probed.

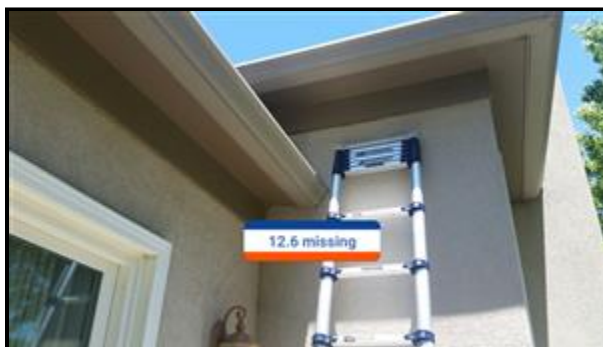
11.2 Picture 2

(2) The moisture content when probed was: 12.6%

The Substrate appears **MISSING** where probed .

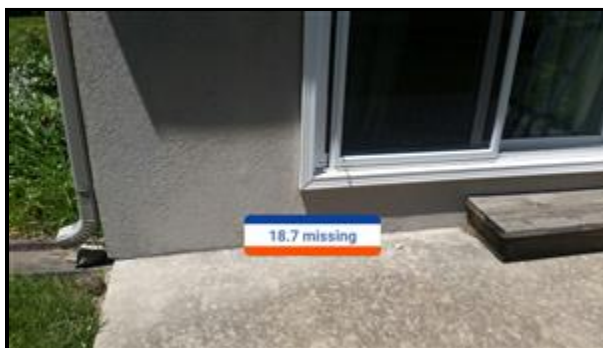
11.2 Picture 3

(3) The moisture content when probed was: **18.7% (very close to high)**

The Substrate appears **MISSING** where probed.

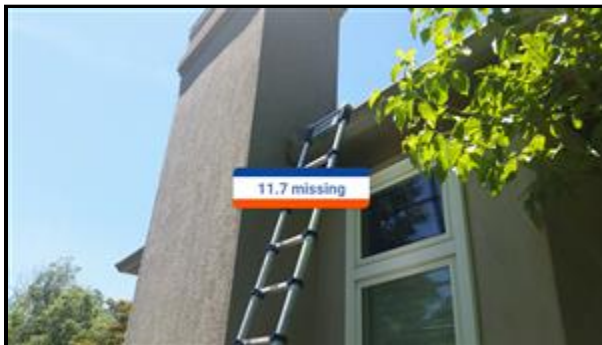
11.2 Picture 4

(4) The moisture content when probed was: 11.7%

The Substrate appears **MISSING** where probed.

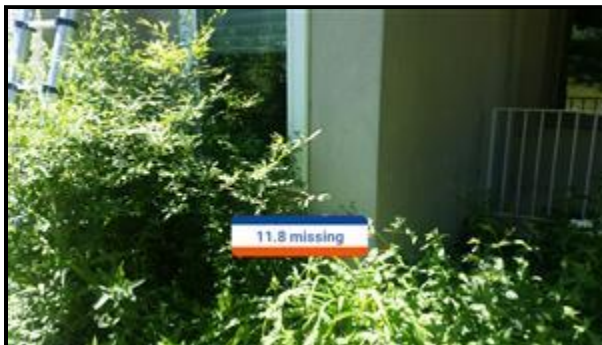
11.2 Picture 5

(5) The moisture content when probed was: 11.8%

The Substrate appears **MISSING** where probed.

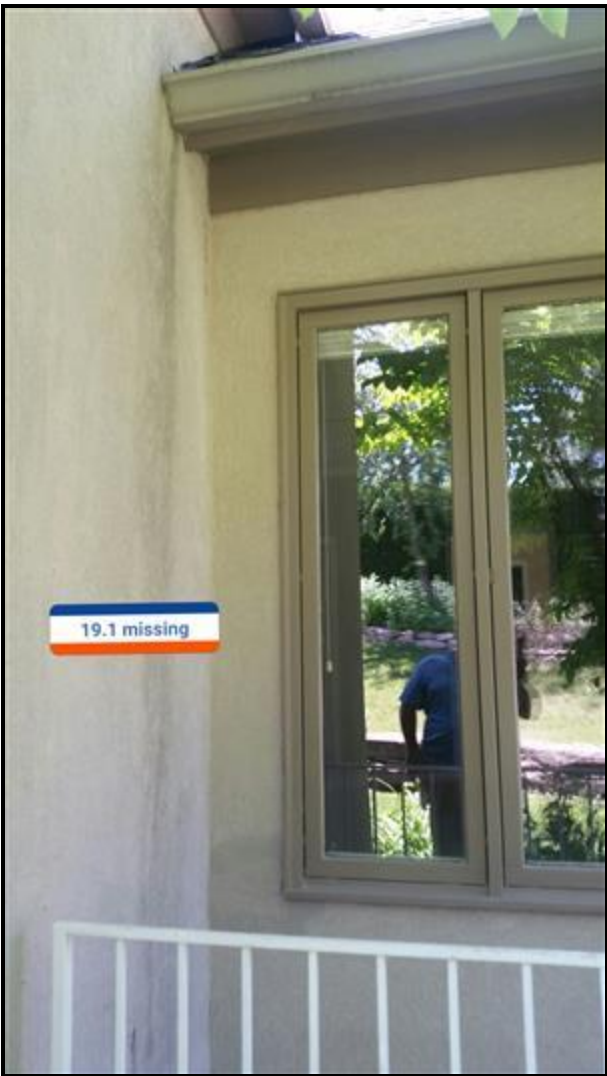
11.2 Picture 6

(6) The moisture content when probed was: 19.1%

The Substrate appears **MISSING** where probed.

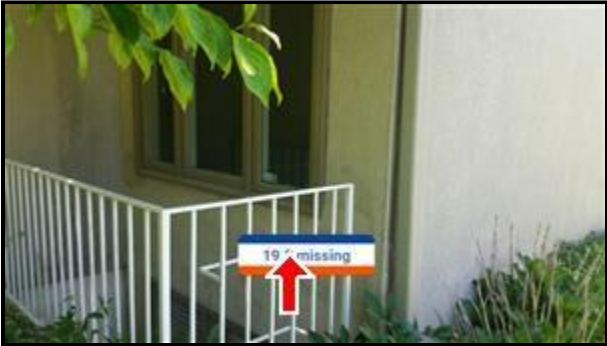
11.2 Picture 7

(7) The moisture content when probed was: **19.0%**

The Substrate appears **MISSING** where probed.

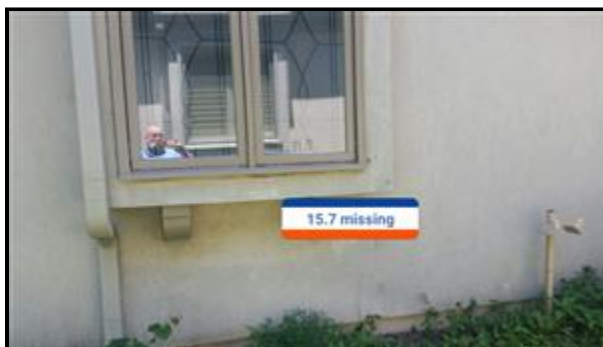
11.3 Picture 2

(2) The moisture content when probed was: 15.7%

The Substrate appears **MISSING** where probed.

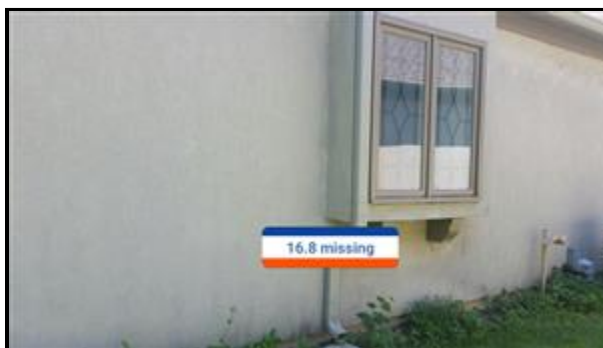
11.3 Picture 3

(3) The moisture content when probed was: 16.8%

The Substrate appears **MISSING** where probed.
