Inspection Report

11320 S. Cook St
Olathe KS 66061

In the enclosed Report you will see our findings of our recent stucco inspection at the subject property.

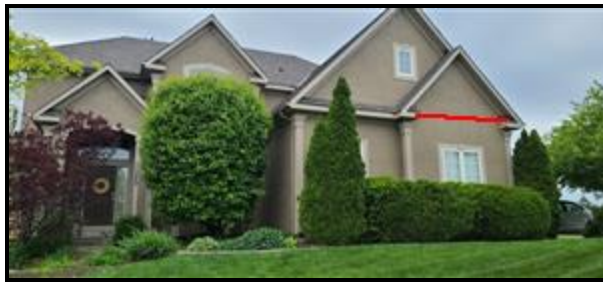
2.2 Picture 1

2.2 The typical architectural details for a Hardcoat Stucco System, such as on this building, are the presence of **"Control Joints"** at certain floor lines and other needed areas on the exterior of the structure. These joints help control cracking of the stucco caused by either: movement of the structure; or due to the shrinkage and compression of the wood framing members. **This detail was lacking at one or more locations** on this building, and we recommend verifying how this detail was handled with the **This detail was lacking** at one or more of the typical locations on a building, and we recommend verifying how the detail was handled with the builder, design architect, installer or your stucco repair contractor. See Example

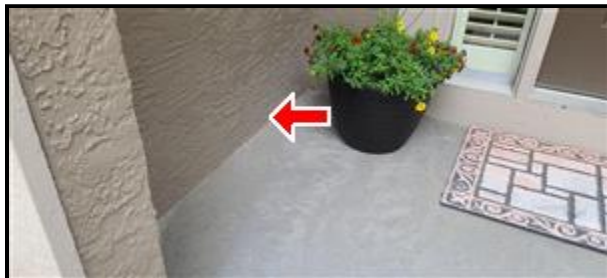
2.3 Picture 1

2.3 (1) There was at least one or more locations where concrete slabs, masonry or other flatwork were too close and/or touching the stucco wall(s). This is a common but improper building practice. There should have been about a 2' space or gap where they meet to allow any future movement of the flatwork from causing cracks or moisture damage to the stucco walls. Stucco is porous and on drainage systems this can allow moisture to escape from behind the stucco.

Solution if Ever Needed: Stucco industry details have flashing at the base of the wall or, alternatively, a 2" clearance above the hard surface with an integrated weep screed. Install proper flashing and/or weep screed per stucco manufacturer's recommended repair details and specifications.

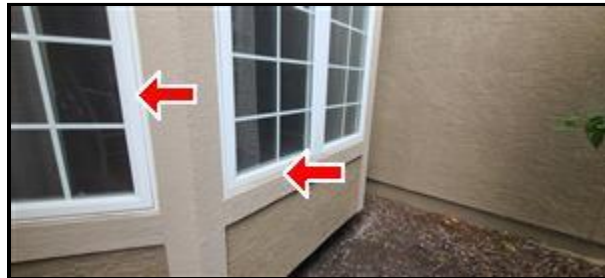
3.0 Picture 1

3.0 Caulk or re-caulk windows exteriors. This includes the window frames and trim and where the frame or trim meets another building element (stucco, stone, wood, etc.).

Most caulking looks like it was good to start, but now has places where it is worn, etc. Have a competent stucco contractor caulk **AND** re-caulk any place below the soffit line where the stucco meets another building material, such as windows, doors, trim, siding, wood, mitre joints, masonry, flashing, etc.

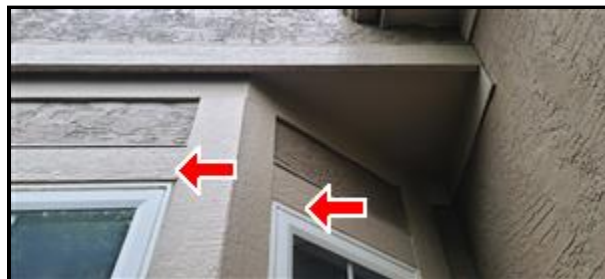
4.0 Picture 1

4.0 There were some windows or doors or their trim with no visible flashings. Some windows or doors may have an integral flashing fin built into them. Once installed we can not see or verify this. Have the builder, installer, building designer or your stucco repair contractor verify how this detail was handled to determine if repair or modification is needed.

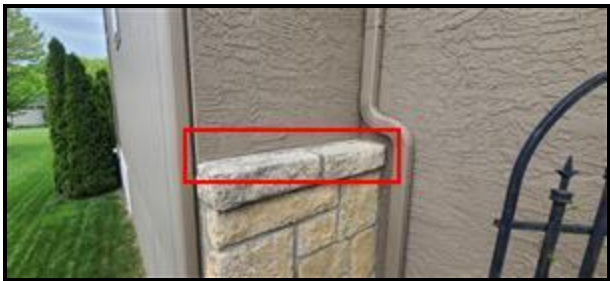
4.6 Picture 1

4.6 (1) Proper flashings were not visible at all recommended locations. There were various locations at one or more areas where missing and/or improper flashings were observed. Areas where flashings are typically installed are: over doors, windows, trim or decorative pieces extending out from the siding or house wall over 3/8". Flashing is installed to help prevent ponding moisture from entering the structure and/or causing water damage, etc. Modification of areas with missing or improper flashing is recommended. Repairs may include; creating end dams; sealing overlaps, caulking the bottoms, installing flashing; etc.

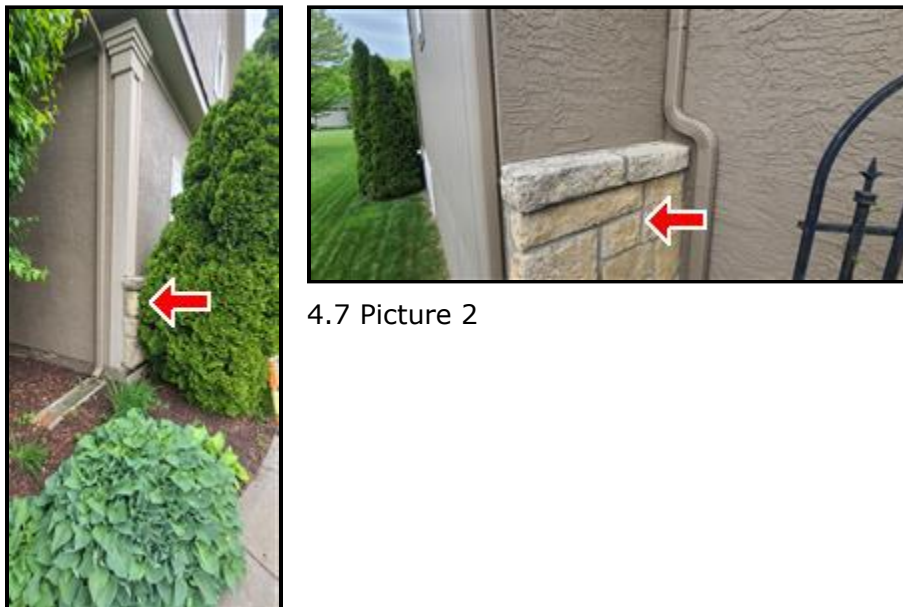
4.7 A Masonry stone wall was present ~ NOT INSPECTED in Stucco Inspection - BUT it appears to have some weak details that can allow moisture penetration into wall cavities (like at the thru wall flashing, sealant, gaps at wall, etc). Contractor to Service as Needed,

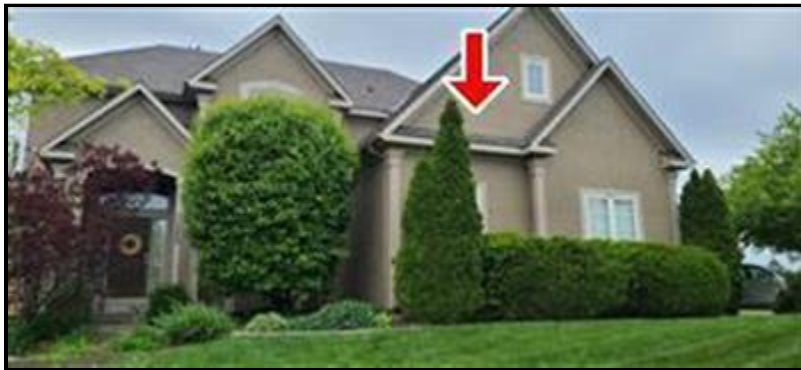
6.1 Picture 1

6.1 A gutter / downspout would be recommended at this area.

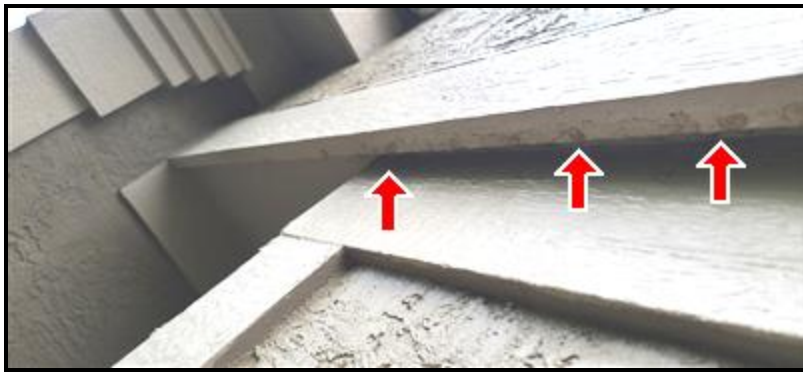
7.0 Picture 1

7.0 Elevated moisture readings **WERE found** during the course of the inspection. The industry standards considers moisture readings **over 19%** as being in the **unacceptable range** and elevated.

See Moisture Probing Results at SECTION 11 At Probing Pics / Also See Pic here of moisture staining on bottom of wood trim coming from behind stucco

Stucco Contractor to Service and Repair as Needed

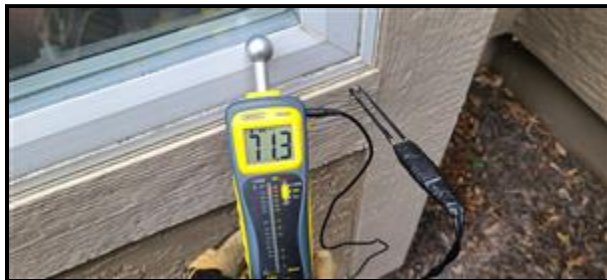
7.1 Picture 1

7.1 Very High moisture - Rotten wood trim around some windows, etc - Replace

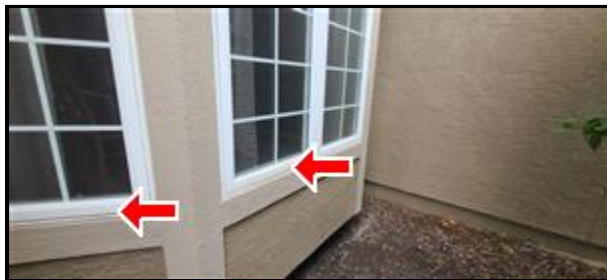
9.0 Picture 1

9.0 There were flat accents present at various places on the house (the Stucco system and by the windows, etc). All flat accents need to be kept sealed and well caulked. Ideally Stucco would not have flat accents, but should have been sloped to allow moisture to run-off and prevent it from ponding on the accent.

9.1 Not all of the flat accents and/or quoins were well caulked, sealed, or sloped correctly. This can allow moisture to enter behind the stucco and cause moisture damage to the stucco and structure. Caulk, seal or slope all flat accents or trim, etc.

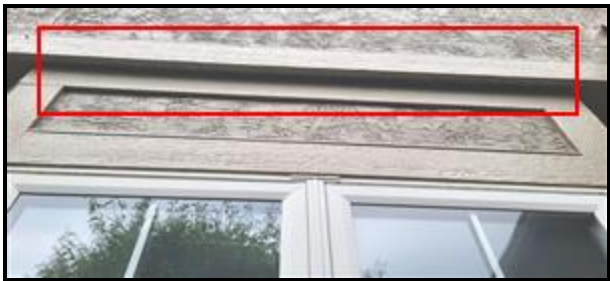
9.3 Picture 1

9.3 There are areas where stains are present on the Stucco walls and/or trim. These areas should be cleaned with a mild soap or cleaner recommended by the stucco manufacturer. Careful or no use of a high-pressure sprayer is advised Apply the cleaner using a sponge or brush.

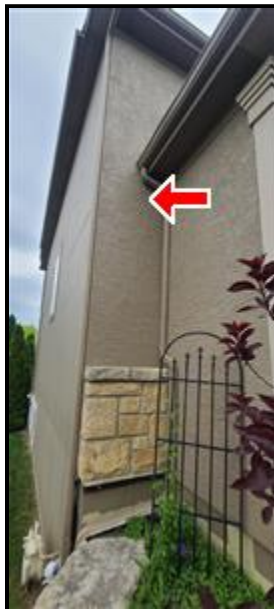
11.0 Picture 2

(2) The moisture content when probed was: 9.9%

The Substrate appears SOLID where probed.

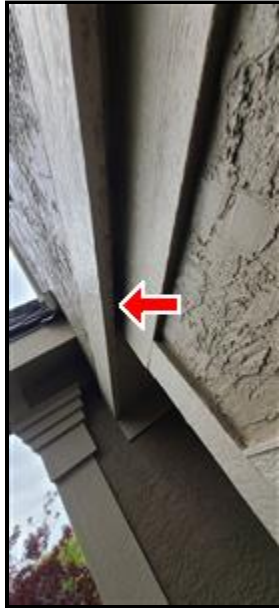
11.0 Picture 3

(3) The moisture content when probed was: 12.6%

The Substrate appears SOLID where probed.

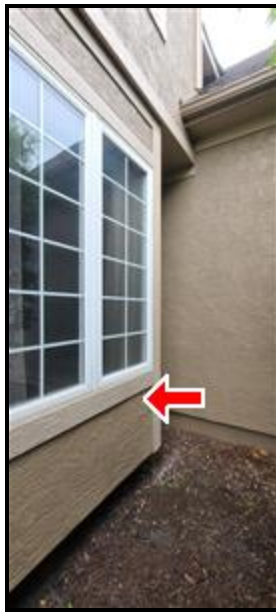
11.0 Picture 7

(4) The moisture content when probed was: 18.2% (Getting High)

The Substrate still appears SOLID where probed.

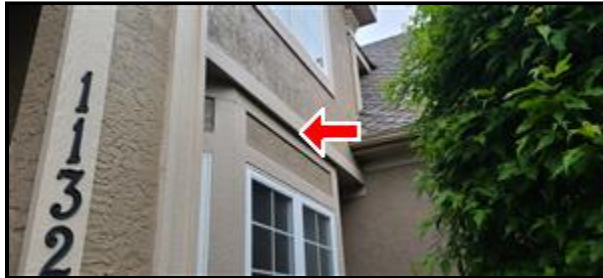
11.0 Picture 8

(5) The moisture content when probed was: 42.6% (Very High)

The substrate was **SOFT** when probed.

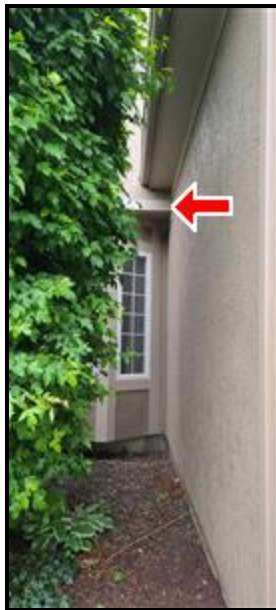
11.0 Picture 11

(6) The moisture content when probed was: 11.4%

The Substrate appears **SOLID** where probed.
