Inspection Report

9725 Hollywood Ave
Leawood KS 66224

Date: 10/28/2007	Time: 09:30 AM	Report ID: 6378 - Visual Sample
Property: 9725 Hollywood Ave Leawood KS 66224	Customer: Jack & Jill Smith	Real Estate Professional: NONE

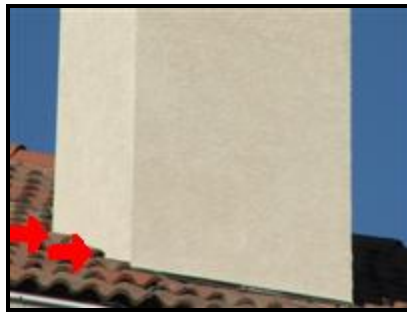
2.4 Picture 1

2.4 There were one or more locations where roof coverings were close or touching the stucco wall. This is a common but improper building practice. There should have been a space where they meet to allow any movement of the roof covering from causing cracks or moisture damage to the stucco walls. Damage to the stucco can occur if it is too close to a roof covering. Seal the stucco at least 6" up the wall.

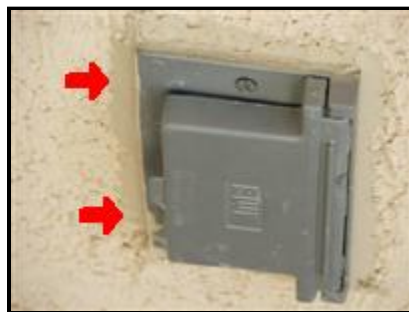
3.4 Some breeches were well sealed, others were not. Plastic mesh was still showing through the walls at locations like by the A/C unit freon lines and under the kickout flashing by the garage. Caulk or re-caulk any place below the soffit line where stucco meets another material, such as around meter openings, electrical outlets, light fixtures, utility lines, cable TV openings, downspout fasteners and any other types of "breeches" to the stucco system.

3.4 Picture 1 Breach Sealed

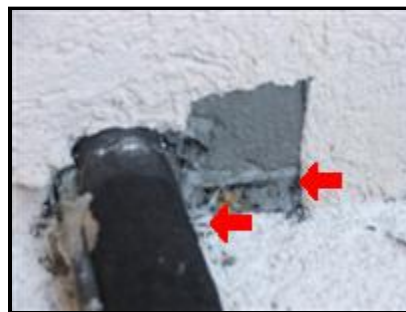
3.4 Picture 2 A/C Freon Lines

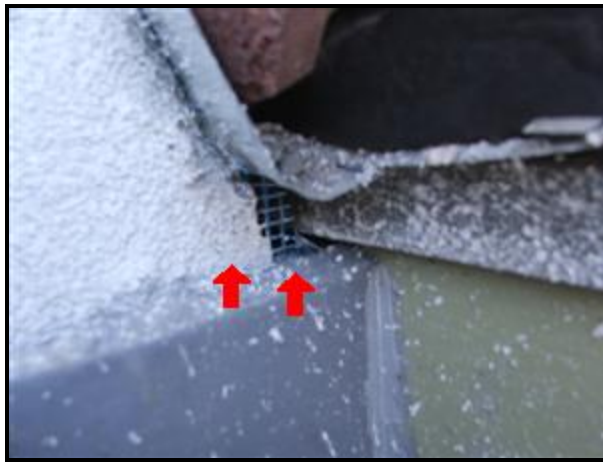
3.4 Picture 3 Under Kickout Flashing

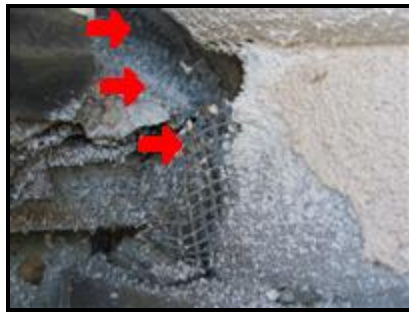
Missing or improperly installed "kickout flashings" have been a common moisture entry point on stucco homes. We recommend installing proper kickout flashings where applicable. Some kickout flashings are missing and should be installed at the needed locations, such as the secondary kickout location by the garage. The existing kickout flashings did not fully appear to be properly installed. In our opinion they should be modified. Correct installation and sealant help assure a watertight exterior.

4.6 Picture 1 No Kickout by Garage

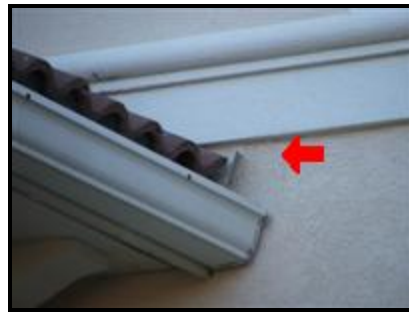
4.6 (1) In a house clad with stucco, there should be a "kickout flashing" installed at any area where a gutter meets a wall or at certain roof/wall junctions. At this home "kickout flashings" were not present at all recommended locations, some were not properly installed **OR** not properly sized according to industry design criteria at some areas. A competent stucco contractor can install proper "kickout flashings" for about \$395-\$450 each.

4.6 Picture 2 Kickout - Front of House

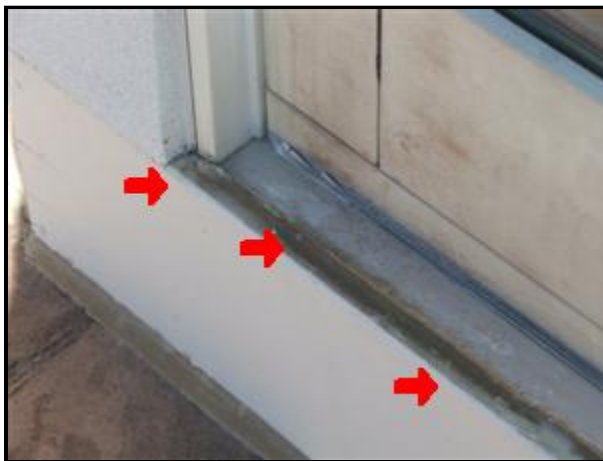
Also note the sills at the two double doors on the front porch don't fully cover the wood jamb below them.

5.1 Picture 1 Door Jamb

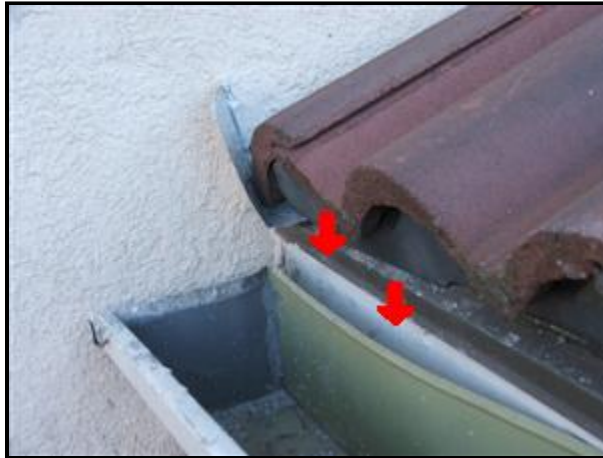
6.1 Picture 1

6.1 Most gutters look functional. You were missing a downspout by the garage. The gutters were loose at the fascia over the garage area, and should be secured to the fascia tightly and not allow water between the gutter and fascia. Secure the gutters to stop this leakage. Repair and Re-seal gutters as needed.

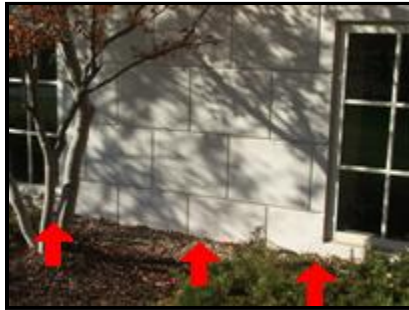
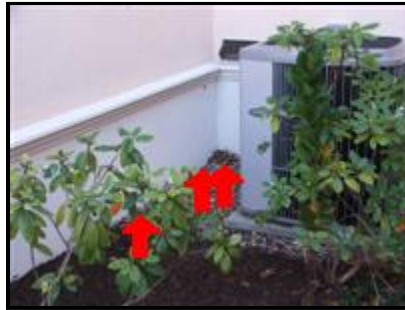
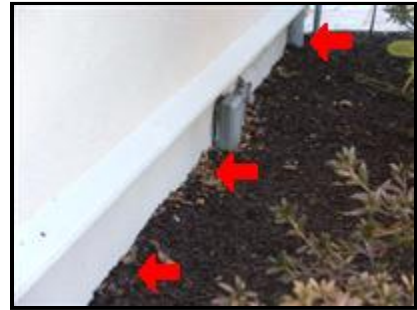
8.0 Your stucco is in direct contact with the ground at some areas, such as at the side, etc. This area should be re-graded to prevent insect infestations and the possibility of moisture intrusion and a Termite Band installed to allow proper Wood Destroying Inset Inspections.

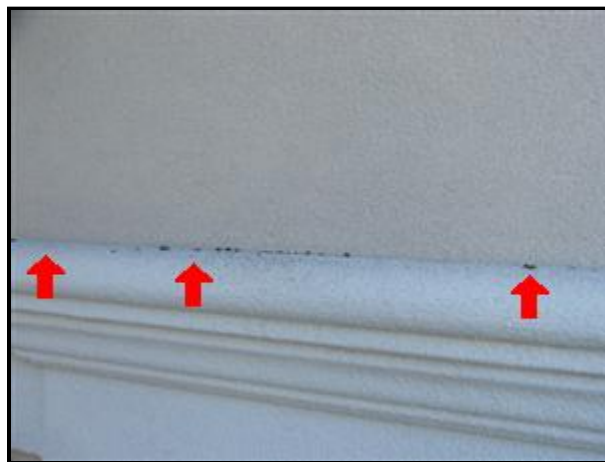
9.0 Picture 1

9.0 (1) Not all of the flat accents were caulked, sealed, or sloped correctly. This can allow moisture to enter behind the stucco and cause moisture damage to the stucco and structure. Caulk, seal or slope all flat accents.

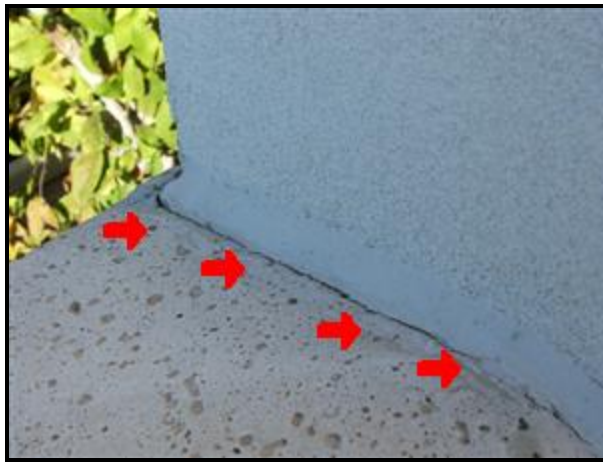
(2) Keep all caulk joints caulked to prevent moisture intrusion. Some locations are already separating.

9.0 Picture 2 Front of House Wall

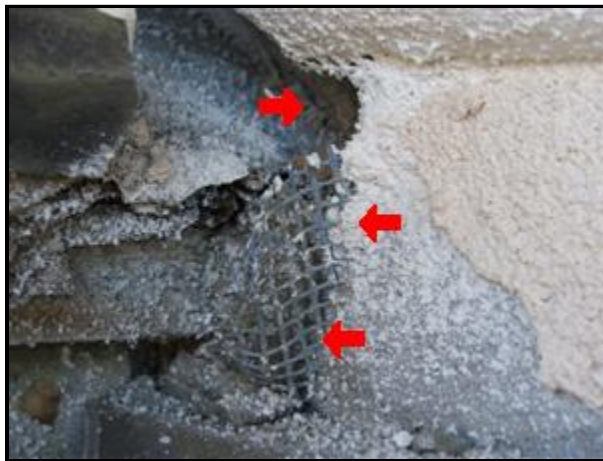
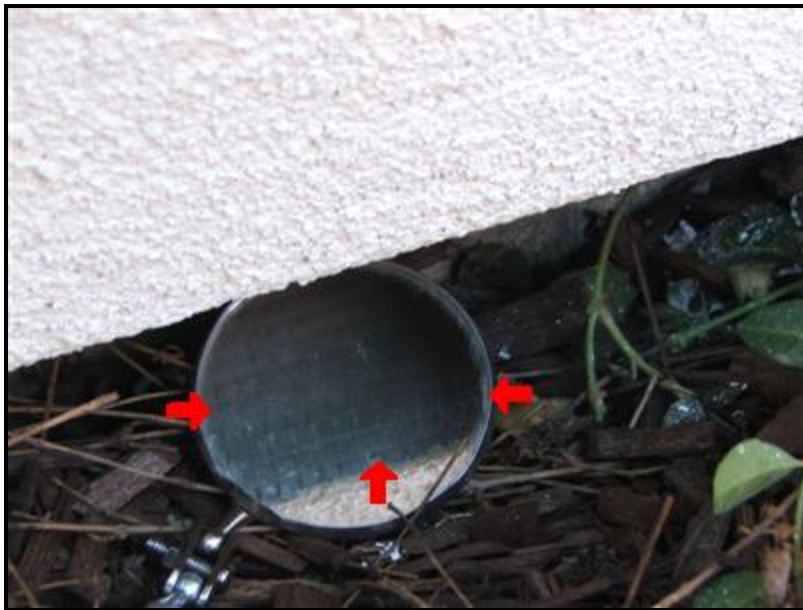
9.2 When foam or reinforcing mesh are visible the stucco can get moisture penetration. These areas should be better sealed to protect the system from potential moisture intrusion.

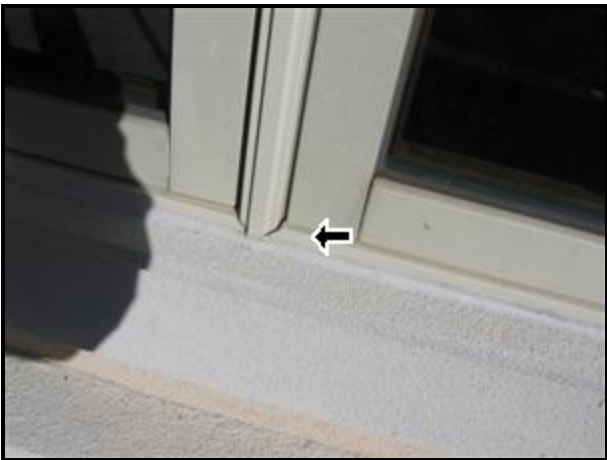
11.0.A Picture 4

(3) Gaps at window high potential for moisture intrusion thru window (typical detail on this house). Caulking needed.

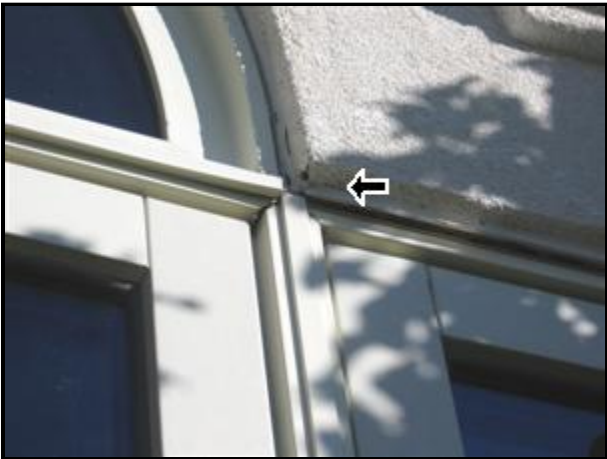
11.0.A Picture 5

(4) Gaps in window flashing. Proper flashing is needed.

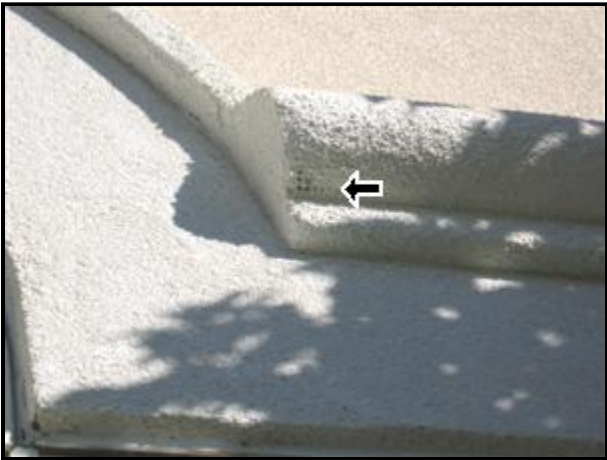
11.0.A Picture 6

(5) The reinforcing mesh shows through the stucco. This often means the base coat is too thin.

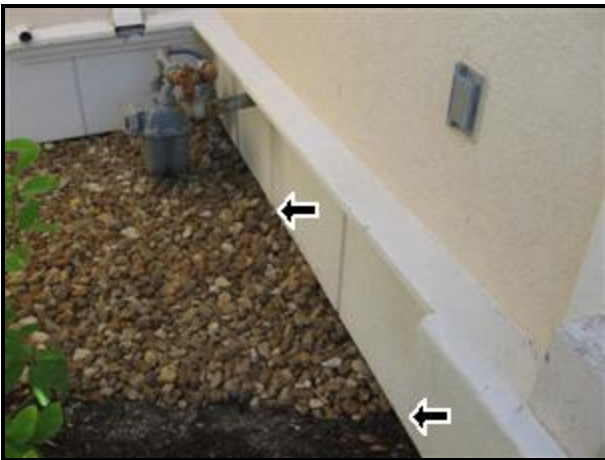
11.0.A Picture 7

(6) The stucco is too close to the soil (typical detail at the rear and sides).

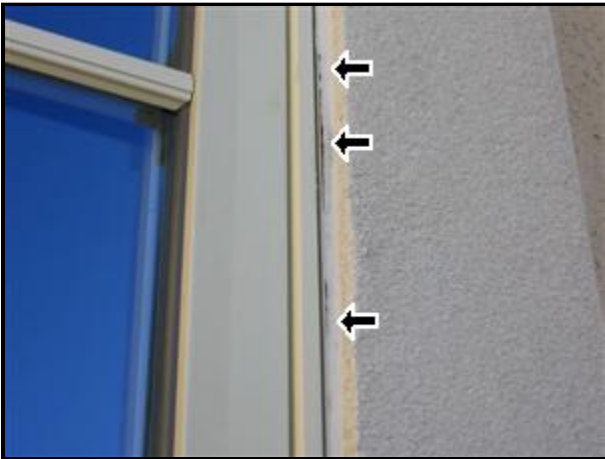
11.0.A Picture 8

(7) The caulking is improperly installed and the wrong type. Also, it appears to be separating or failing.

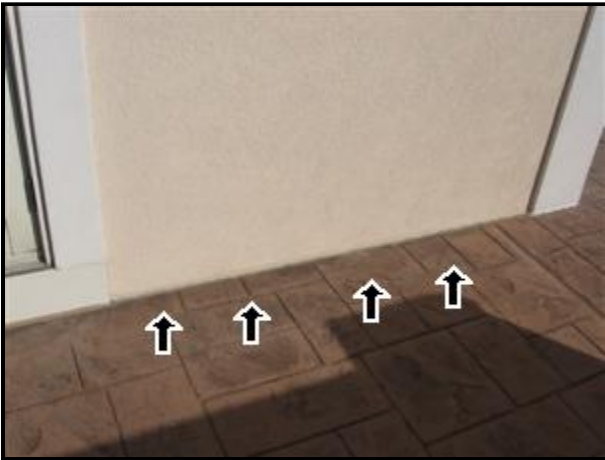
11.0.A Picture 9

(8) The stucco is touching or close to the stoop. Common but improper detail.

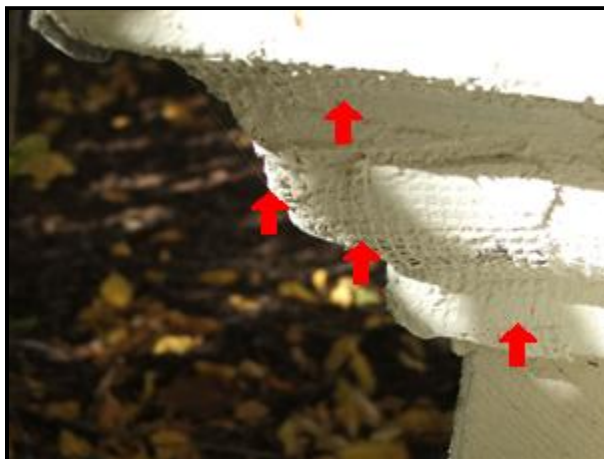
11.0.A Picture 10

(9) The reinforcing mesh shows through the stucco to the left of the front porch. This often means the base coat is too thin.

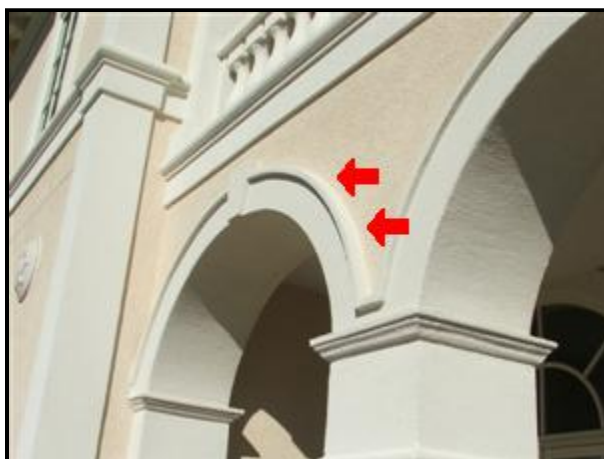
11.0.A Picture 11

(10) Example of flat accents - manufactures recommend they be sloped or flashed to help prevent water ponding there and causing damage.

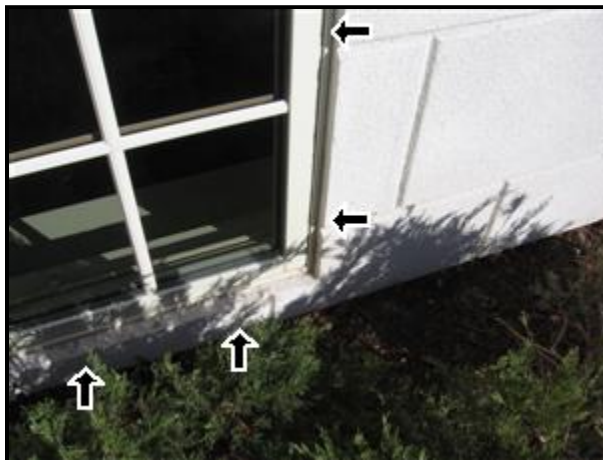
11.0.B Picture 2

(2) A proper type of caulking joint is missing.

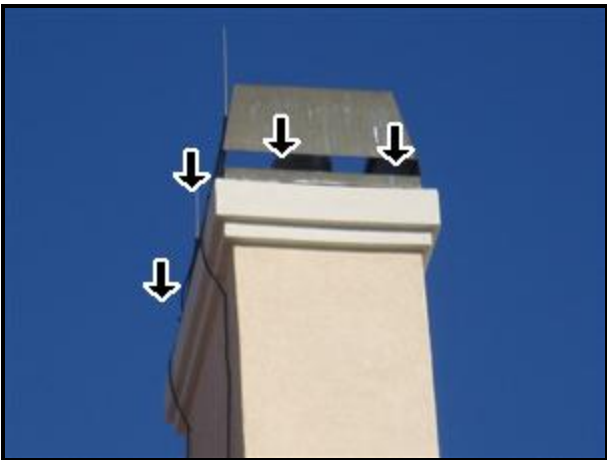
11.0.B Picture 3

(3) A proper chimney cap fully covering the tops of the chimneys was not visible if present.

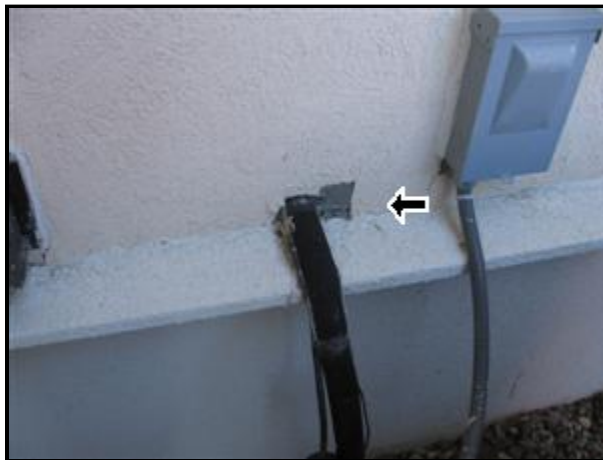
11.0.C Picture 2

(2) In our opinion, it appears that partial replacement of the stucco system was performed. The re-installed stucco appears to be a drainage system, but with improper drainage paths.

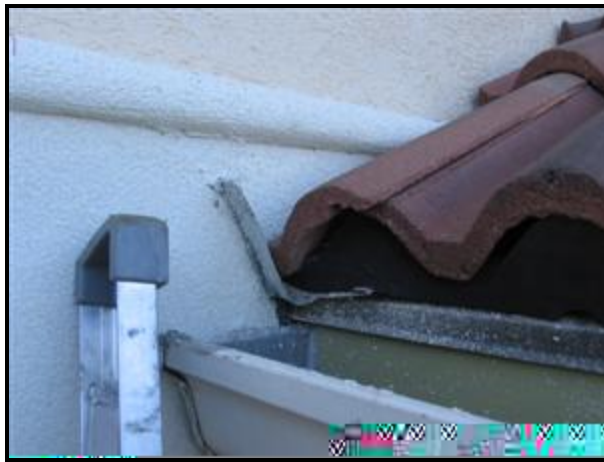
11.0.C Picture 3

(3) The kickout flashing is improperly installed (typical on this house).

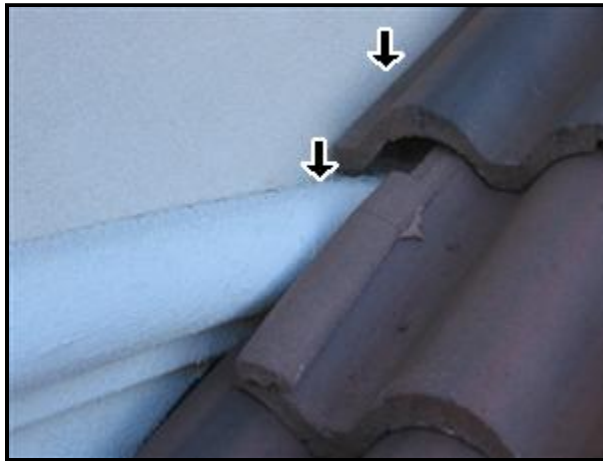
11.0.D Picture 2

(2) The stucco is too close to the roof. Proper flashing is recommended.

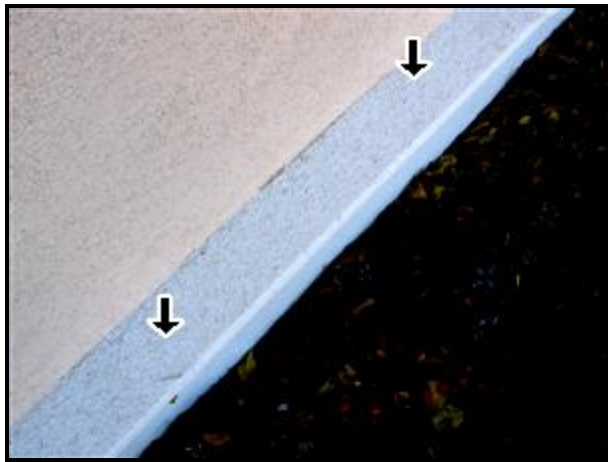
11.0.D Picture 3

(3) The mesh is showing through. The flat area is improperly installed (not sloped and sealed correctly). Typical detail on this house.
