Inspection Report

Property Address:
4478 SW Sample Dr
Columbia MO 65203

Dan Bowers Company

Date: 1/11/2022	Time: 10:00 AM	Report ID: Sample EIFS
Property: 4478 SW Sample Dr Columbia MO 65203	Customer: John Doe	Real Estate Professional: NONE

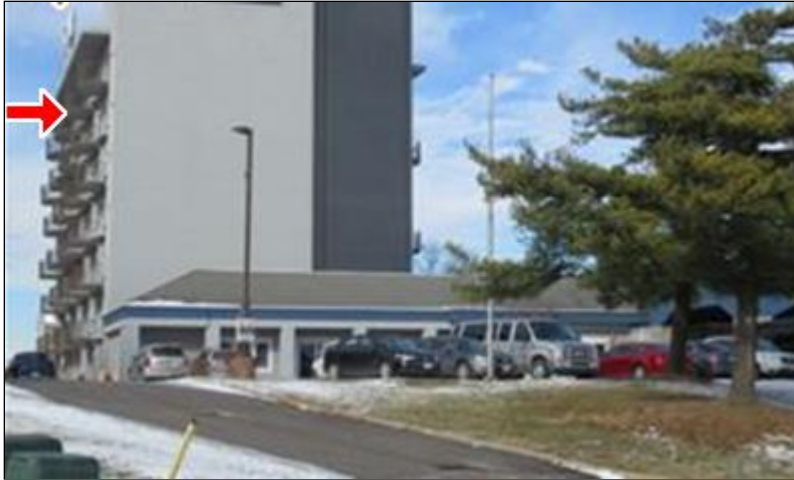
11.0 Picture 1 Tower (not inspected)
