Guidelines for Inspecting EIFS Clad Homes

Senergy provides the following guidelines as an aid to help inspectors, builders, relocation managers, realtors, and homeowners to better understand the importance of key details in relation to the performance of the walls of a home.

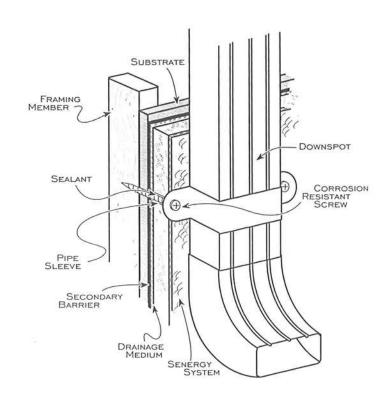
Downspout Attachment

Intended Purpose: Fasten downspout to "screwable" sheathing or wood blocking in a manner to help prevent water intrusion into the EIFS through fastener penetrations.

Considerations: In many instances the fasteners used to attach the downspout straps were not installed through the appropriate sleeve with sealant. It is not necessary to remove the fasteners and downspout straps in order to install a sleeve with sealant. In order to prevent water intrusion into the EIFS, sealant should be applied over all fastener heads and the top edges of the downspout straps.

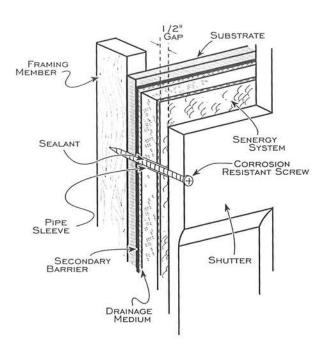
Shutter Attachment

Intended Purpose: Install shutter to "screwable" sheathing or wood blocking in a manner to help prevent water intrusion into the EIFS through fastener penetrations.

Considerations: In many instances the fasteners used to attach the shutter were not installed through the appropriate sleeve with sealant. If the existing shutters are not adequately secured and or sealed, the shutters should be removed and the appropriate sleeve with sealant installed prior to the shutters being reattached.

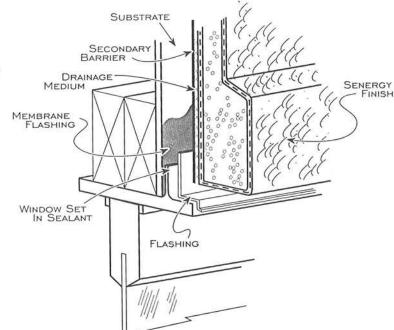
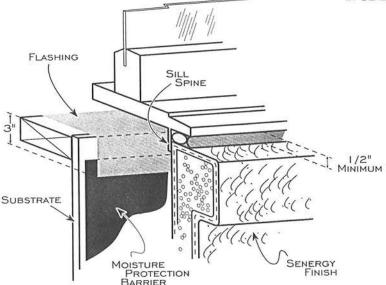
Sealant joints around openings and penetrations

Intended purpose: Prevent water intrusion between the EIFS and adjacent walls, windows, doors and other penetrations.

Considerations: Using the sealants recommended by Senergy in the manner which is prescribed by the sealant manufacturer and Senergy will prevent water from entering the wall at these intersections. Sealants that do not perform as required might limit the degree of protection that the prescribed approach would have provided.

If a space around the window was not provided for backer rod and sealant, and if the window extends out past the EIFS, then a bond breaker and fillet bead of sealant is an effective seal. In such cases, it is not necessary to cut the EIFS back from the window so that backer rod and sealant can be installed.

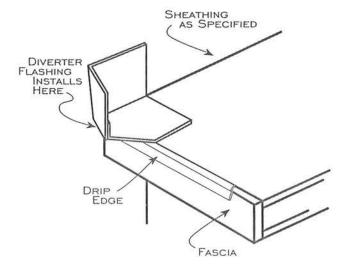
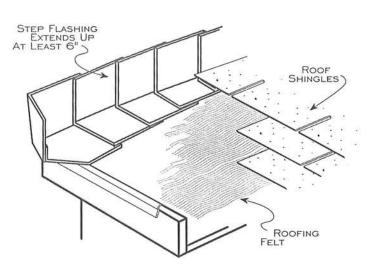
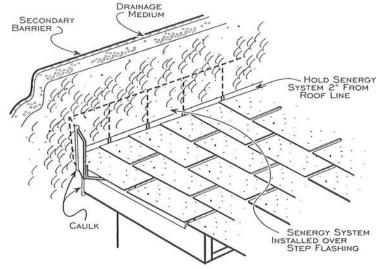
Kickout/Diverter at Roof/Wall Intersection

Intended Purpose: Accumulating water runoff should be directed out and away from the structure. Roof-to-wall flashing requires a kickout/ diverter at its termination to insure that water is directed to the outside.

Considerations: The diverter can vary in its dimensions to accommodate local exposure conditions and specific detailing requirements, as long as it directs water completely away from wall surfaces.

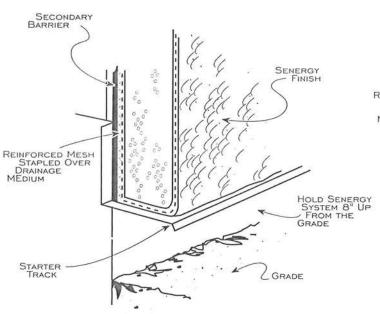
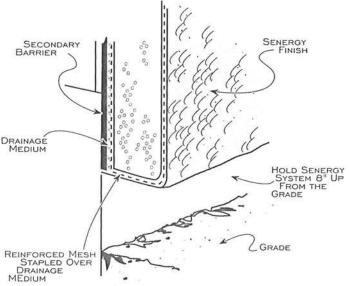
Termination Above Finished Grade

Intended Purpose: The EIFS should be terminated a minimum of 8 inches above grade in order to allow access for visual inspection and treatment of the foundation for pest control.

Considerations: Although Senergy specifications and details have never suggested running the system

to grade or below grade, the Department of Energy originally recommended running insulation below grade. This did not become an issue with pest control companies until the Environmental Protection Agency outlawed the pesticide, chlordane. Now, without a strong and lasting termiticide, the pest control companies often need to visually inspect the base of the wall. This requires the use of the detail that Senergy always showed.

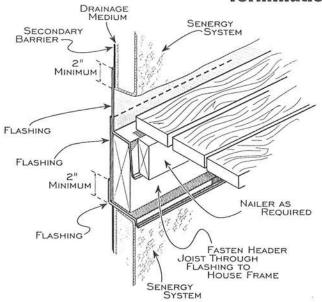
Termination above Roof Line or Deck

Intended Purpose: A gap allows for appropriate system edge termination, ease of roof or deck replacement or repair. It also allows for the system and flashing to be inspected for proper installation.

Considerations: On an existing project, the termination can occur closer to the roof or deck surfaces than indicated in published details without harm, as long as the bottom edge of the EIFS conforms to our requirements. The EIF System does not have to be cut back from the roof line or deck unless the appropriate flashing was omitted and is to be installed.

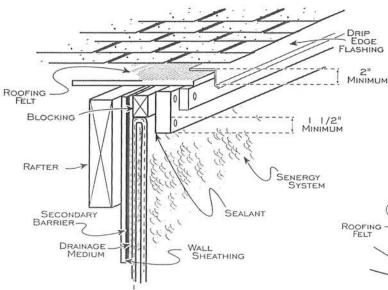
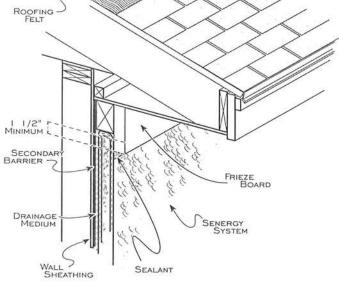
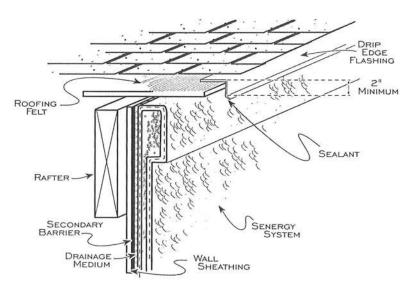
Gable and Soffit End Termination

Intended Purpose: The EIFS should be terminated in a manner to help prevent water from entering between the EIFS and the wall to roof assembly.

Considerations: In some cases the EIFS may have been applied tight against the soffit/gable end. In areas where this occurs, a triangular backer rod with sealant can be installed to help prevent water from entering the EIFS. It is not necessary to cut the EIFS back in order to make room for backer rod and sealant.
