Inspection Report

Property Address:
4478 SW Sample Dr
Columbia MO 65203

Dan Bowers Company

Date: 1/11/2022	Time: 10:00 AM	Report ID: Sample EIFS
Property: 4478 SW Sample Dr Columbia MO 65203	Customer: John Doe	Real Estate Professional: NONE

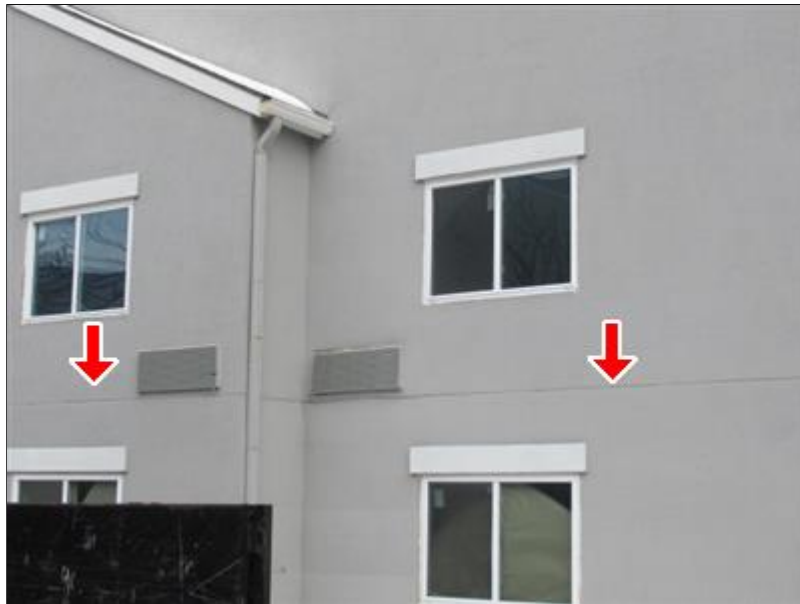
2.2 Picture 1

This detail was present at one or more locations on this building.

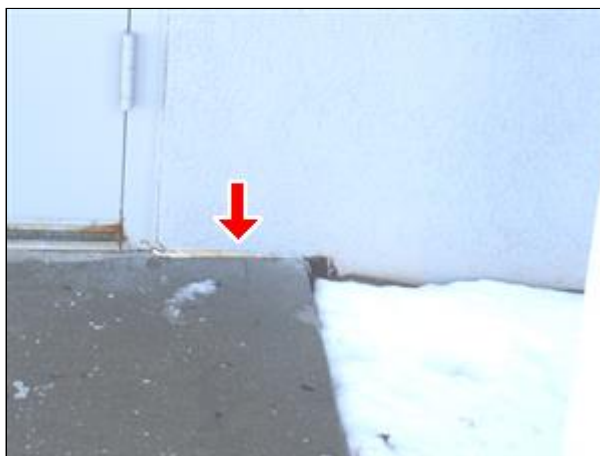
2.3 Picture 2

Comments: Partial, Improper

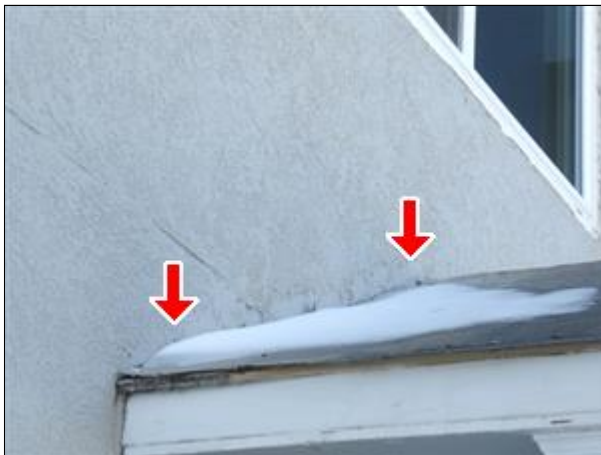
2.4 Picture 1

There was an area at the right wall and the small gable roofs over entry doors with no visible step flashing. Have stucco contractor verify presence, modify or install.

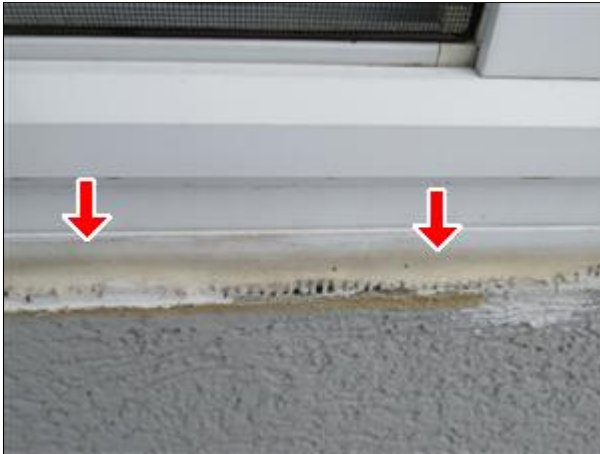
3.0 Picture 1

Caulking looks like it might have been adequate to start, but now has multiple places on all sides of the building where it is worn, separating, the wrong type, split, etc (all of which can allow moisture intrusions into the wall cavity). Have a competent stucco contractor caulk **AND** re-caulk any place below the soffit line where the stucco meets another building material, such as windows, doors, trim, siding, wood, mitre joints, masonry, flashing, etc.

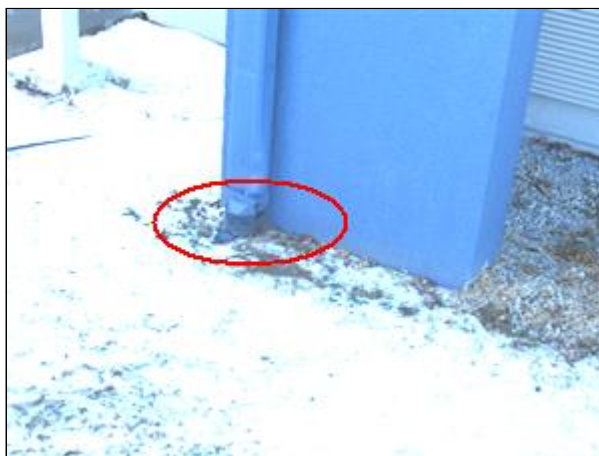
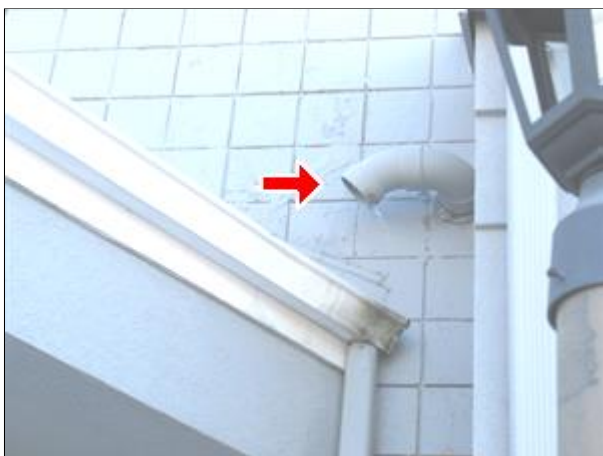
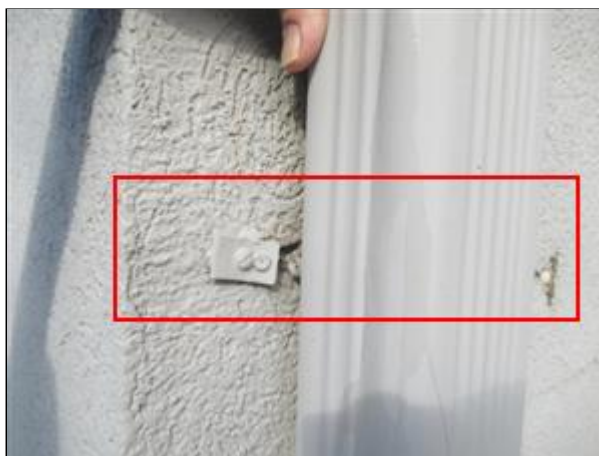
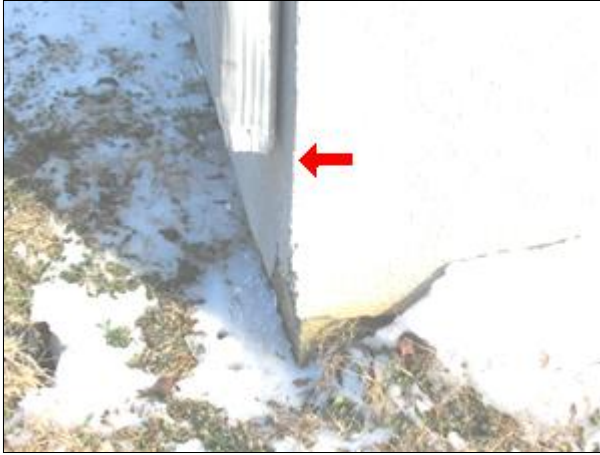
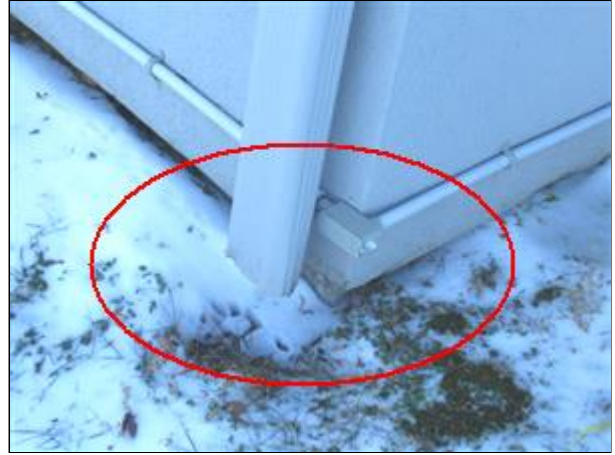
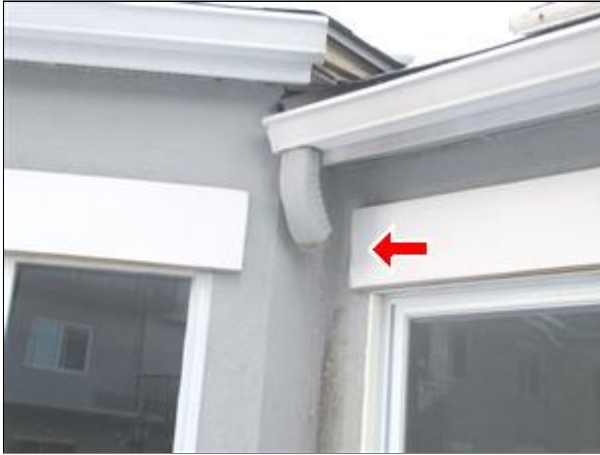
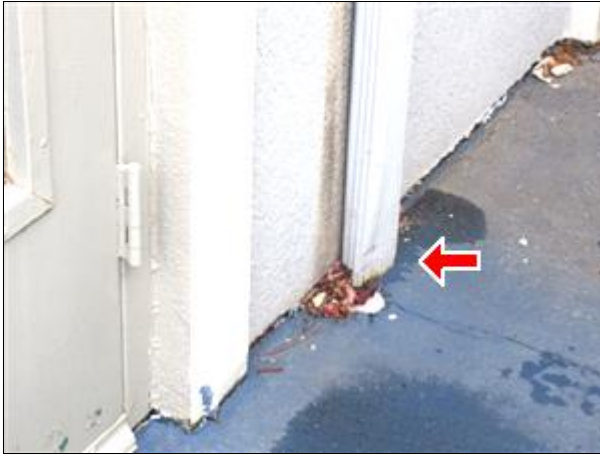
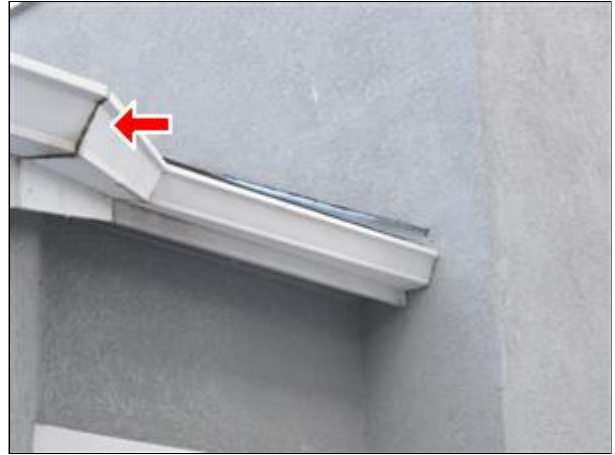
The gutters leak at some areas and there are holes near them. This can allow moisture to get into the stucco clad wall cavities or the fascia board below them. Service and Repair as Needed.

Your downspouts are attached or screwed to the walls in a manner that can allow moisture penetration. Downspout installation can be modified to provide better protection from possible moisture intrusion. The use of clip-on brackets provide a better protection from moisture. The brackets are attached to the stucco cladding - sealed - and then the downspout can be attached to this.

We noted some gutters or downspouts improperly depositing the roof run-off water next to the foundation. This can lead to leaks or foundation movement. We recommend extending them further away from the building (6' or more).

Loose or missing downspouts and elbows were noted at various locations on the building. Service and Correct.

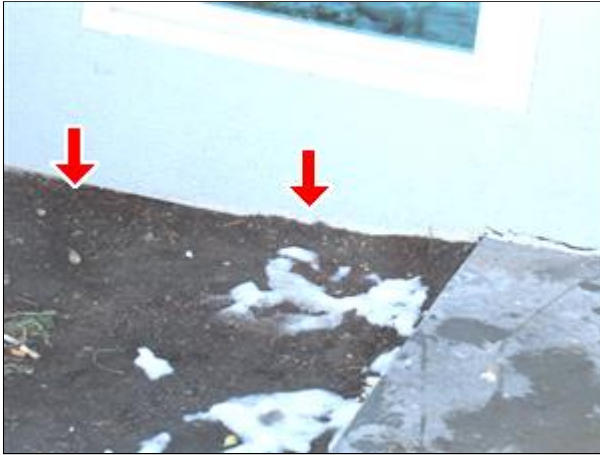
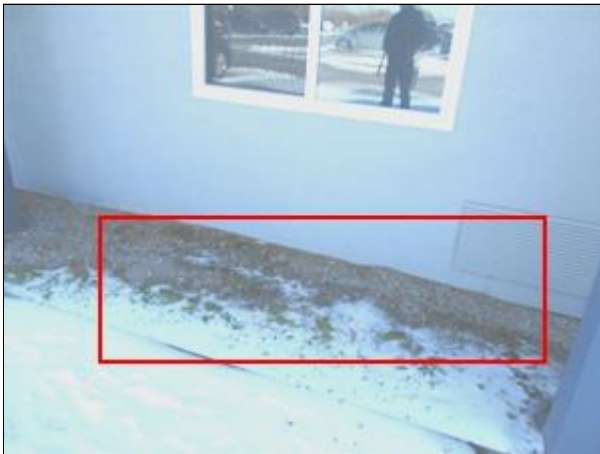
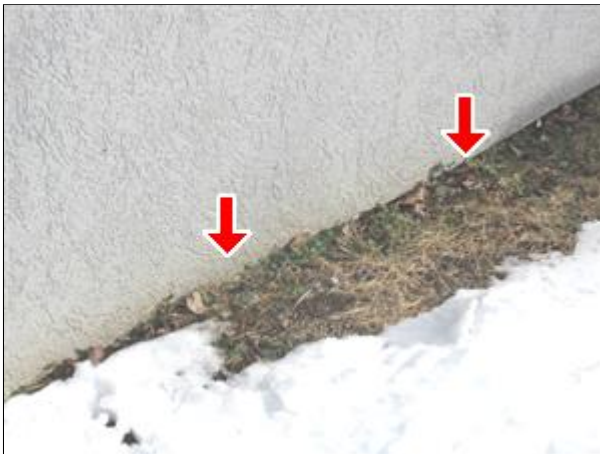
The stucco is touching and/or too close to the ground at many location(s). **Damage has occurred at many of these areas.** The location(s) where the soil to stucco distance is less than 6" should be regraded to provide a proper gap of 6" or more.

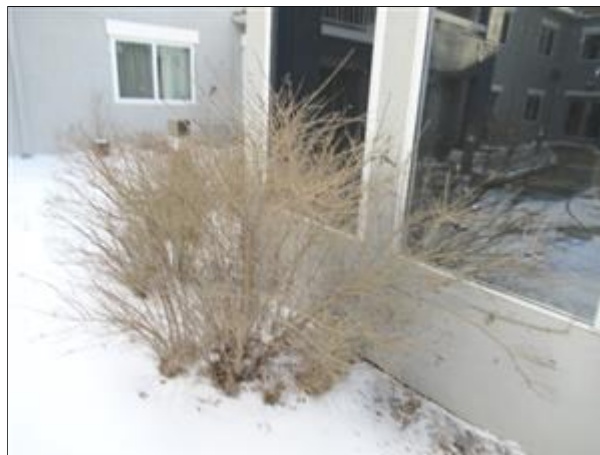
8.2 Picture 1

Although it is winter and they are dead at this time and not in bloom, etc Bushes or other foliage are close **OR** rub the stucco walls at a few locations around the buildings exterior. This can give pests an easy bridge into the structure and can also allow for moisture damage. Trim the bushes or other foliage back at least 2' or more from the walls.

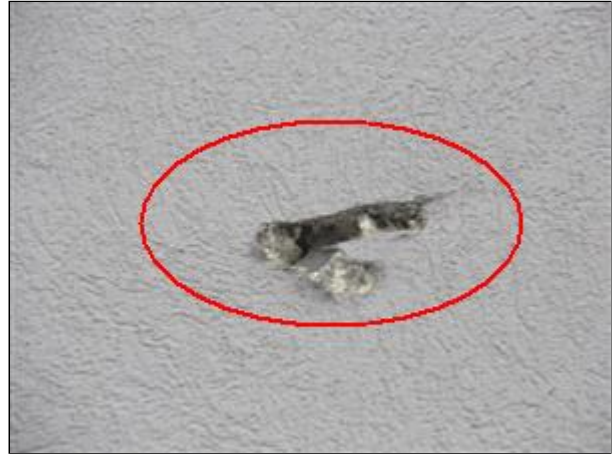
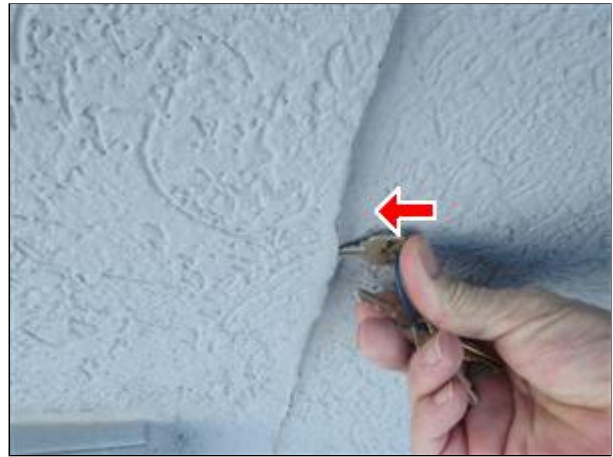
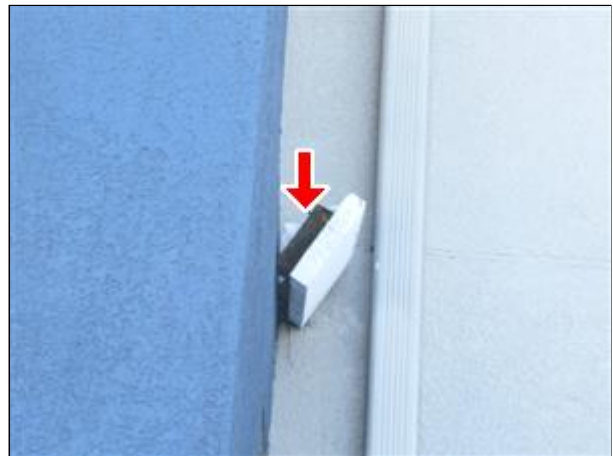
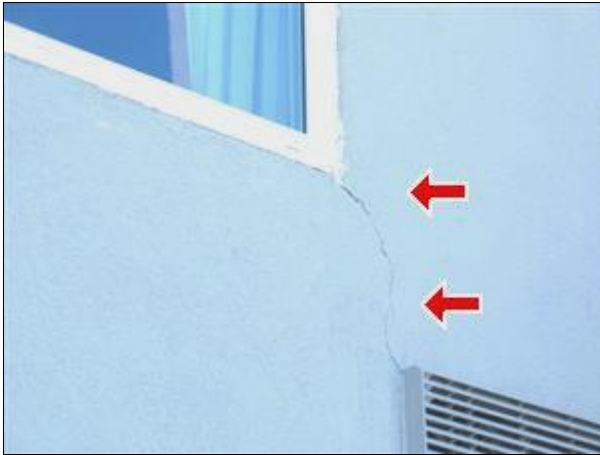
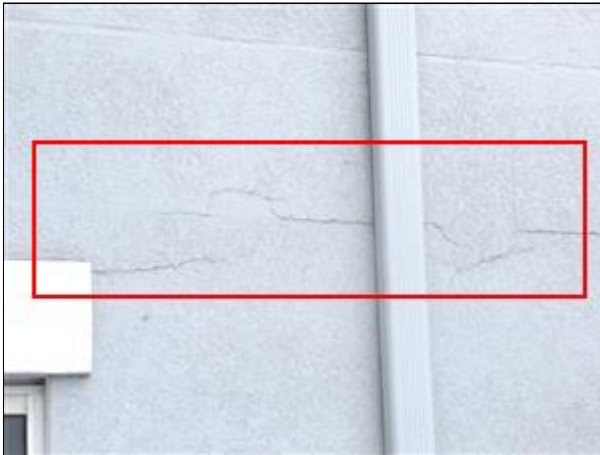
There were many areas at most all sides of the building where impact damage, cracks and/or holes were noted. These may allow moisture intrusion and should be repaired.

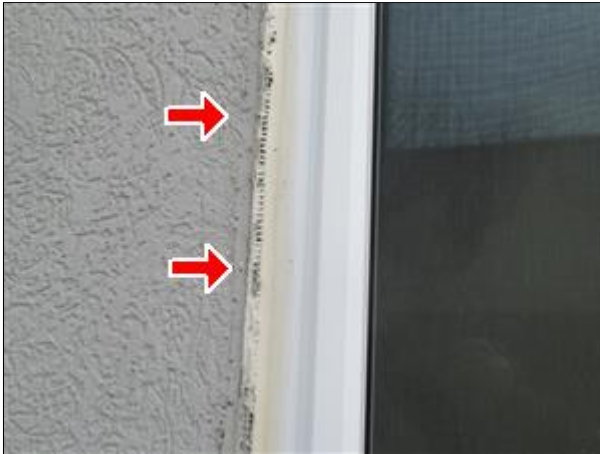
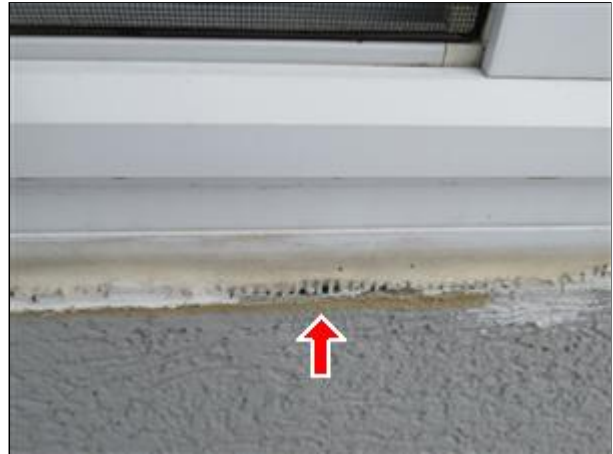
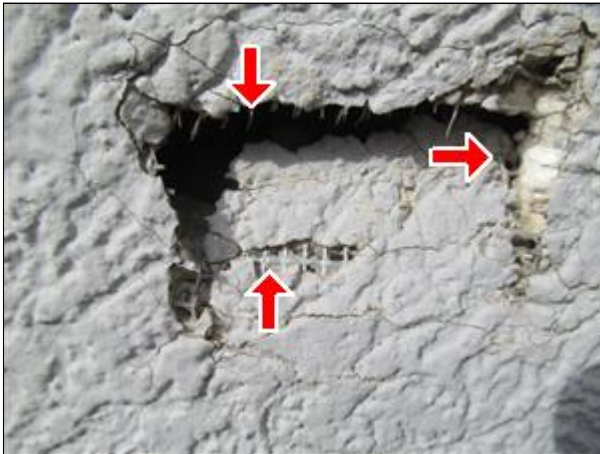
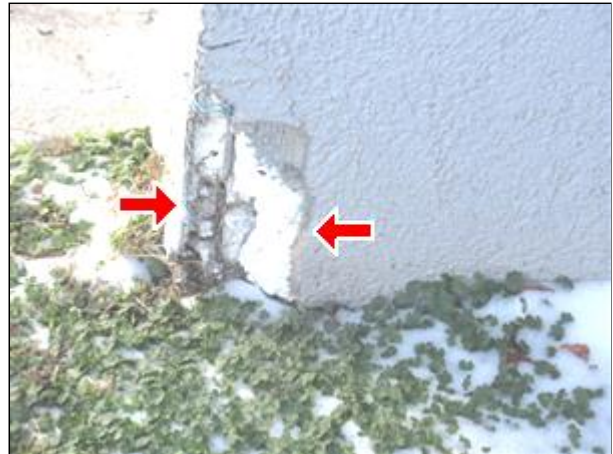
There are multiple locations on most sides of the building where plastic mesh or foam is exposed. When the foam and / or reinforcing mesh is visible the stucco could have moisture penetration. These areas should be Repaired to protect the system from potential moisture intrusion.

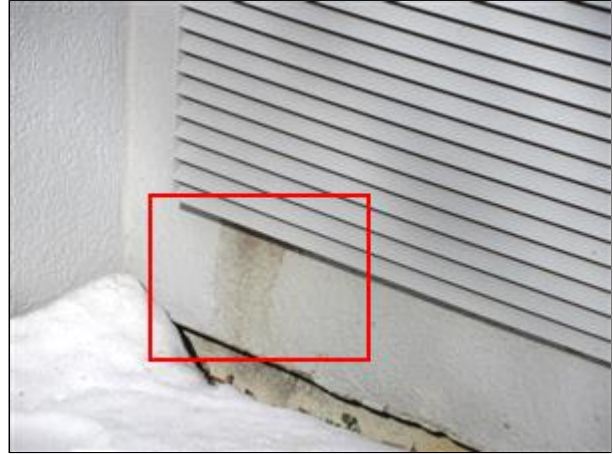
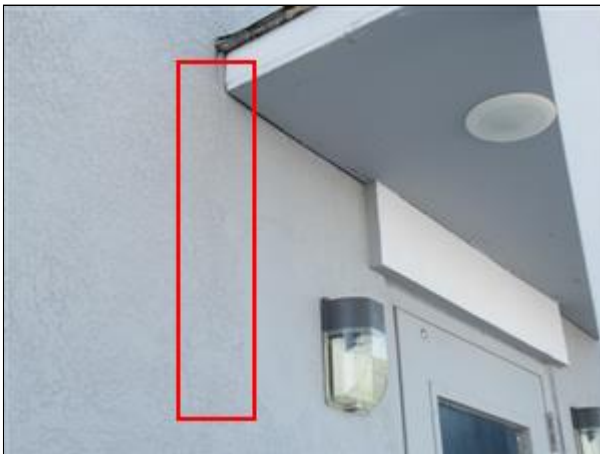
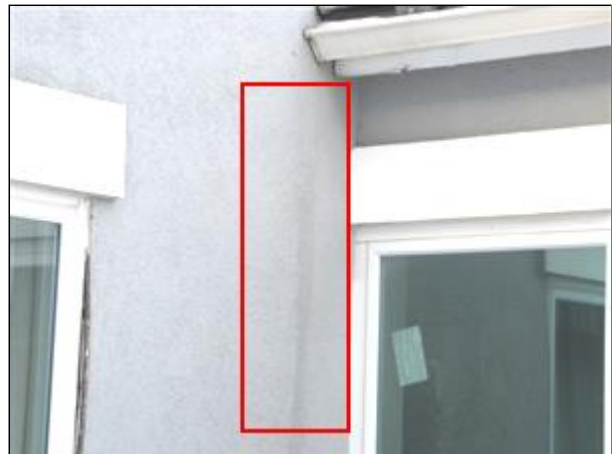
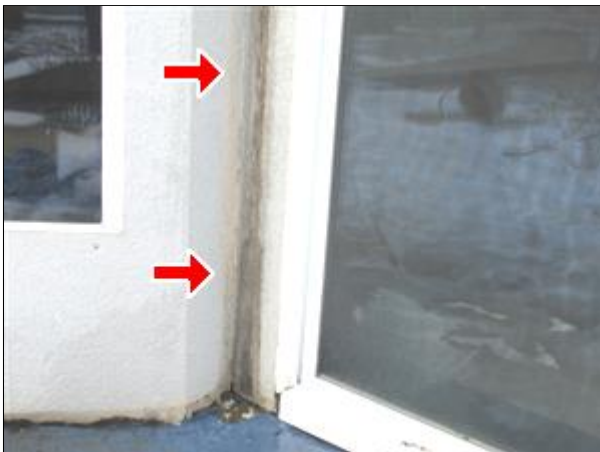
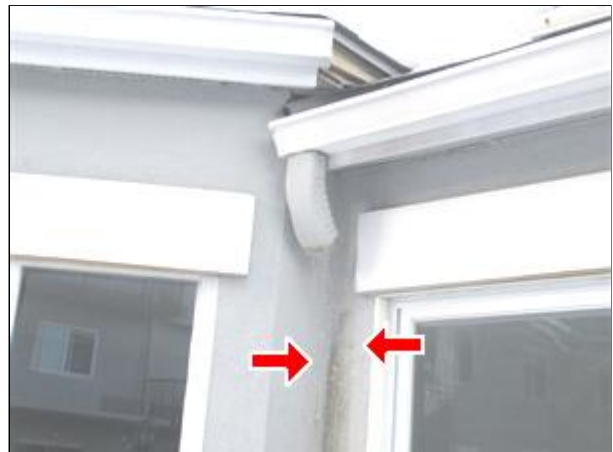
There are areas where stains are present on the Stucco walls and/or trim. These areas should be cleaned with a mild soap or cleaner recommended by the stucco manufacturer. Careful or no use of a high-pressure sprayer is advised. Apply the cleaner using a sponge or brush.

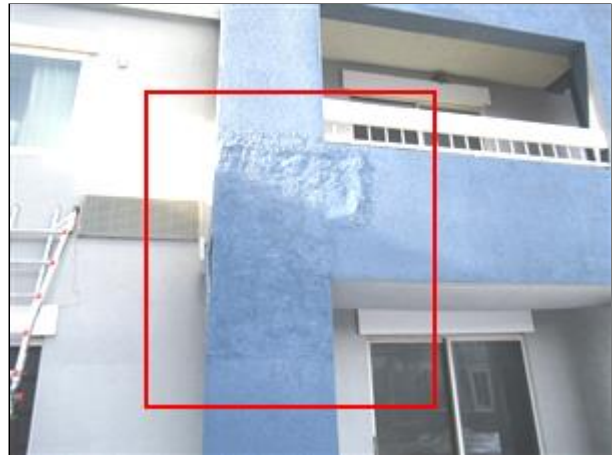
(2) Prior repairs were noted, that in our opinion look like an amateurish type See Examples in Courtyard area.

Have your stucco contractor evaluate then provide a proper Repair as Needed.

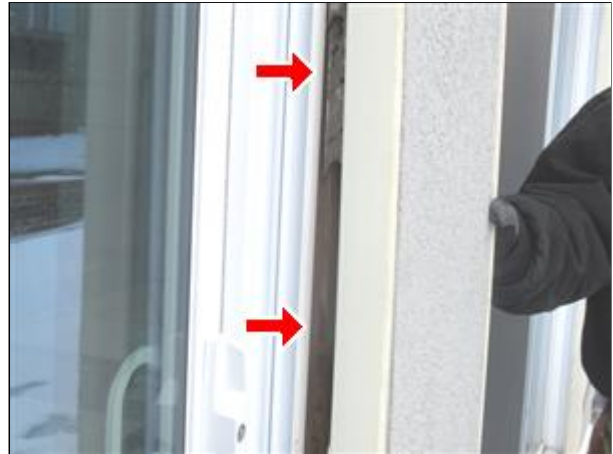
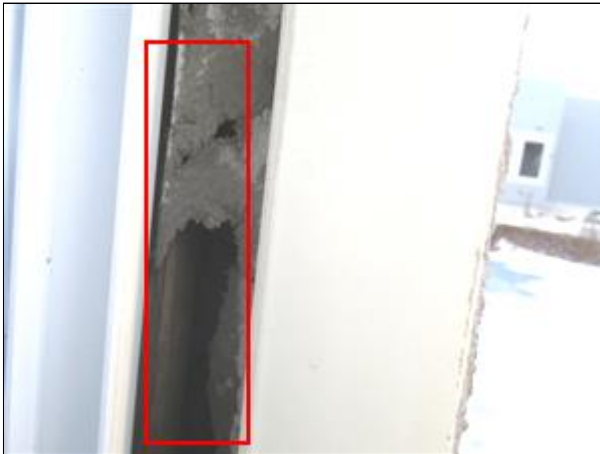
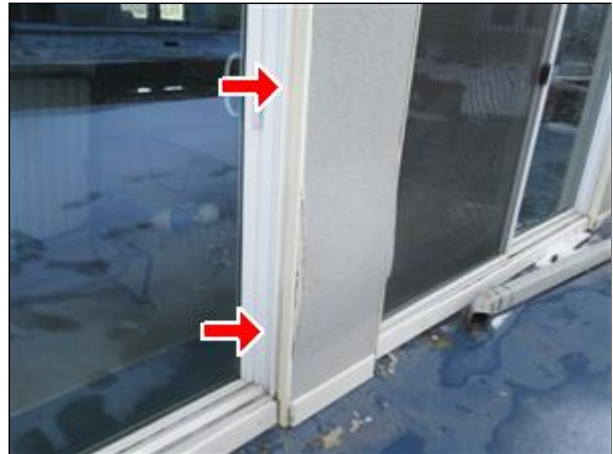
(3) Several areas in the Courtyard area have bulging and/or separated stucco. **It looks like Drywall was used at some areas for a substrate instead of wood.** Have your stucco contractor evaluate then provide a proper Repair as Needed.

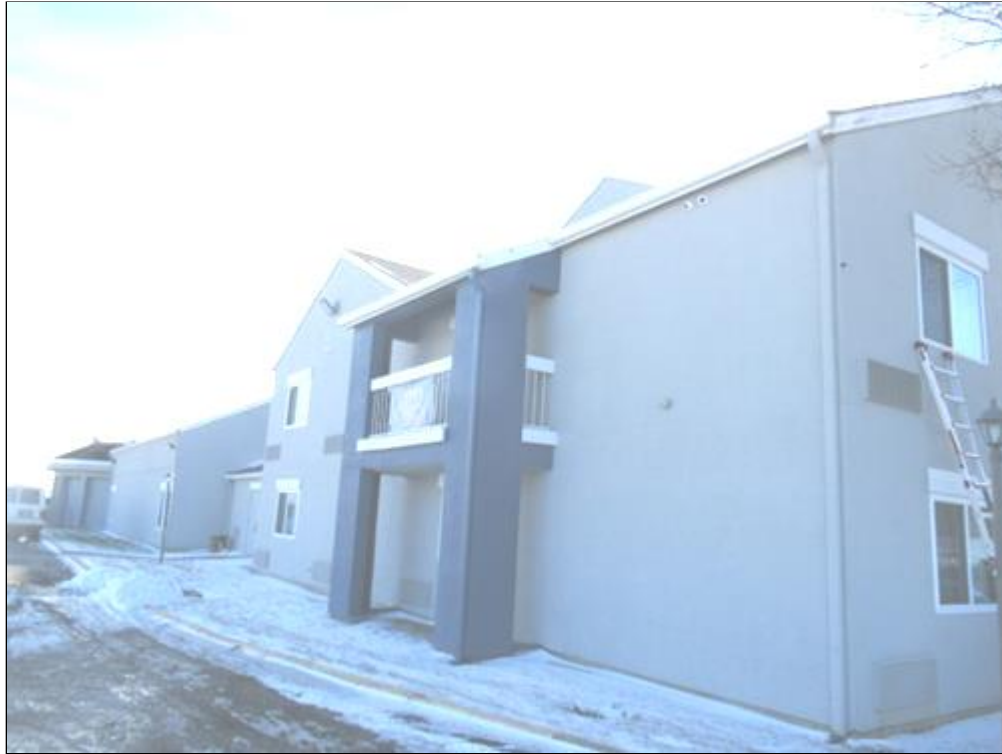
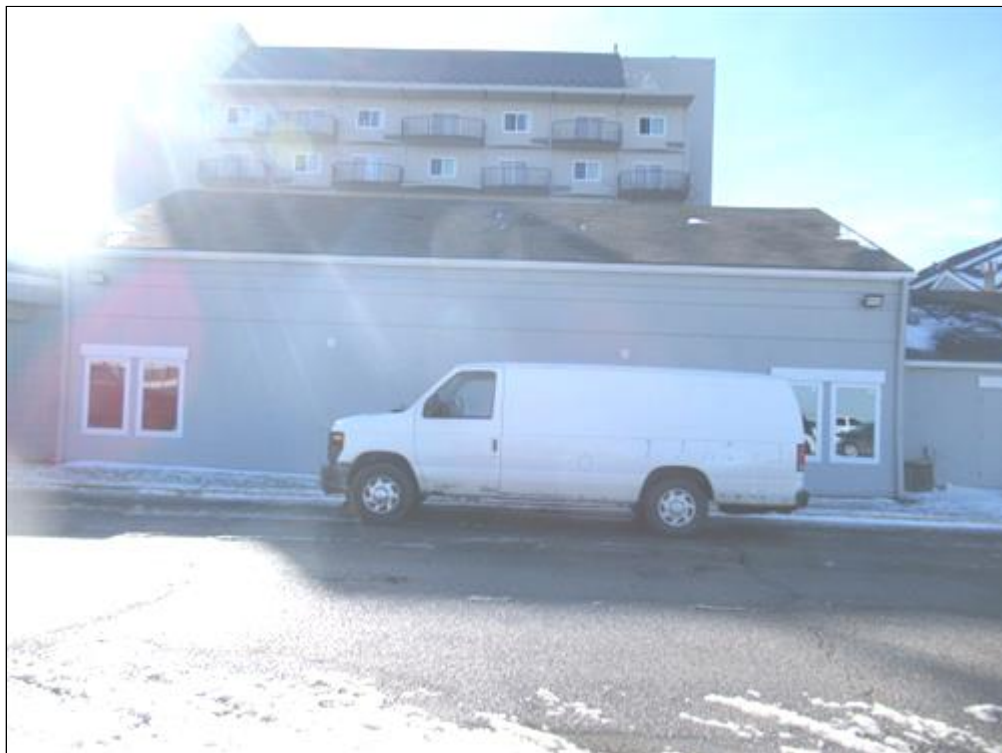
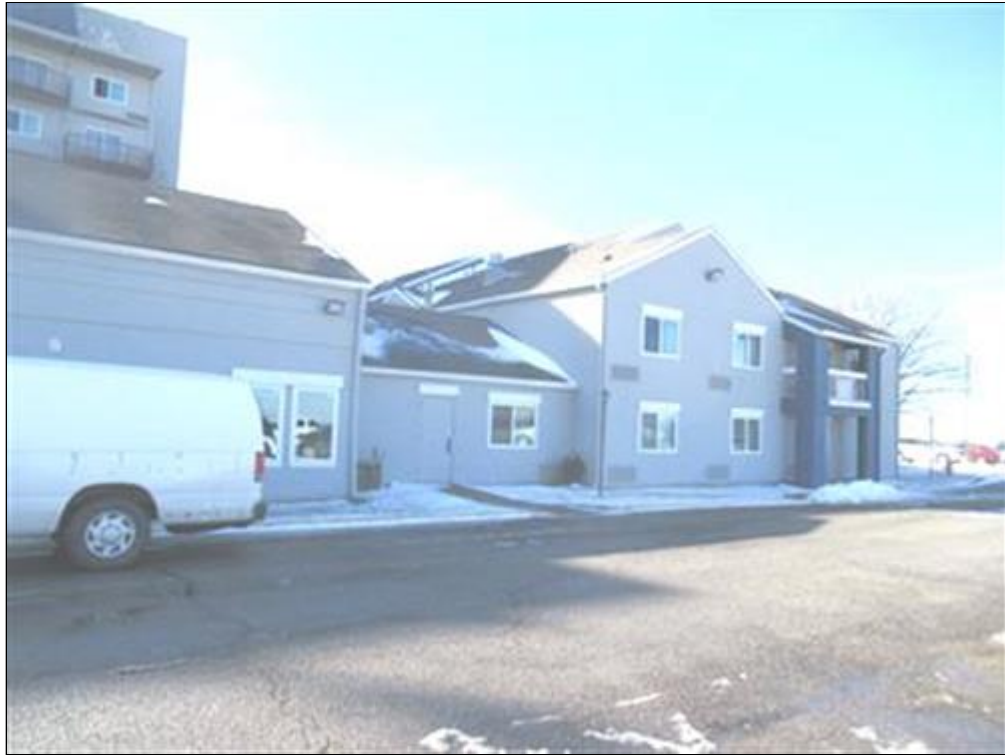
(1) Right Elevation Right Side of 2-Story Bldg

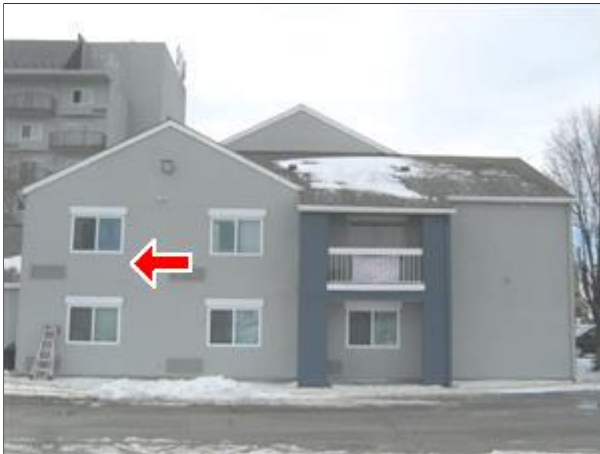
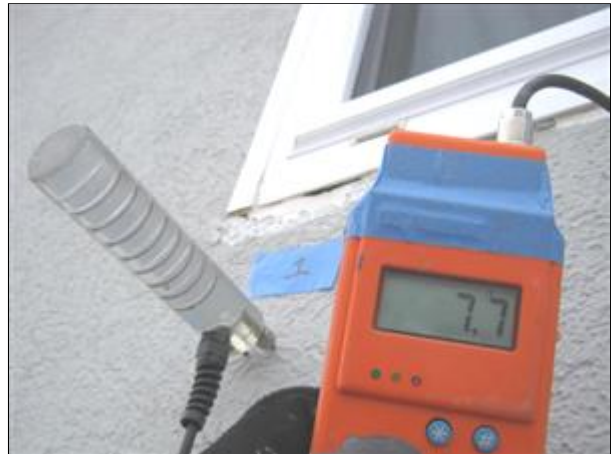
(2) The moisture content when probed was: 7.7%

The substrate was SOFT when probed.

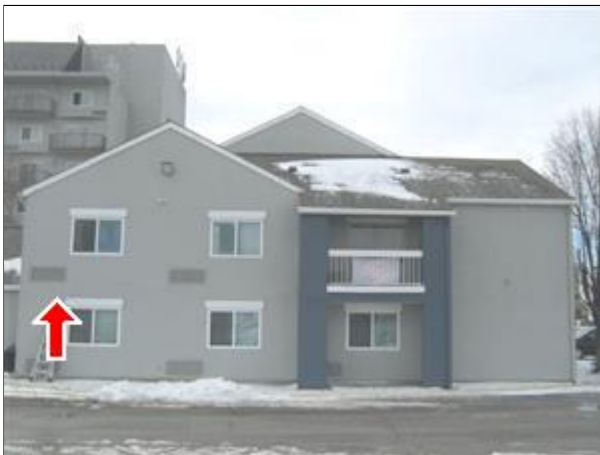
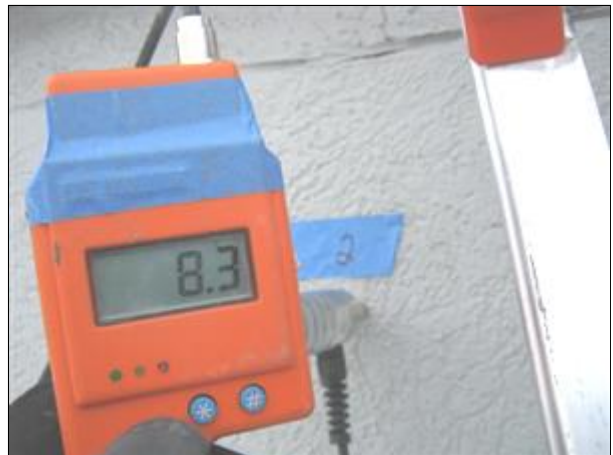
(3) The moisture content when probed was: 8.3%

The substrate was SOFT when probed.

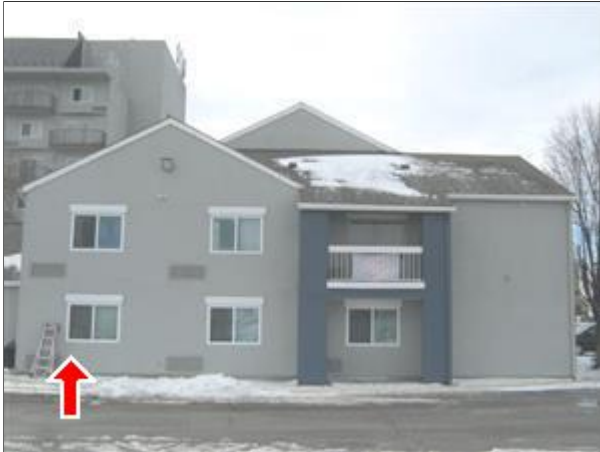
11.1 Picture 9

(4) The moisture content when probed was: 6.3%

The substrate was SOFT when probed.

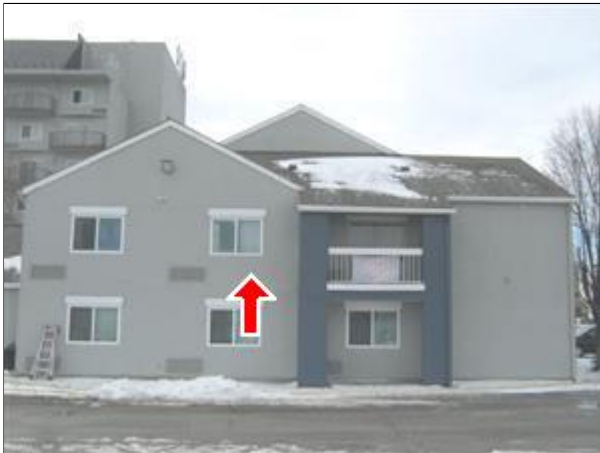
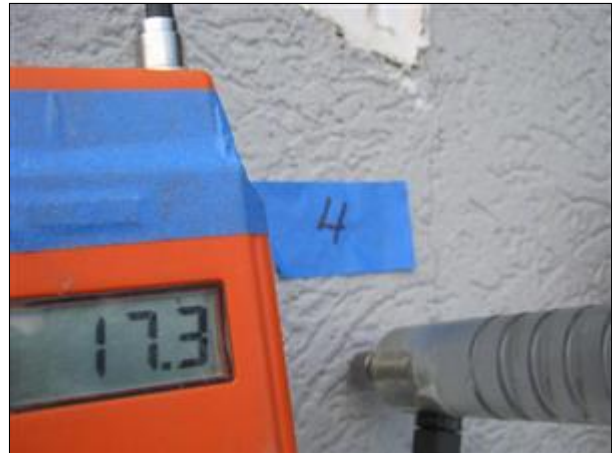
(5) The moisture content when probed was: **17.3% (Almost High)**

The substrate was SOLID when probed.

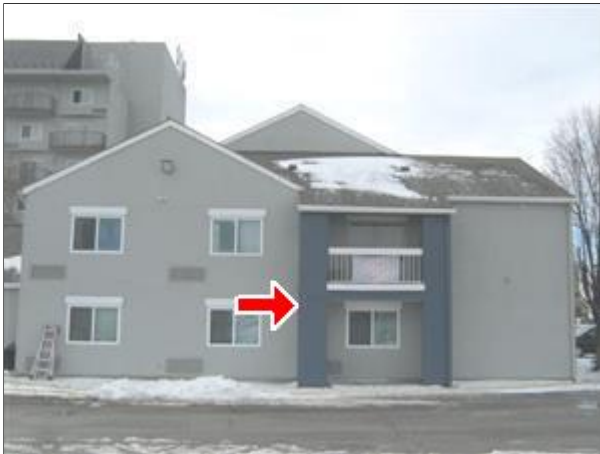
11.1 Picture 13

(6) The moisture content when probed was: 7.6%

The substrate was SOFT when probed.

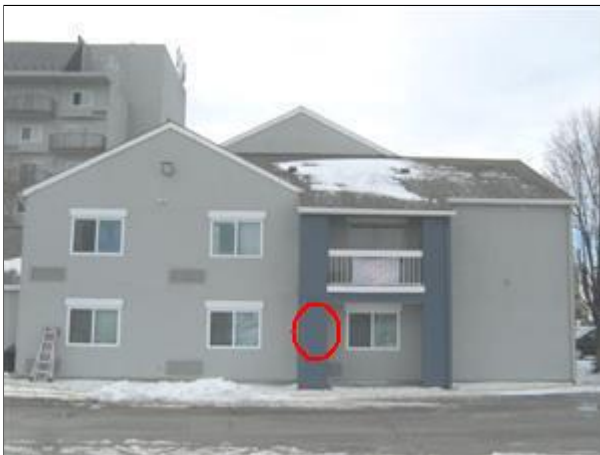
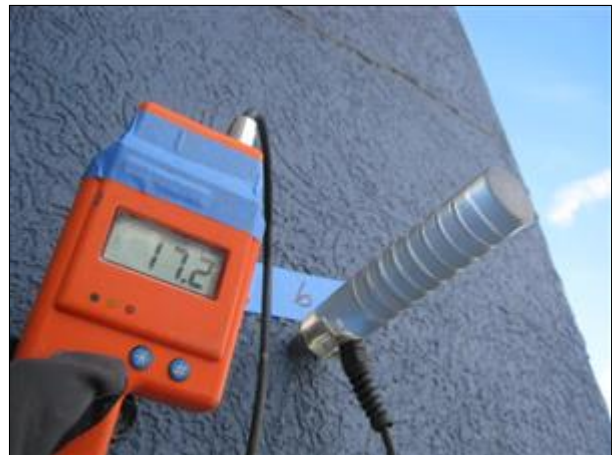
(7) The moisture content when probed was: **17.2% (Almost High)**

The substrate was SOFT when probed.

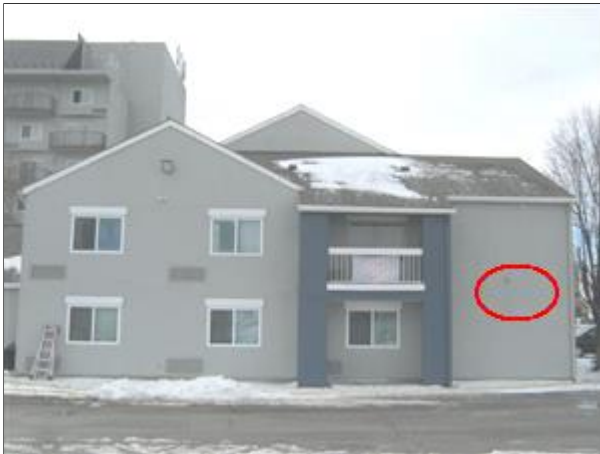
(8) The moisture content when probed was: 8.7%

The Substrate appears SOLID where probed.

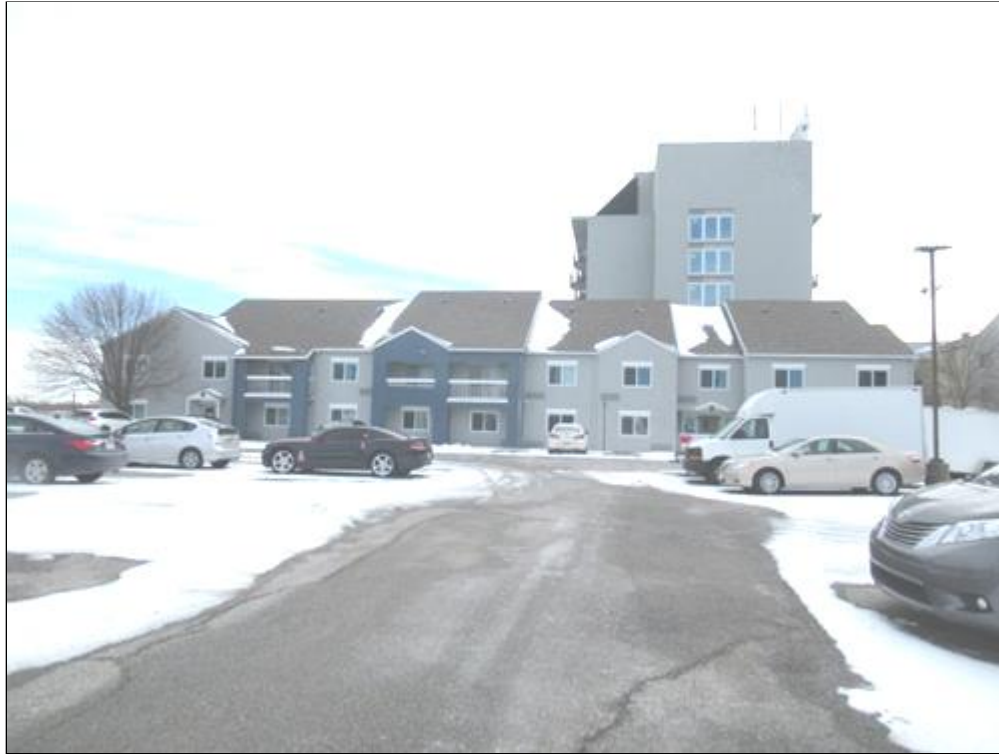
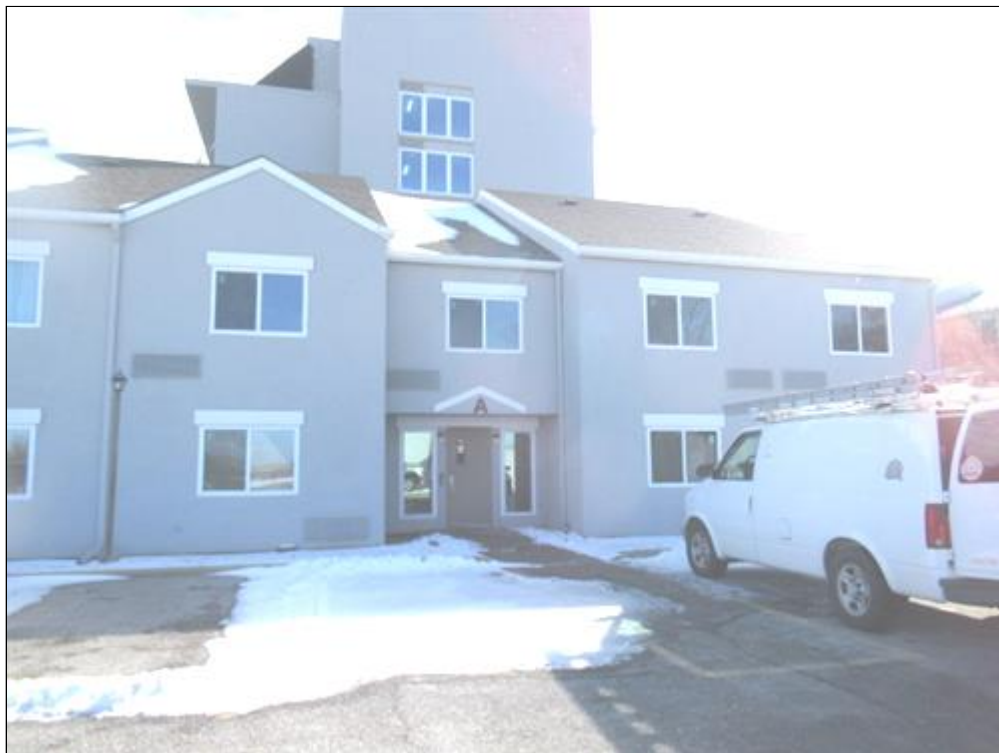
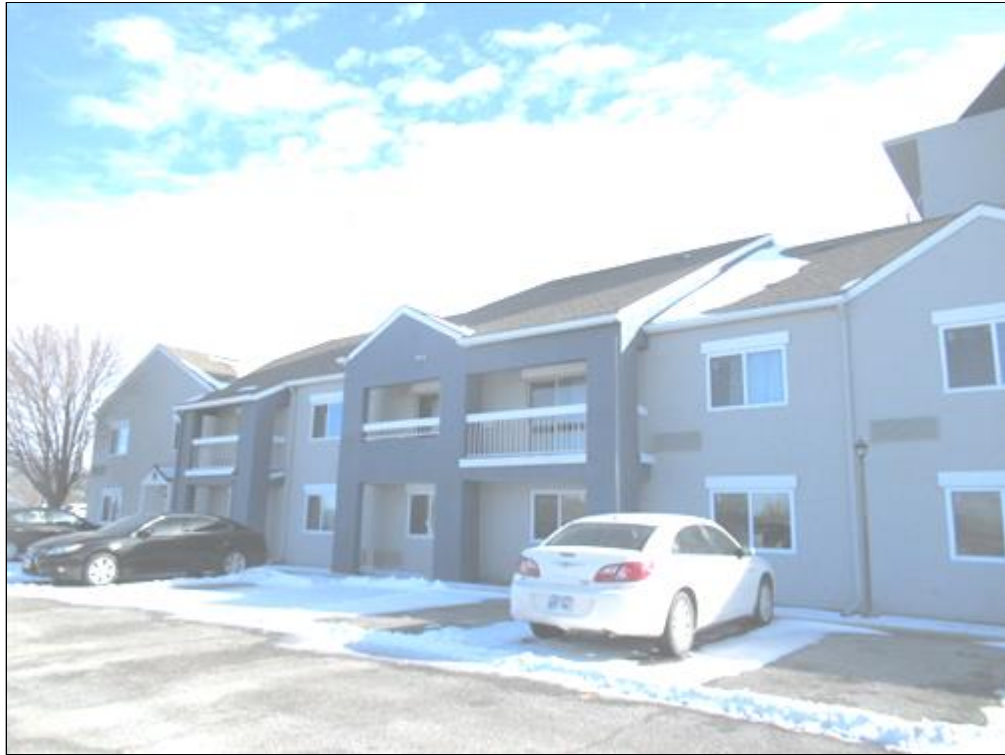
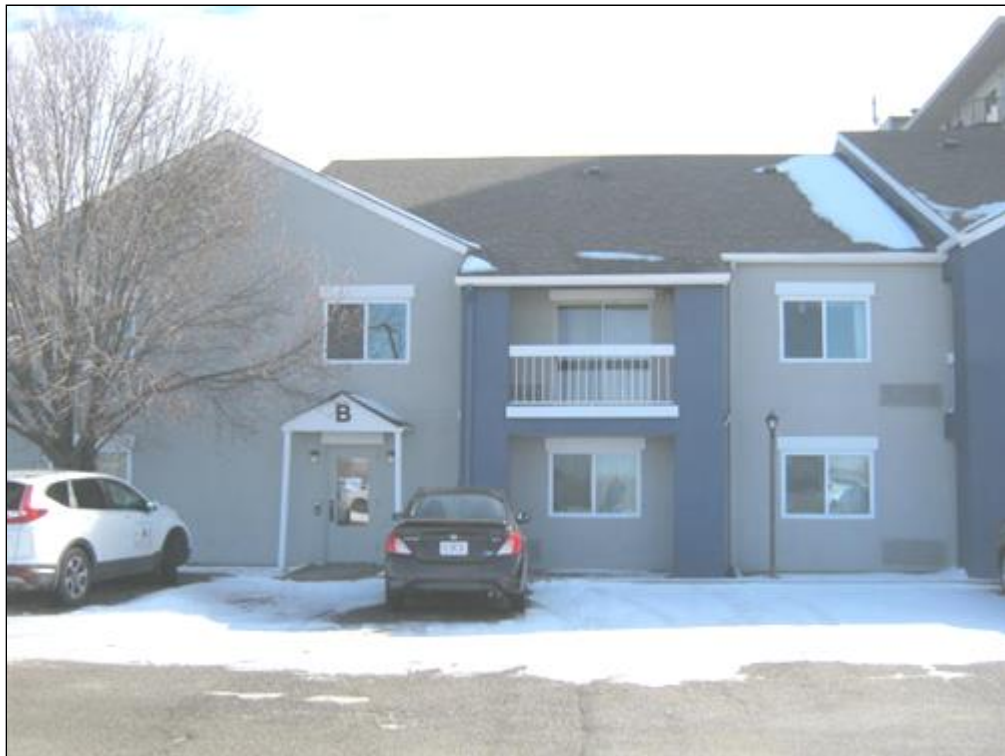
(1) Rear Elevation (Left Side of Rear Facing 2-Story Bldg)

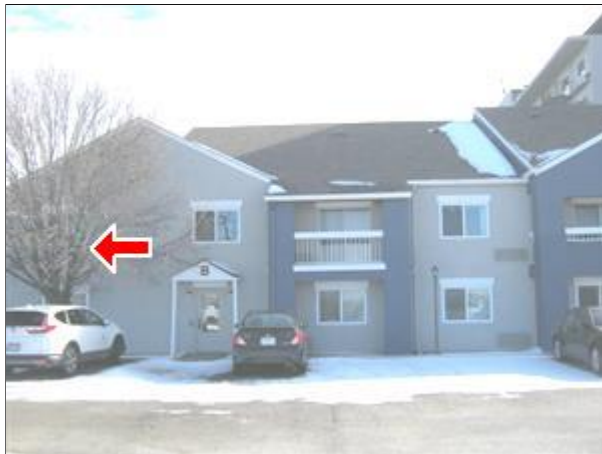
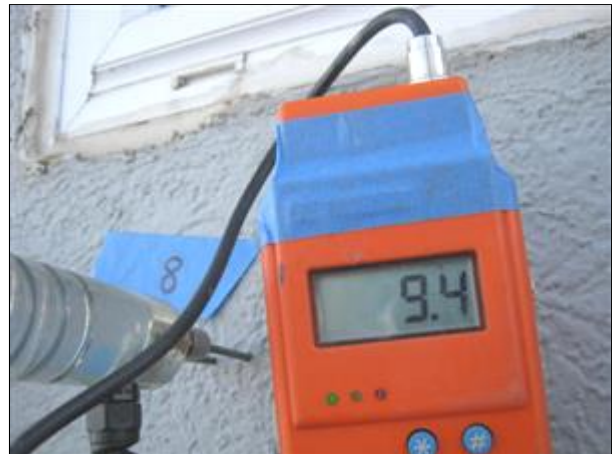
(2) The moisture content when probed was: 9.4%

The Substrate appears SOLID where probed.

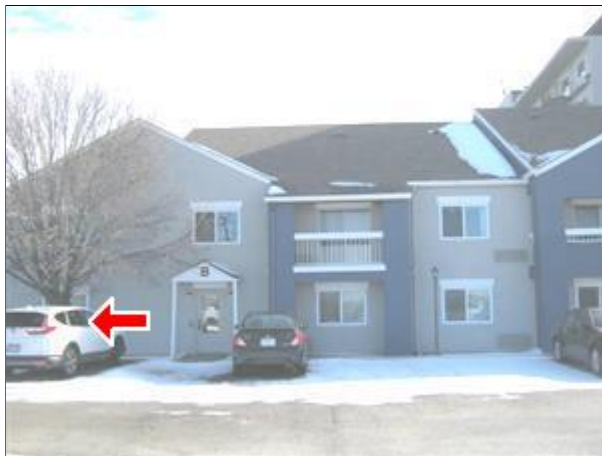
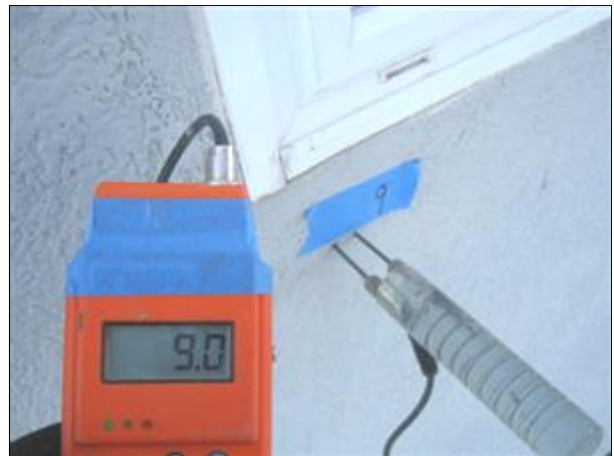
(3) The moisture content when probed was: 9.0%

The Substrate appears SOLID where probed.

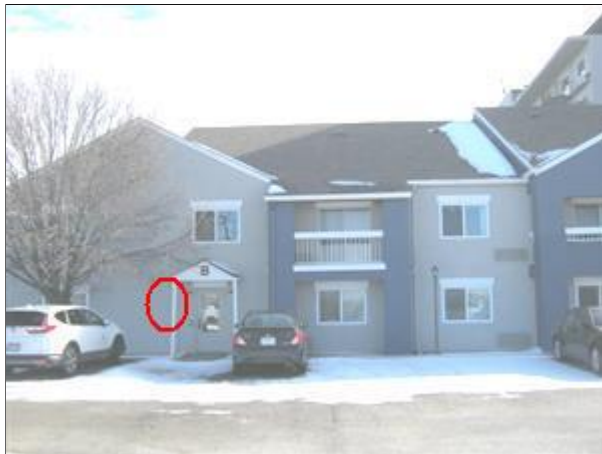
11.2 Picture 9

(4) The moisture content when probed was: 6.1%

The Substrate appears SOLID where probed.

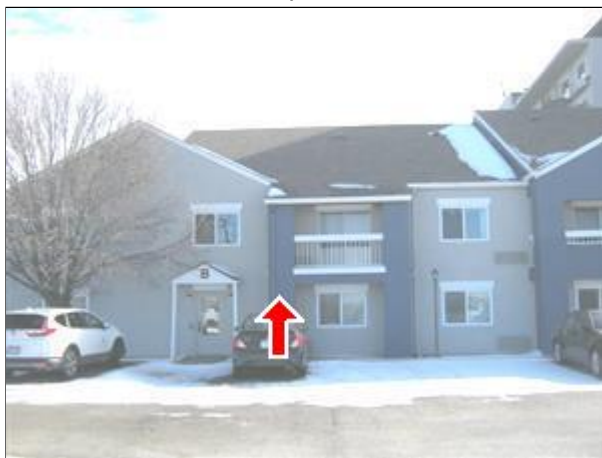
11.2 Picture 11

(5) The moisture content when probed was: 6.4%

The substrate was **SOFT** when probed.

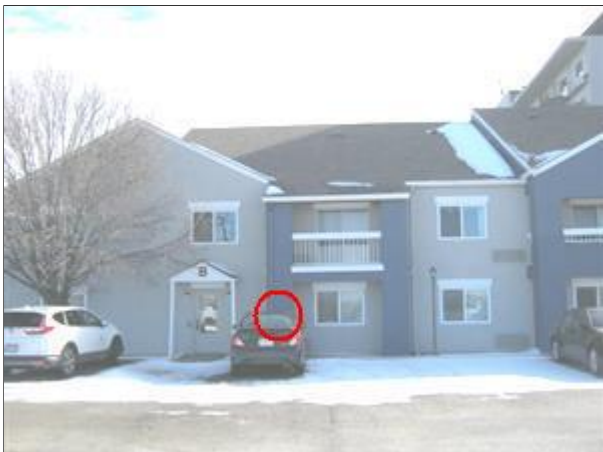
11.2 Picture 13

(6) The moisture content when probed was: 8.0%

The substrate was **SOFT** when probed.

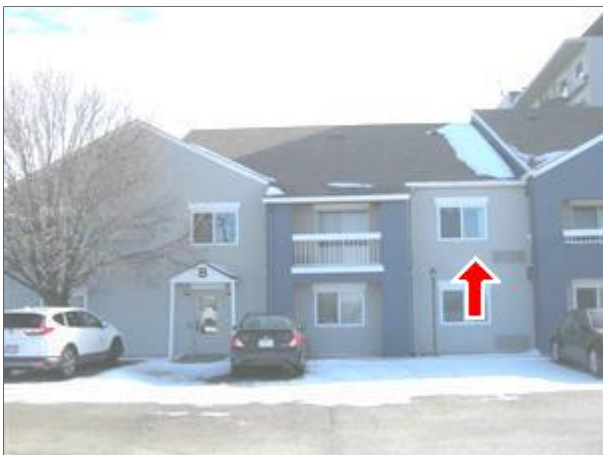
11.2 Picture 15

(7) The moisture content when probed was: 9.4%

The Substrate appears **SOLID** where probed.

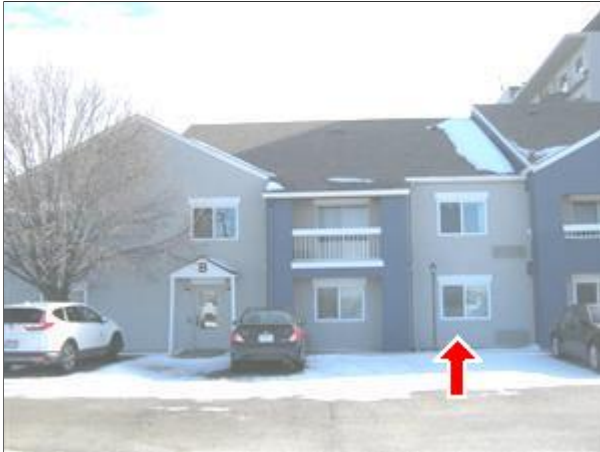
11.2 Picture 17

(8) The moisture content when probed was: 6.9%

The substrate was **SOFT** when probed.

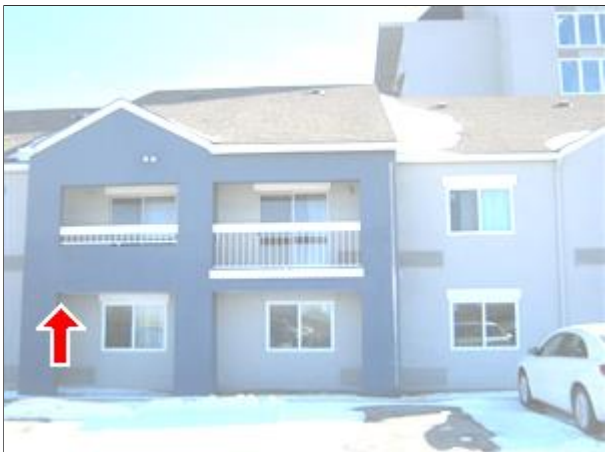
11.3 Picture 2

(2) The moisture content when probed was: 9.4%

The Substrate appears SOLID where probed.

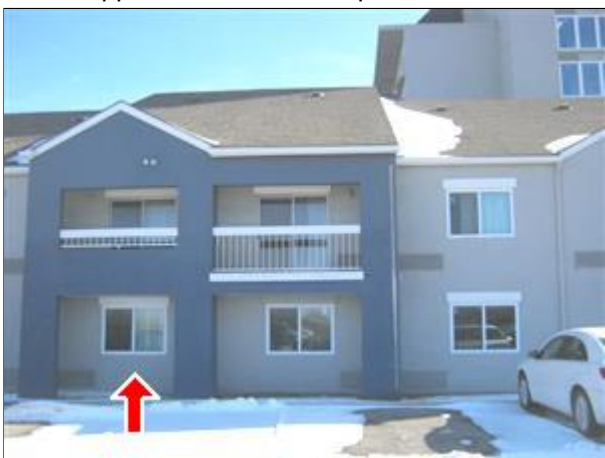
11.3 Picture 4

(3) The moisture content when probed was: 10.2%

The Substrate appears SOLID where probed.

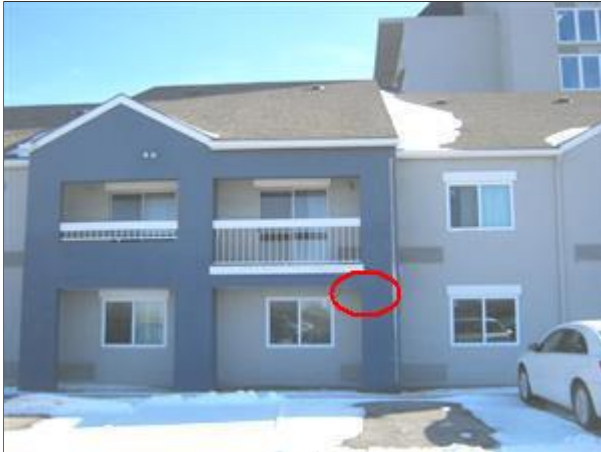
11.3 Picture 6

(4) The moisture content when probed was: 14%

The Substrate appears SOLID where probed.

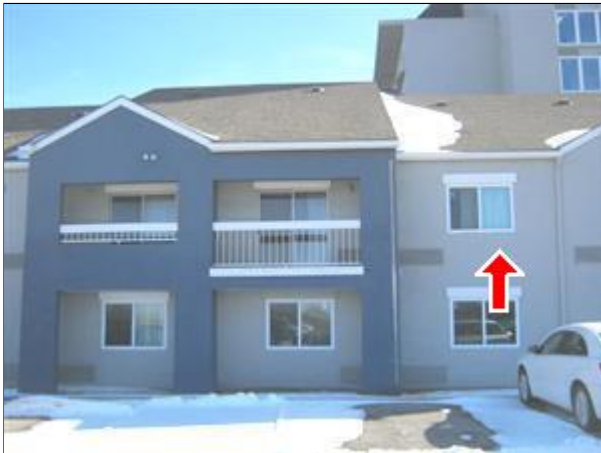
11.3 Picture 8

(5) The moisture content when probed was: 11.1%

The Substrate appears SOFT where probed.
