Inspection Report

Property Address:
4478 SW Sample Dr
Columbia MO 65203

Dan Bowers Company

Date: 1/11/2022	Time: 10:00 AM	Report ID: Sample EIFS
Property: 4478 SW Sample Dr Columbia MO 65203	Customer: John Doe	Real Estate Professional: NONE

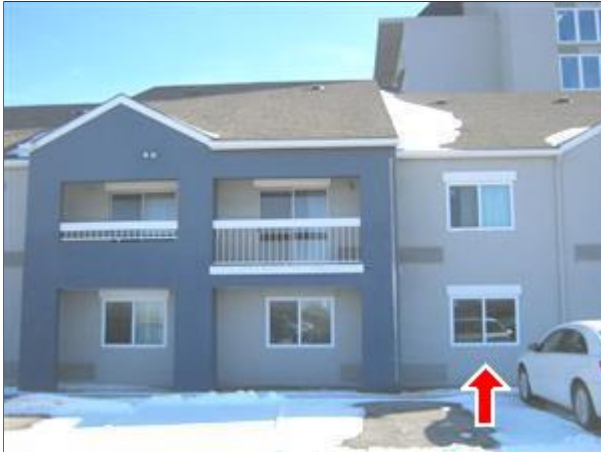
11.3 Picture 10

(6) The moisture content when probed was: **40% (High)**

The Substrate appeared still SOLID where probed.

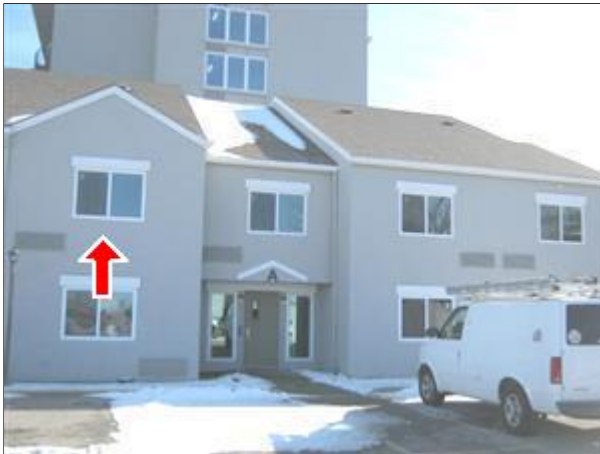
11.4 Picture 3

(2) The moisture content when probed was: **40% (High)**

The Substrate appears **SOFT** where probed.

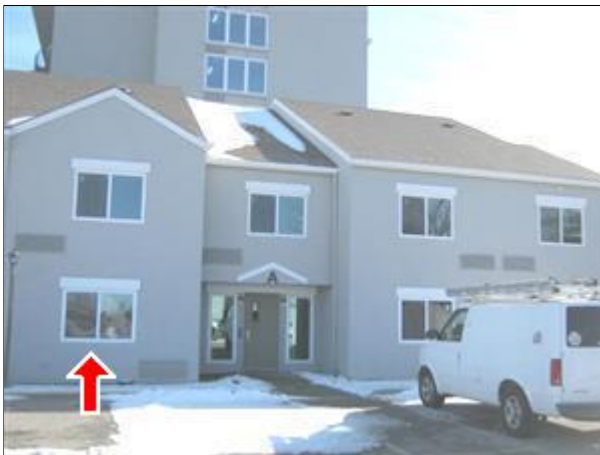
11.4 Picture 5

(3) The moisture content when probed was: **40% (High)**

The Substrate still appeared **SOLID** where probed.

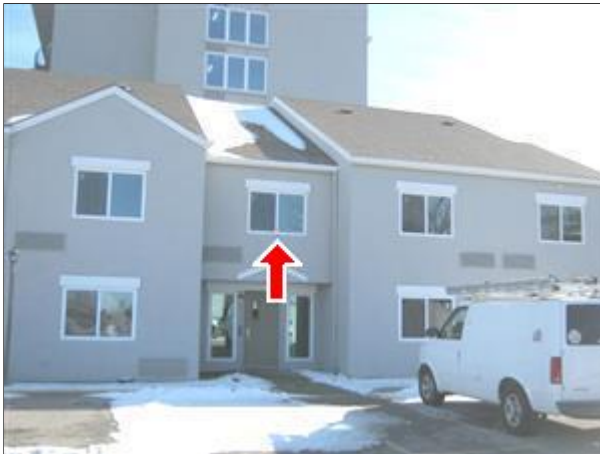
11.4 Picture 7

(4) The moisture content when probed was: **17.8% (Very Close to High)**

The Substrate appears SOLID where probed.

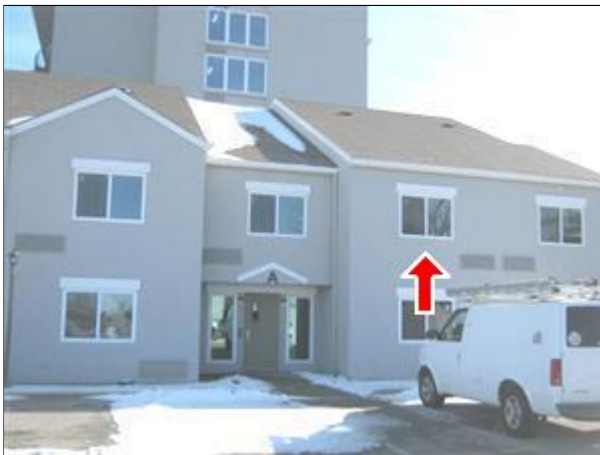
11.4 Picture 9

(5) The moisture content when probed was: 7.7%

The Substrate appears SOLID where probed.

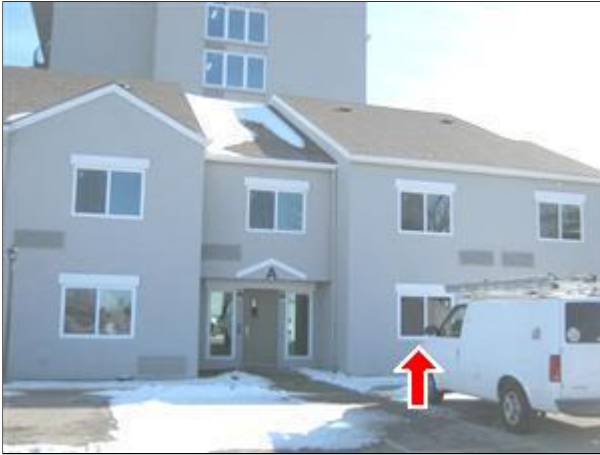
11.4 Picture 11

(6) The moisture content when probed was: 9.9%

The Substrate appears SOLID where probed.

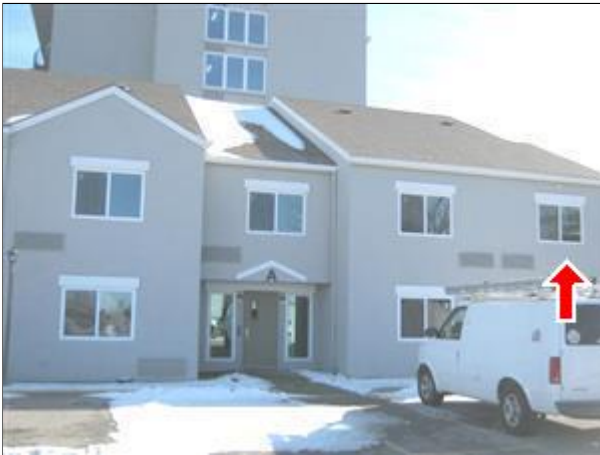
11.4 Picture 13

(7) The moisture content when probed was: 14.8%

The Substrate appears SOLID where probed.

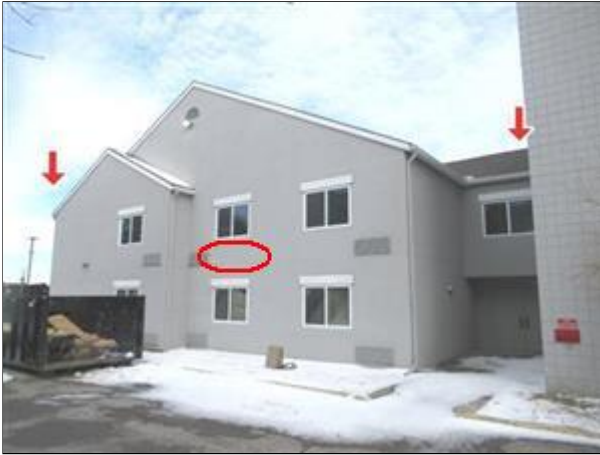
11.5 Picture 2

(2) The moisture content when probed was: 9.3%

The substrate was **SOFT** when probed.

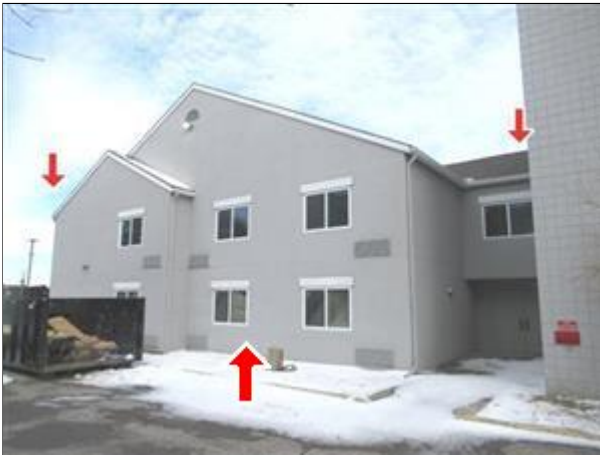
11.5 Picture 4

(3) The moisture content when probed was: **21.1% (High)**

The substrate was still **SOLID** when probed.

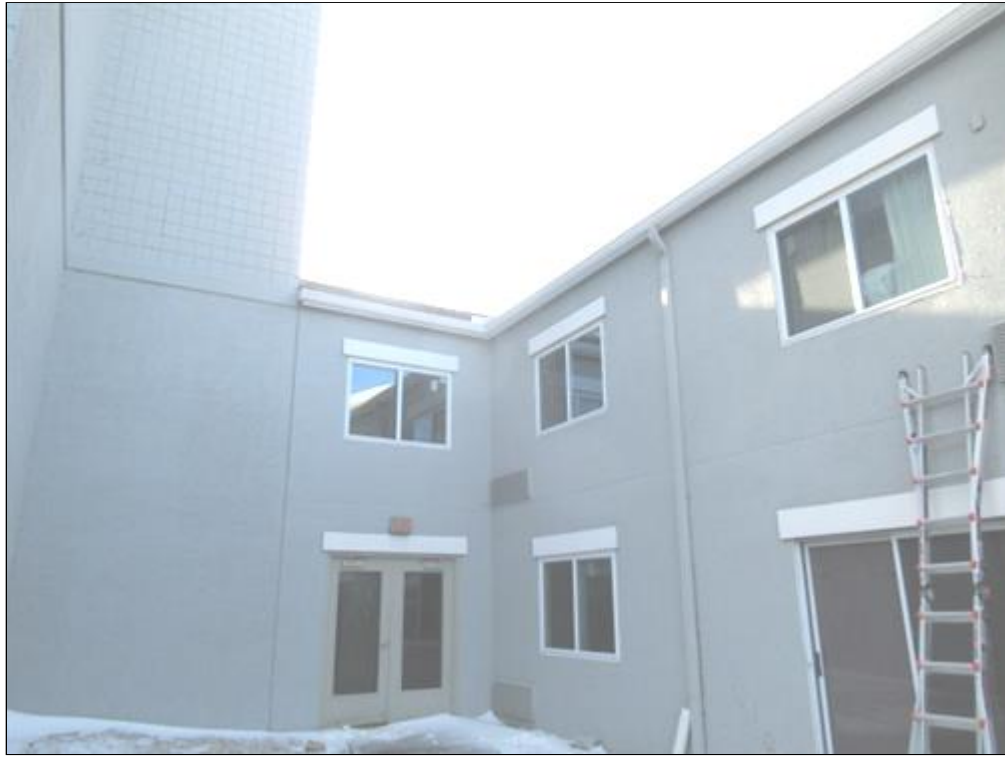
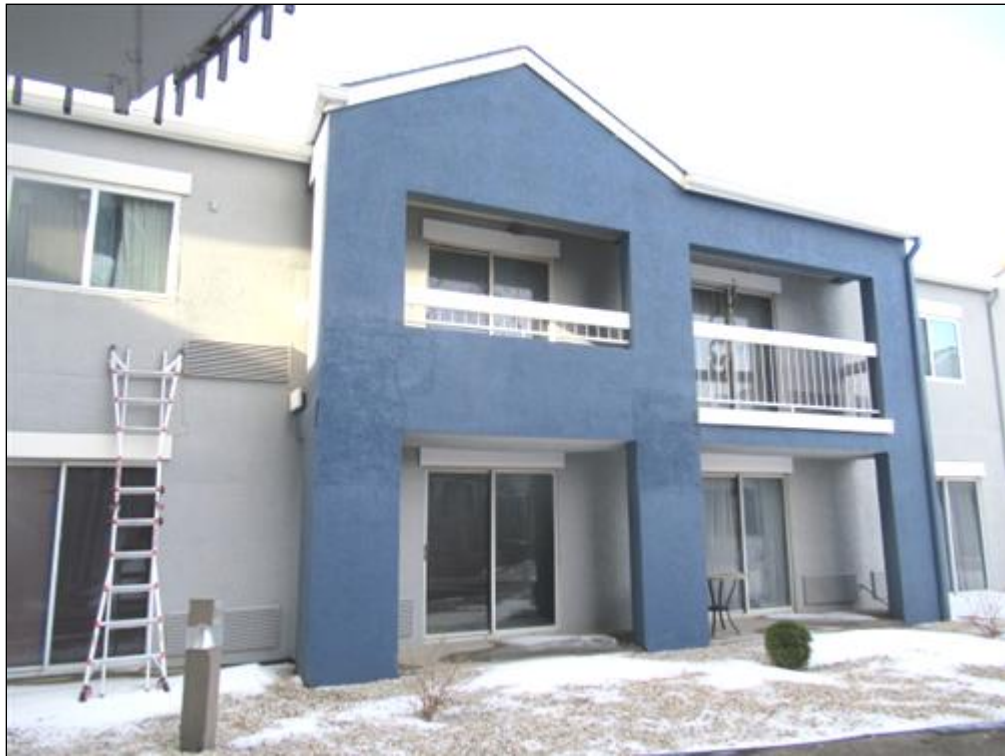
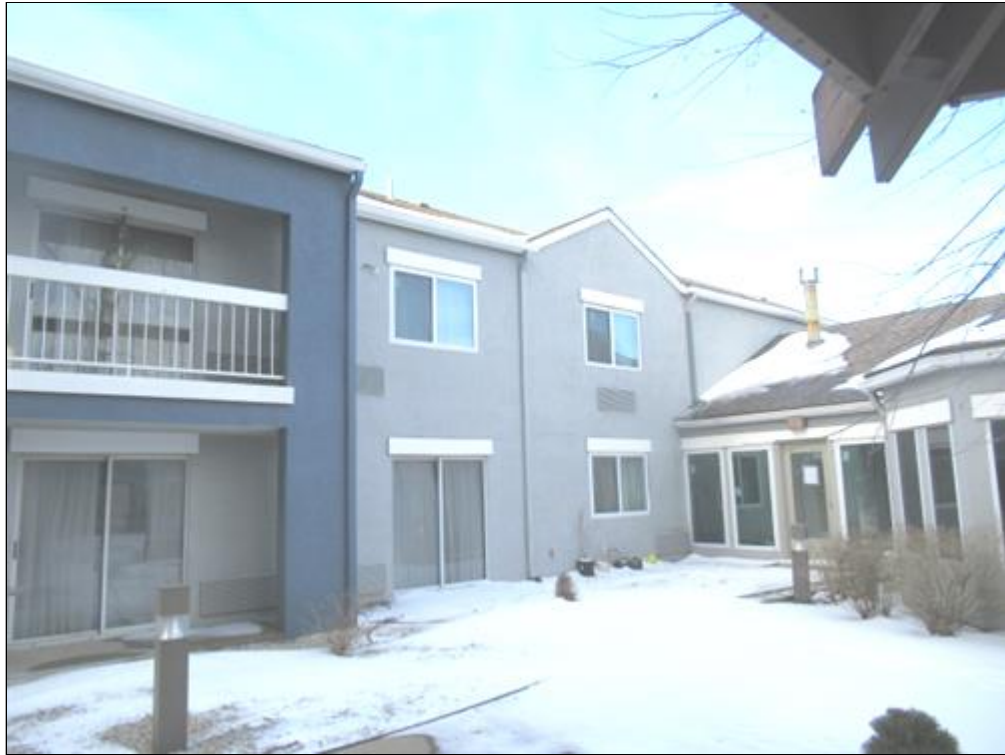
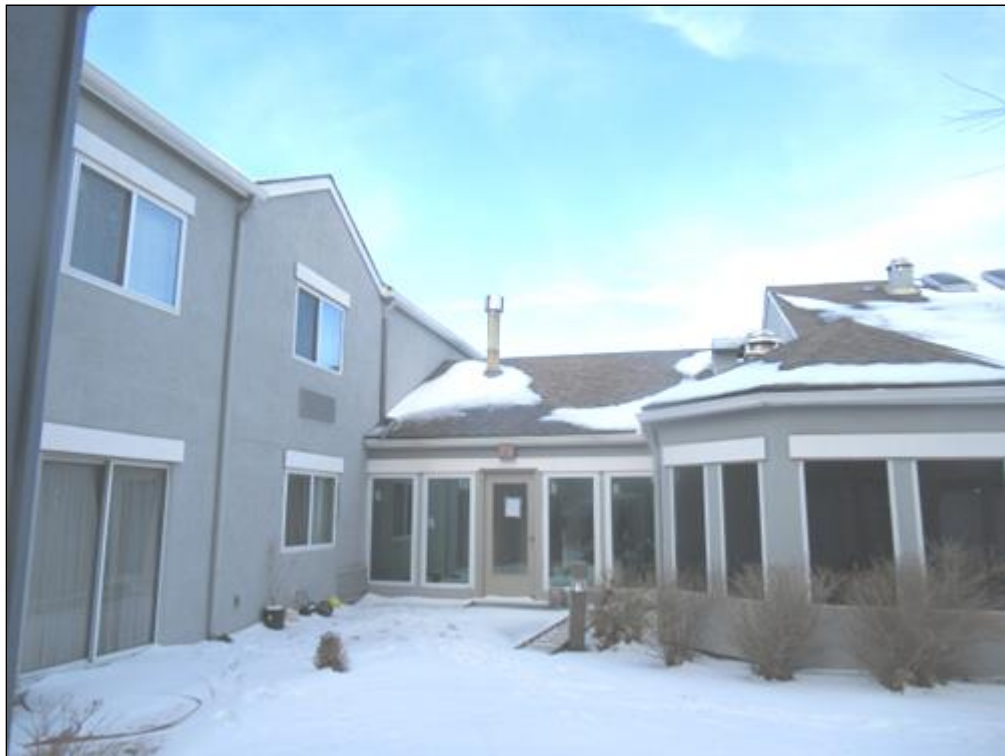
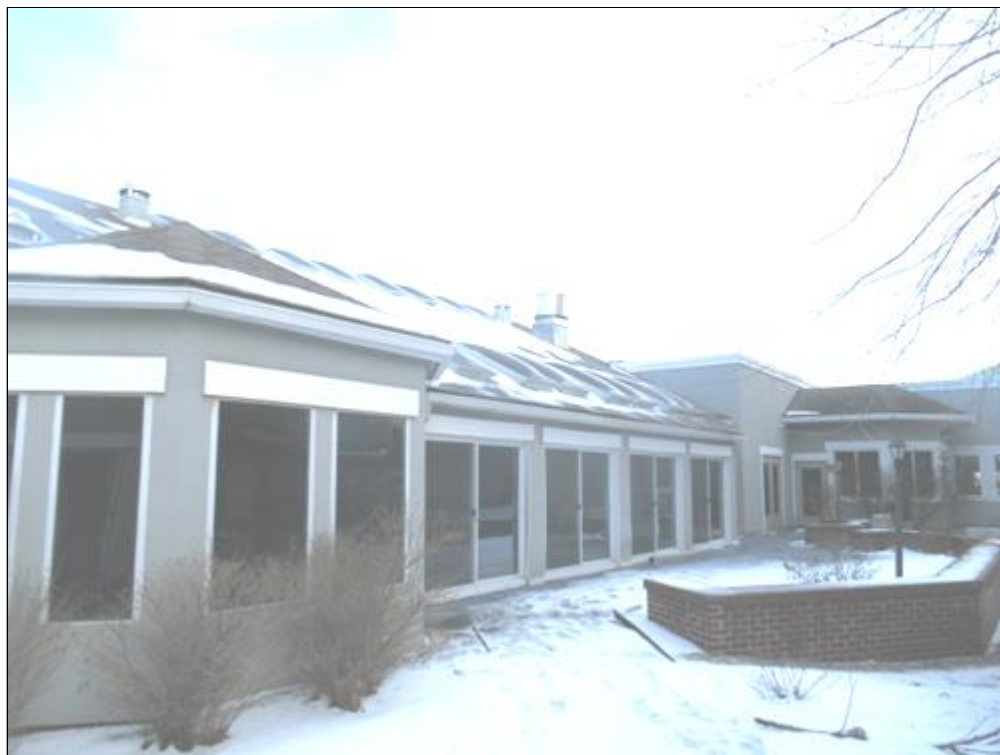
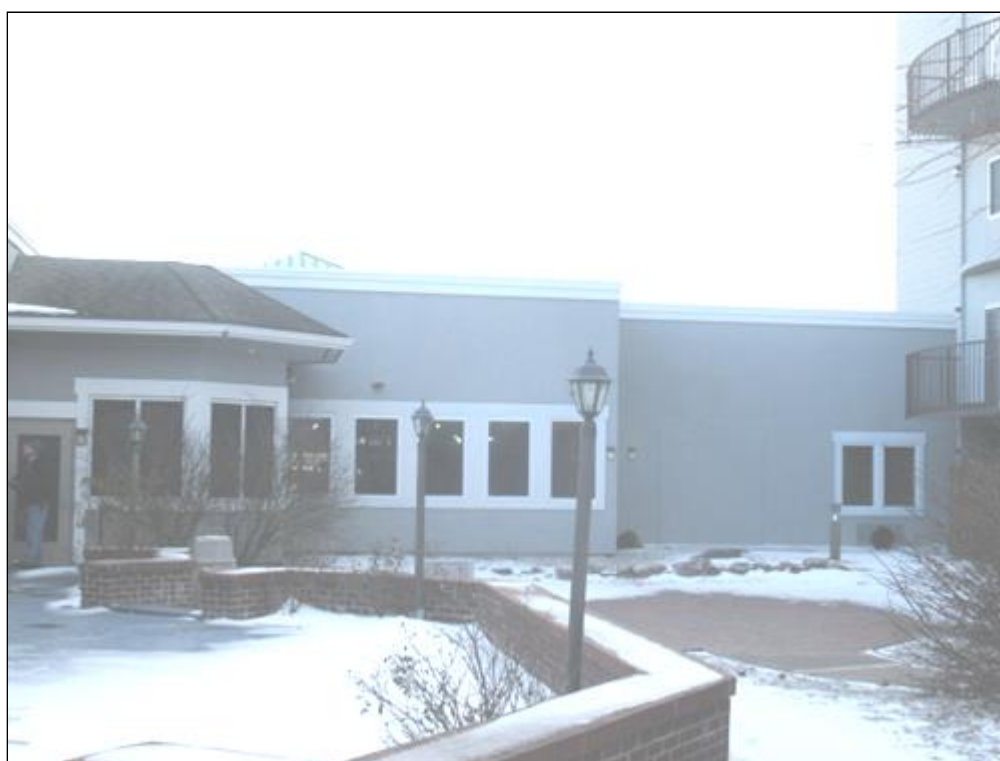
Probing in the Courtyard Areas at various places it felt or looked like they used Drywall for a substrate versus wood.

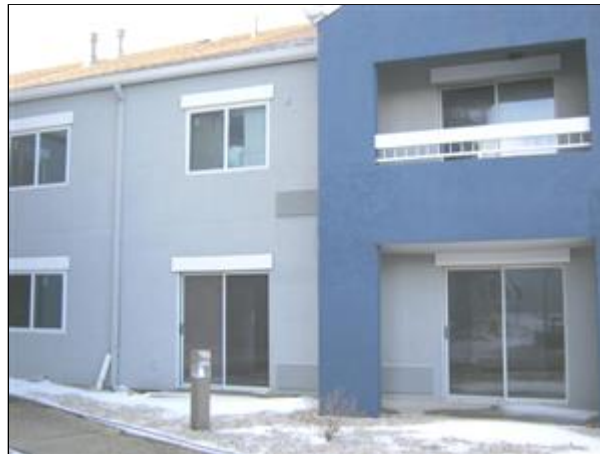
11.7 Picture 1

(1) Inside Courtyard Facing Toward the Parking Lot

Probing in the Courtyard Areas at various places it felt or looked like they used Drywall for a substrate versus wood.

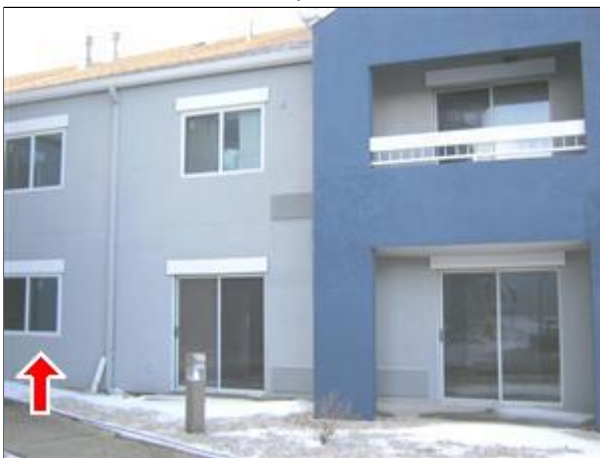
11.7 Picture 2

(2) The moisture content when probed was: 8.6%

The substrate was SOLID when probed.

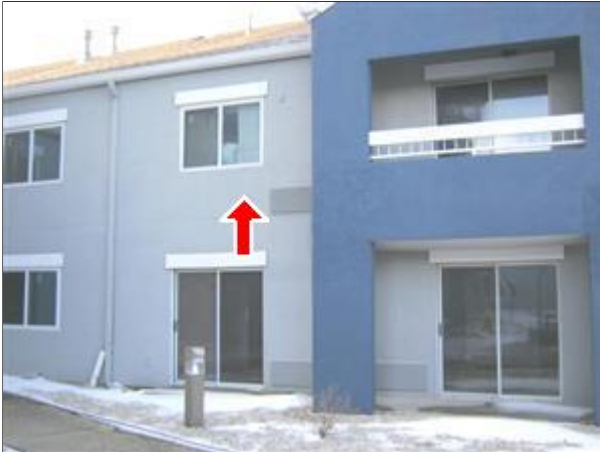
11.7 Picture 4

(3) The moisture content when probed was: **0.0% (Probes hit nothing)**

The substrate was **SOFT** when probed.

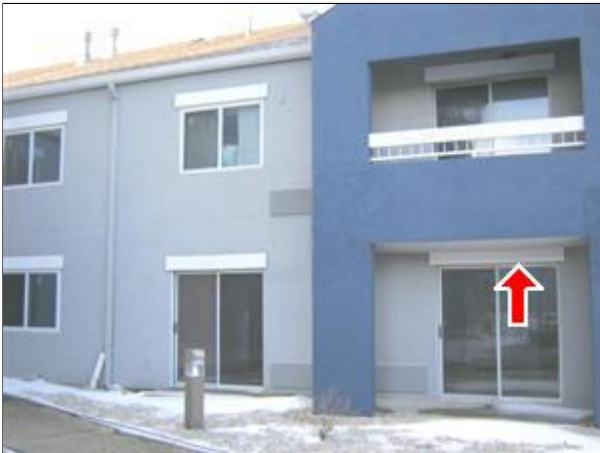
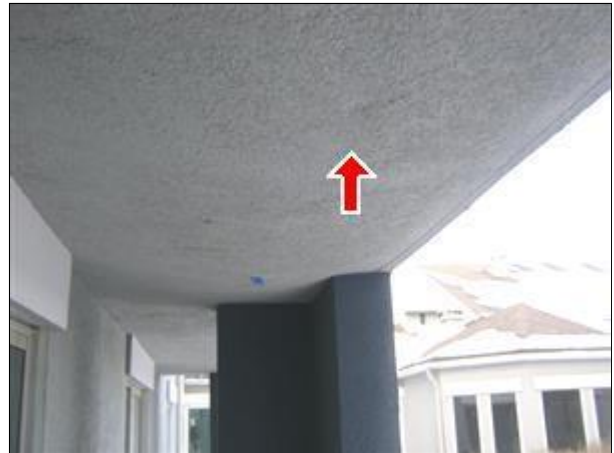
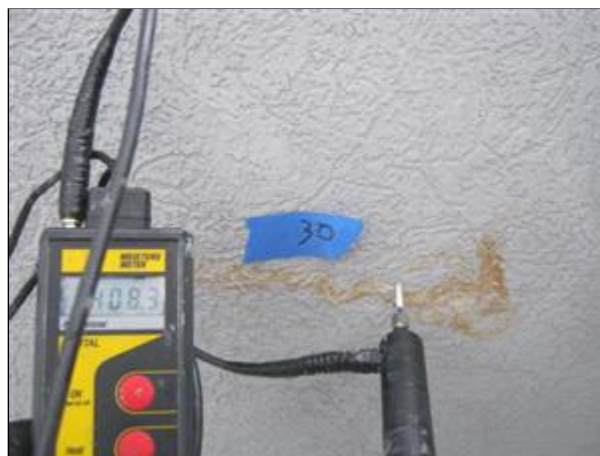
(4) The moisture content when probed was: **8.3% (EIFS is Bowing under Balcony)**

The substrate was **SOFT** when probed.

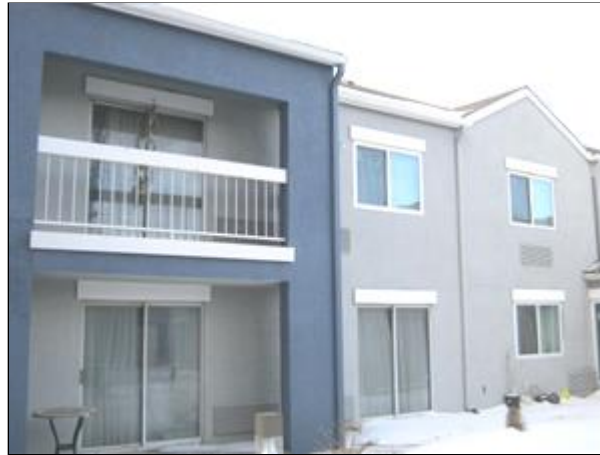
11.8 Picture 1

(1) Courtyard Elevations / Inside Courtyard In Courtyard Facing the Right Side of Bldg Drive

Probing in the Courtyard Areas at various places it felt or looked like they used Drywall for a substrate versus wood.

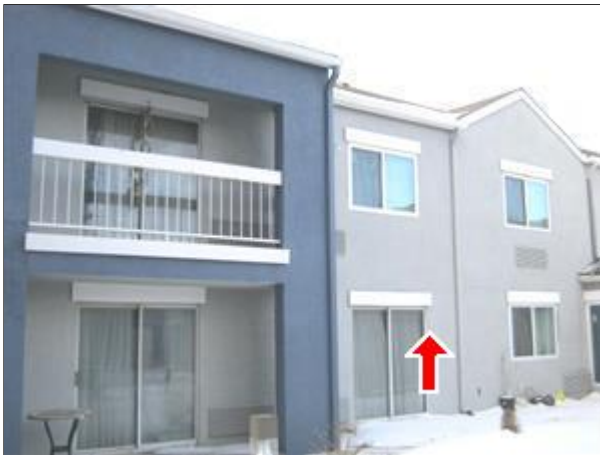
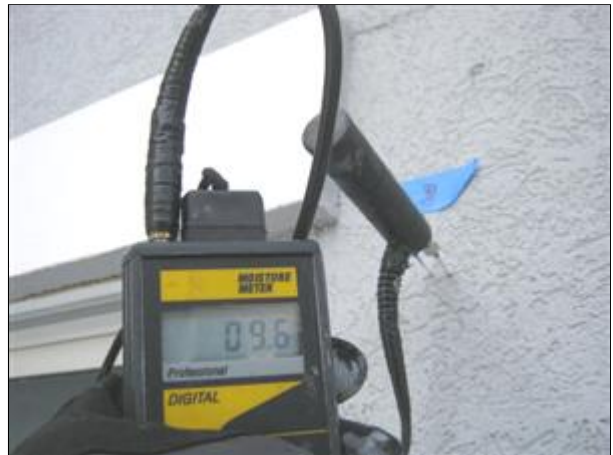
(2) The moisture content when probed was: 9.6%

The Substrate appears SOLID where probed.

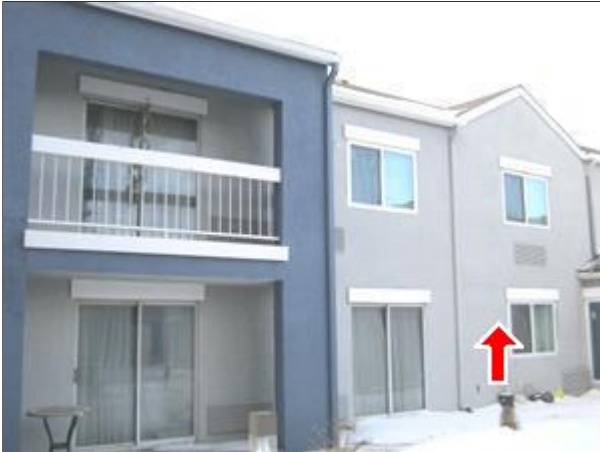
11.8 Picture 4

(3) The moisture content when probed was: 13.9% (By Cracks)

The Substrate appears SOLID where probed.

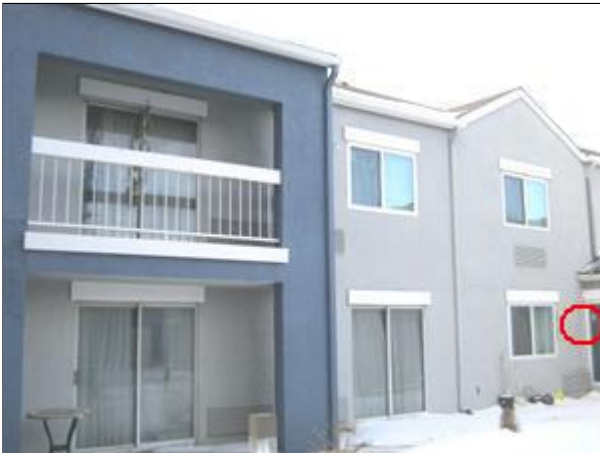
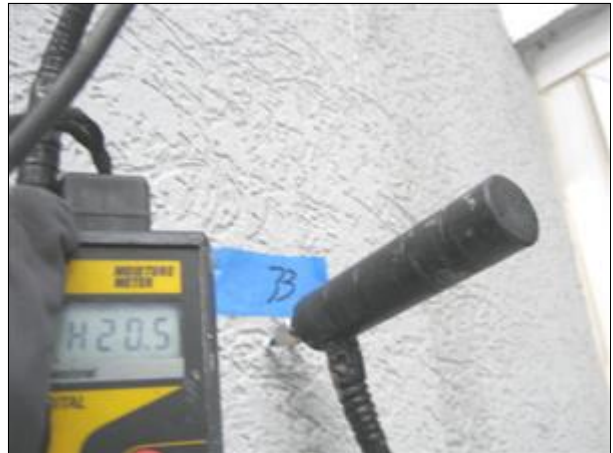
(4) The moisture content when probed was: **20.5% (High Under Missing Kickout)**

The Substrate appears **SOFT** where probed.

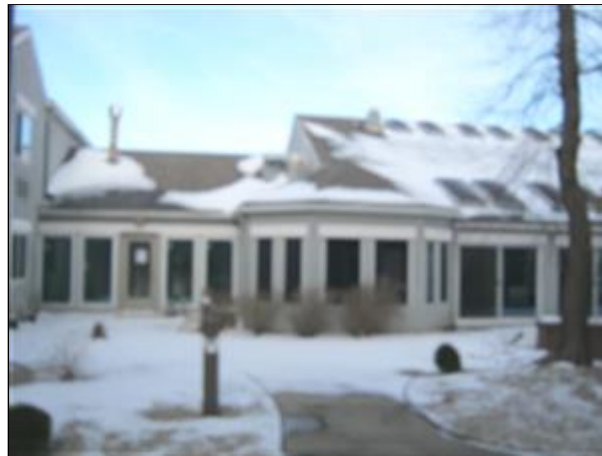
11.9 Picture 1

(1) Courtyard Elevations / Inside Courtyard In Courtyard Facing left Side

Probing in the Courtyard Areas at various places it felt or looked like they used Drywall for a substrate versus wood.

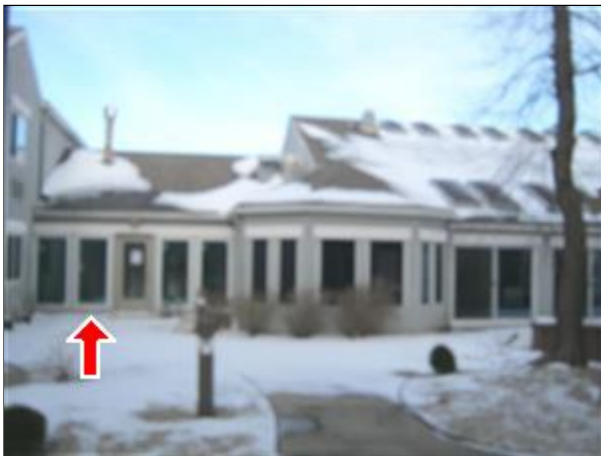
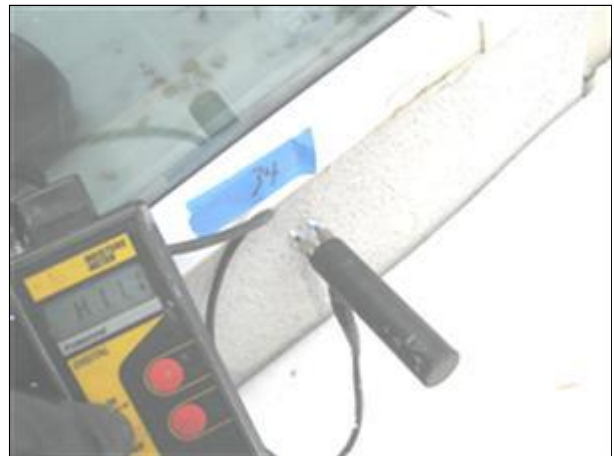
(2) The moisture content when probed was: 11.1%

The Substrate appears SOLID where probed.

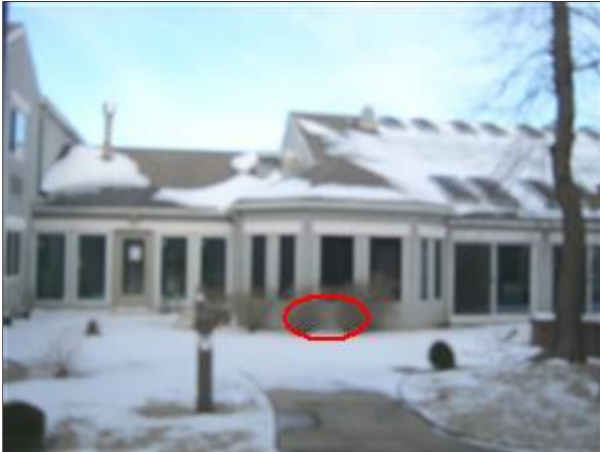
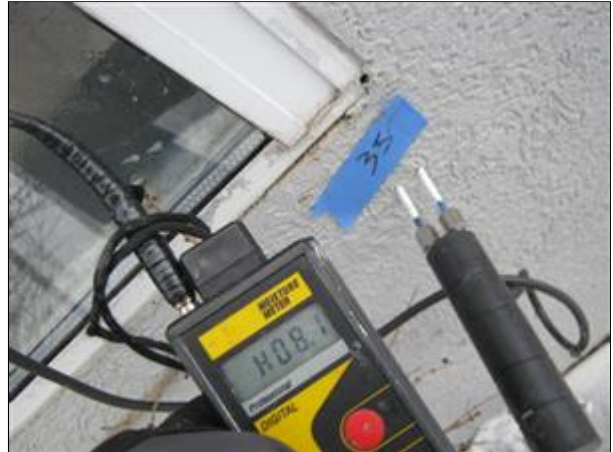
(3) The moisture content when probed was: 8.1%

The Substrate appears SOLID where probed.

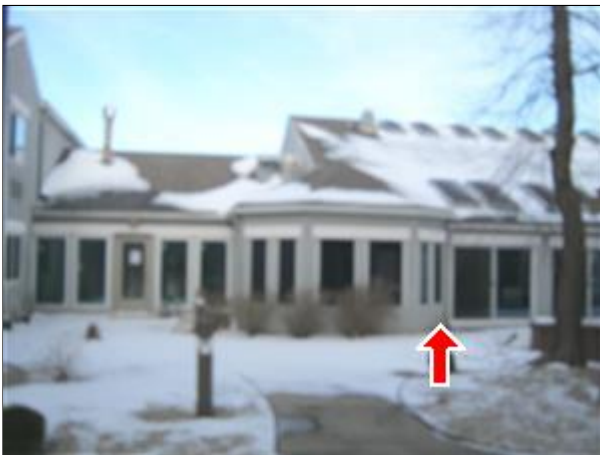
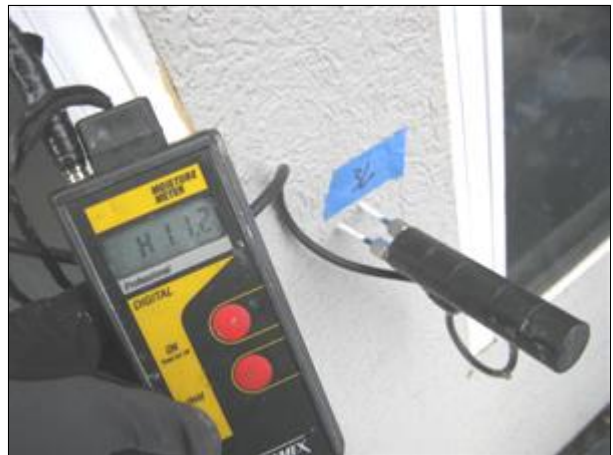
(4) The moisture content when probed was: 11.2%

The Substrate appears **SOFT** where probed.

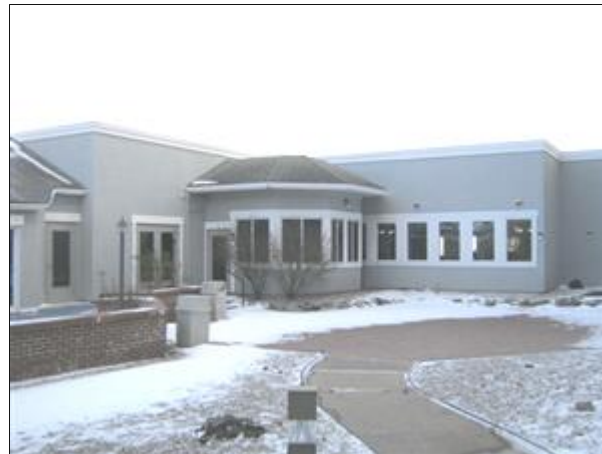
11.10 Picture 1

(1) Courtyard Elevations / Inside Courtyard In Courtyard Facing toward the Office Area

Probing in the Courtyard Areas at various places it felt or looked like they used Drywall for a substrate versus wood.

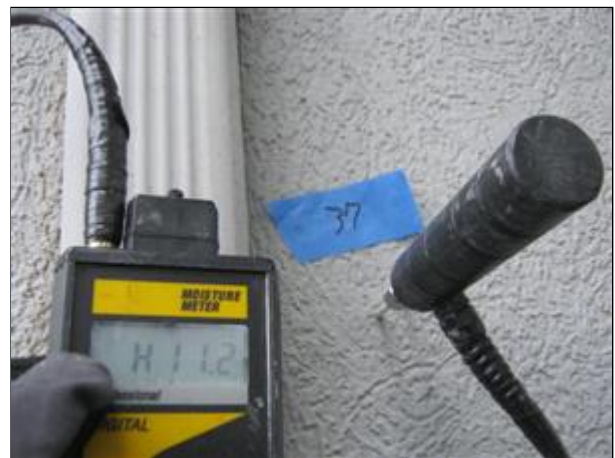
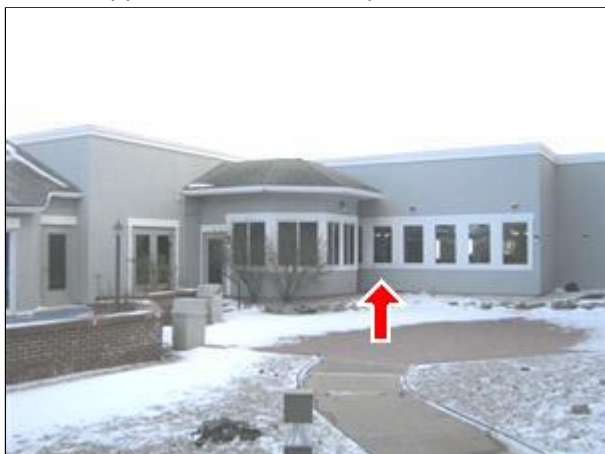
(3) The moisture content when probed was: 10.8%

The Substrate appears SOLID where probed.

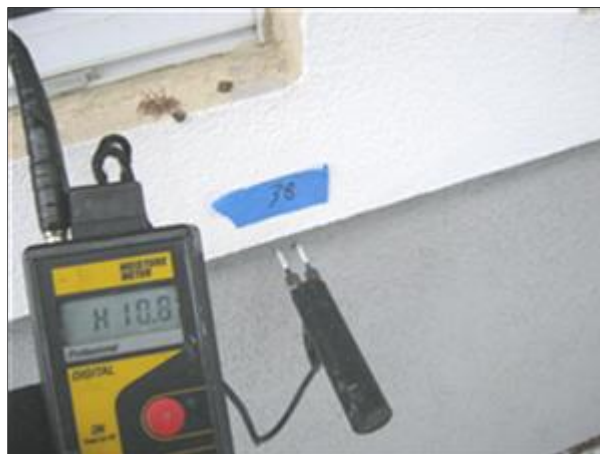
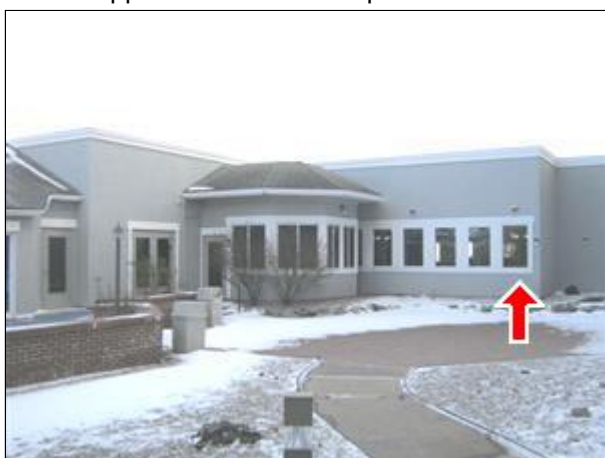
(4) The moisture content when probed was: 6.9%

The Substrate appears SOLID where probed.
