# Inspection Report

**Property Address:**  
4154 Anywhere Street  
Overland Park KS 66208

<b>Date:</b> 5/31/2020	<b>Time:</b> 01:00 PM	<b>Report ID:</b> 4207 - EIFS
<b>Property:</b> 4154 Anywhere Street Overland Park KS 66208	<b>Customer:</b> Tom Thumb	<b>Real Estate Professional:</b> RALTER

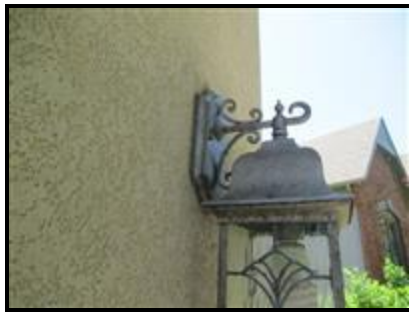
3.1 Picture 1

**3.1** Anywhere an electrical line, gas line, light fixture, plumbing hose bibb, etc. penetrate the exterior walls they are commonly called a "breach location" in the stucco world. Although some breach locations were properly sealed, others were not. Caulk or re-seal any place below the soffit line where stucco meets another material such as around dryer vents, hose bibbs, electrical outlets or light fixtures, cable TV openings, freon lines, and other penetrations of the wall cladding materials.

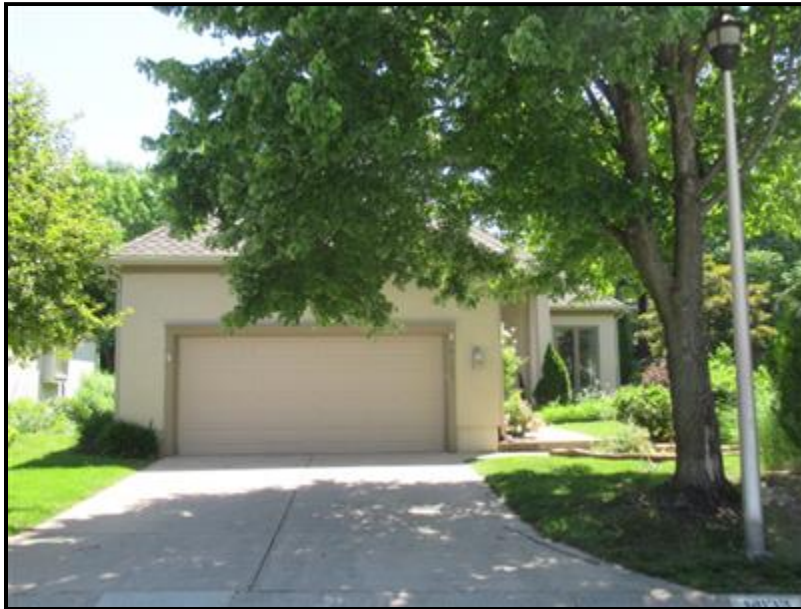
11.0 Picture 1

(2) The moisture content when probed was: 14.7%

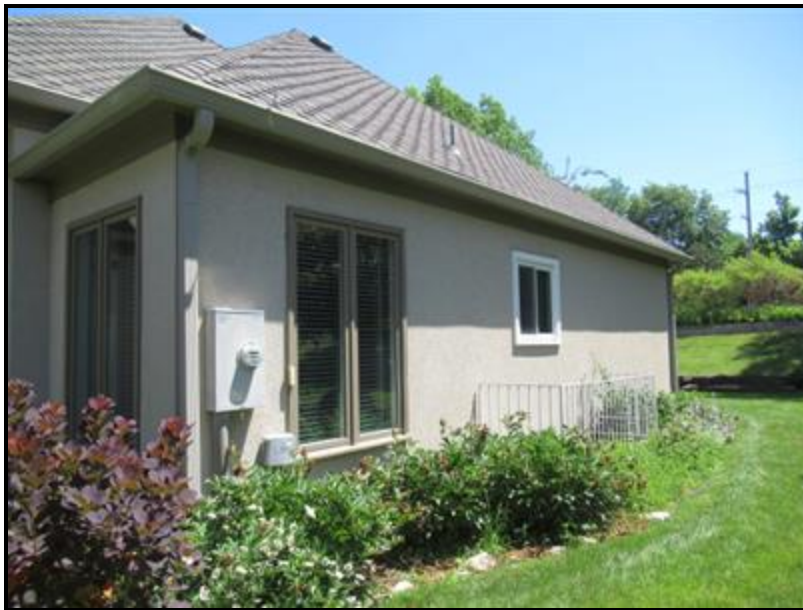
11.1 Picture 1

(2) The moisture content when probed was: 9.8%

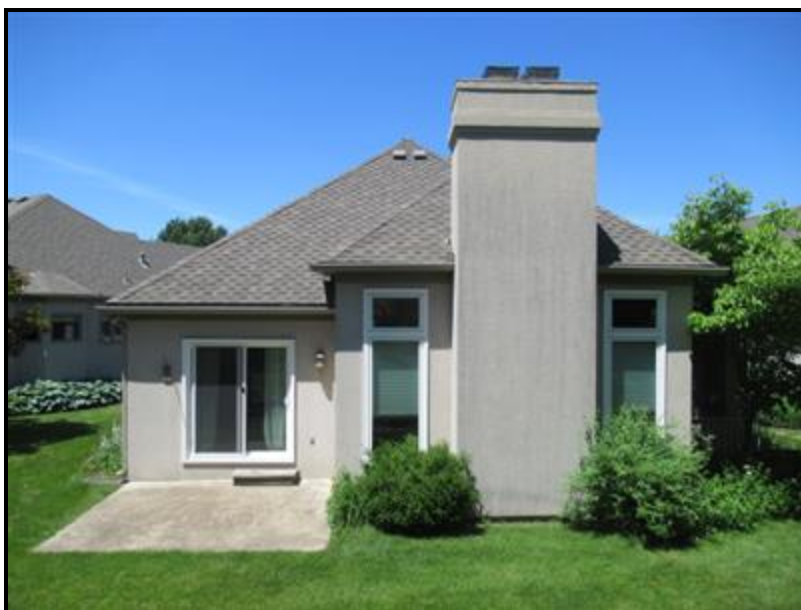
11.2 Picture 1

(2) The moisture content when probed was: 12.6%

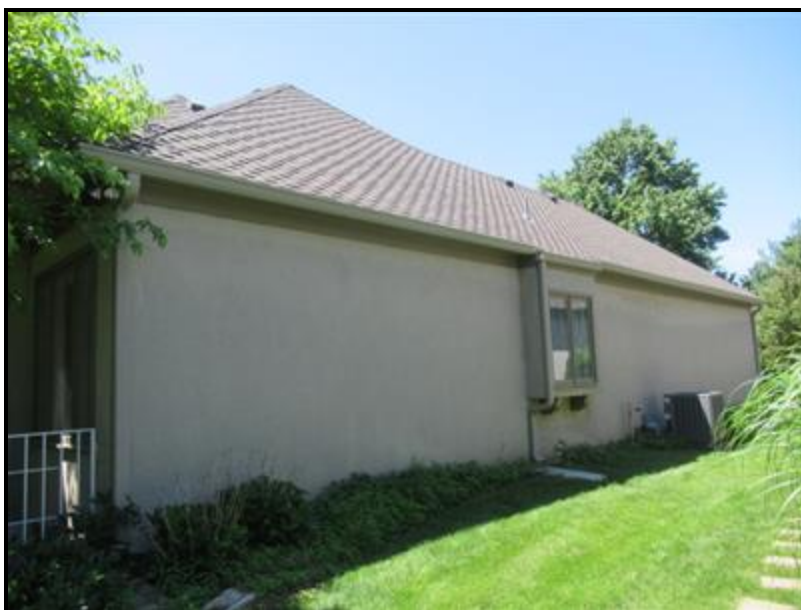
11.3 Picture 1

(2) The moisture content when probed was: 15.7%
